THIRD BROOK WATERSHED MANAGEMENT PLAN

December 2013

MMI #4444-01

MILONE & MACBROOM, INC.
99 Realty Drive
Cheshire, CT 06410
(203) 271-1773
www.miloneandmacbroom.com

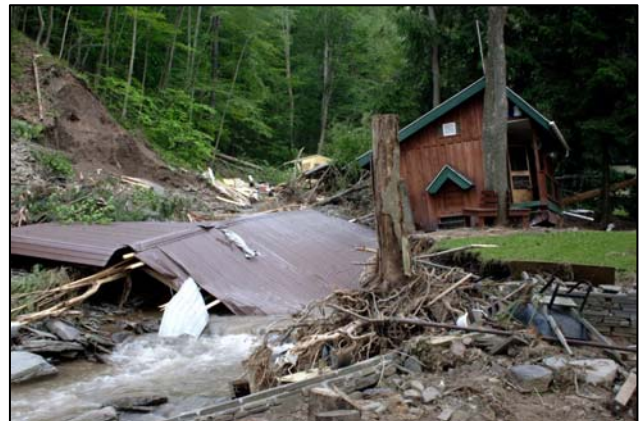
Damage in residential area along east side of Third Brook

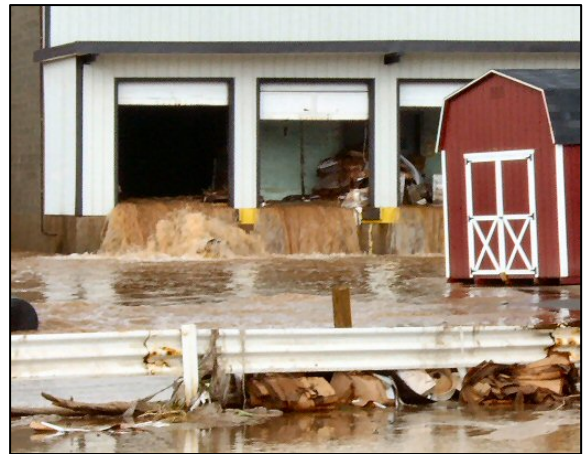
Downstream of Ogden Street, the Klinger Power Sports buildings were flooded, and contents were destroyed. Water flowed through the buildings, as shown in the photograph to the right. The entire block of commercial buildings from Klinger down past the old Agway store to the Robinson Auction House was badly flooded, as shown in the photograph below. Additional debris was picked up by floodwaters through this block of commercial properties.

Klinger Power Sports, courtesy of www.klingerpowersports.com

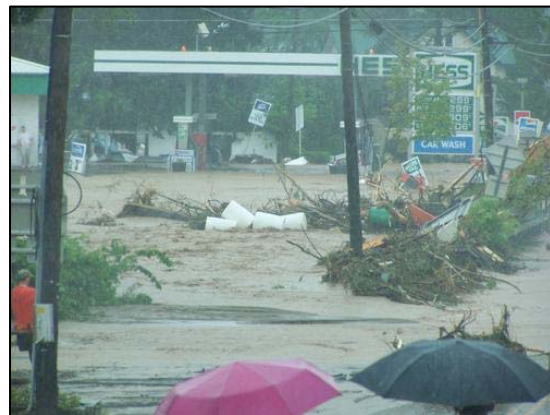
Debris in the Third Brook floodwaters clogged the bridge at Ogden Street and Delaware Street, making flooding worse. The Hess gasoline service station was flooded on the upstream side of Delaware Street as pictured to the right.

**Hess service station courtesy of
www.floodny06.zoomshare.com**

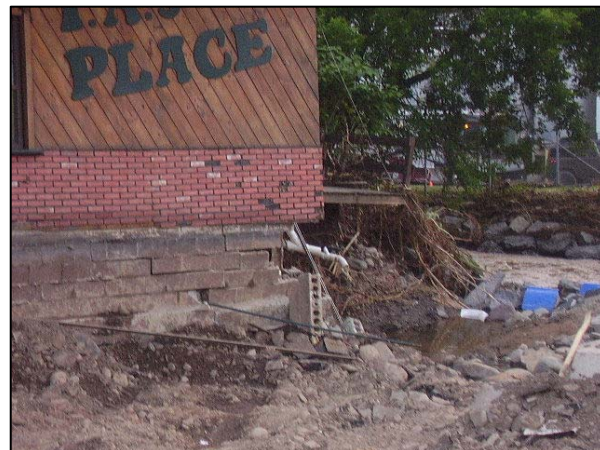
Across the street, TA's Restaurant, Subway, and associated properties were flooded, and buildings were damaged.

**TA's Place courtesy of
www.floodny06.zoomshare.com**

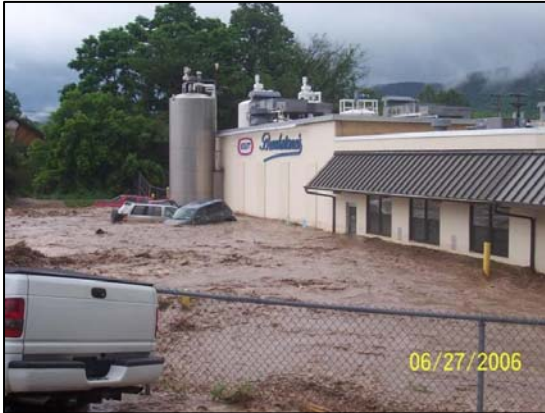
Across the brook from TA's Place, floodwaters engulfed the Kraft facility, and floating debris from upstream reaches damaged the buildings.

Kraft, courtesy of Delaware County

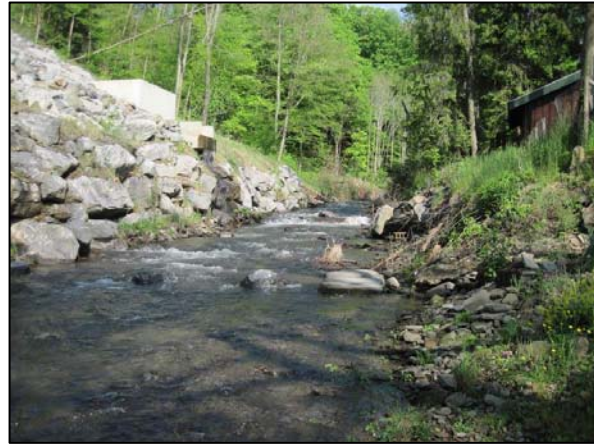
Incised channel with riprap slope stabilization on the right descending bank

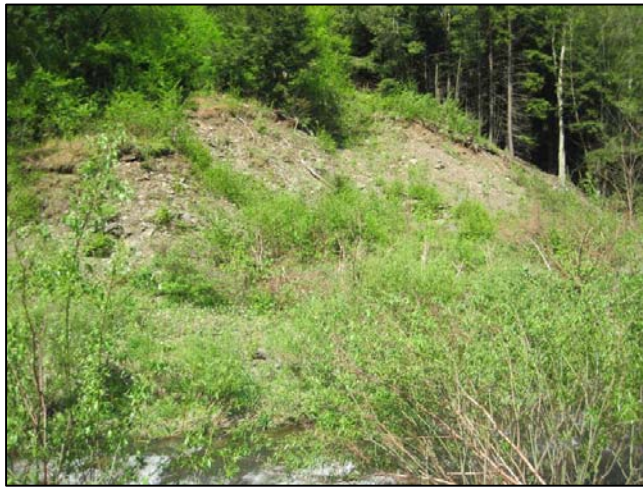
Bank slope failure near station 58+00

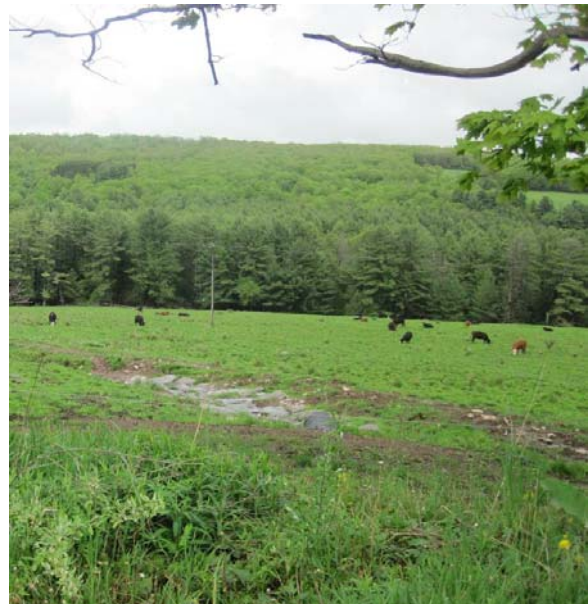
Tributary to Third Brook flowing over pasture with soil erosion evident. Confluence with Third Brook is between stations 290+00 and 280+00.

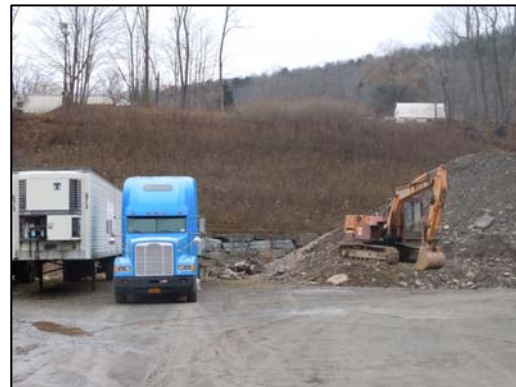
**View of failure 1 from Harold Neale
Excavating Company**

3.7). When facing the new outfall, it is apparent that the right-hand side of the former failed slope is still at risk. The toe of the slope is eroding, and a scarp is visible near the top of the slope. Few trees are located on the slope; it is primarily grassy. The area of the failing part of the slope is 11,145 square feet.

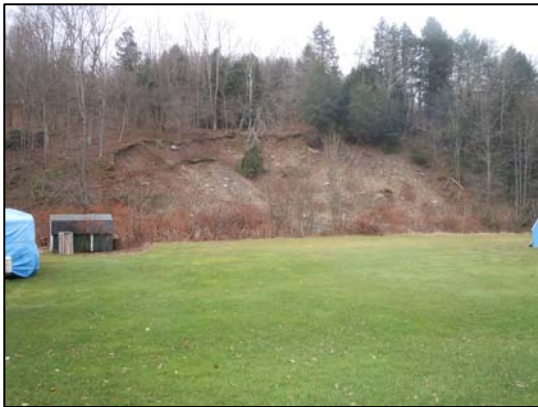
View of failure 4 from opposite side of brook

Failure 4 has a variable surface with some fallen trees. Photographs from March 2007 show groundwater seeping from the face of the slope. The area of the failing part of the slope is 20,758 square feet.

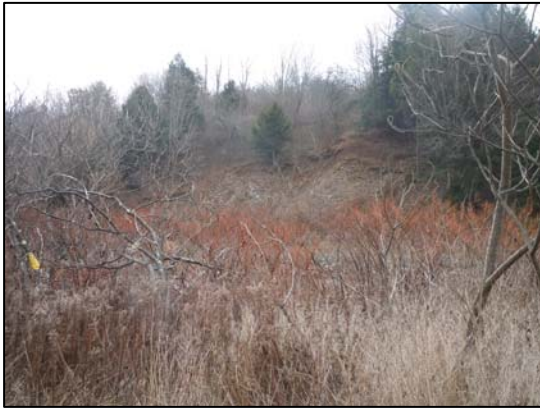
View of failure 6 from opposite side of brook

Failure 6 has a variable surface with some fallen trees. The scarp does not appear to reach the top of the slope. The combined area of failures 5 and 6 is 32,807 square feet.

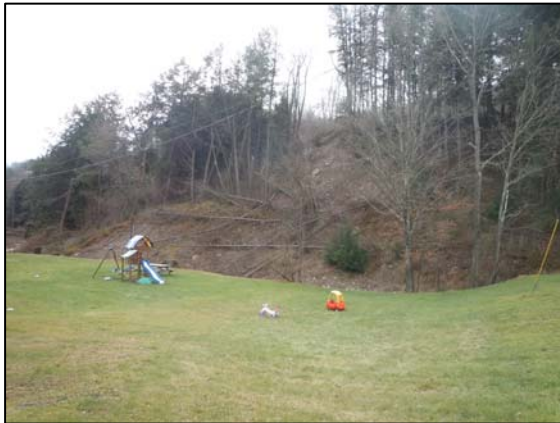
View of failure 8 from opposite side of brook

Failure 8 is downhill from a field, and it may receive some runoff from this area, especially given that drainage outfalls associated with Route 206 are located along this field. The scarp reaches from the top of the slope to the brook and is therefore higher than some of the others. The combined area of failures 7 and 8 is 100,234 square feet (over two acres).

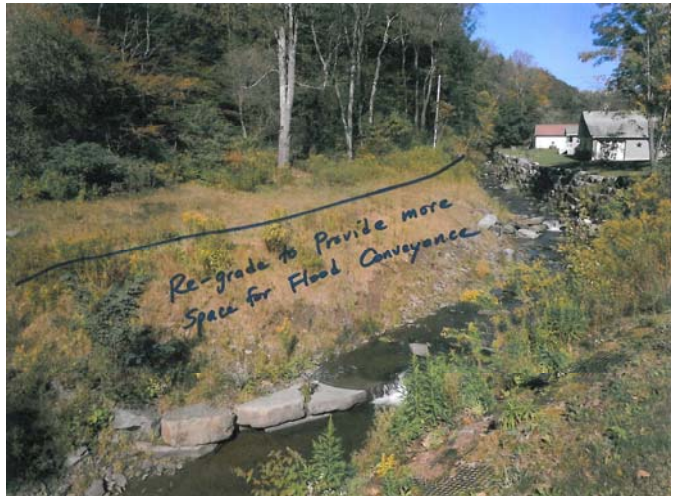
Potential area of floodplain bench behind 599 and 683 Lower Third Brook Road

- ❑ A mature previously failed slope is located across the brook from the homes at 683 and 599 Lower Third Brook Road. Cross section 8 is located in this area. The slope is vegetated and appears stable. The lower part of the slope is currently not mapped as a SFHA but may provide limited floodplain function. It may be possible to excavate the lower part of this slope and create a lower floodplain. If so, the new floodplain may allow some spreading of flood flows in this area, possibly providing flood mitigation immediately upstream for the homes at 683 and 709 Lower Third Brook Road or providing lower shear stress on the rock walls on the left bank.

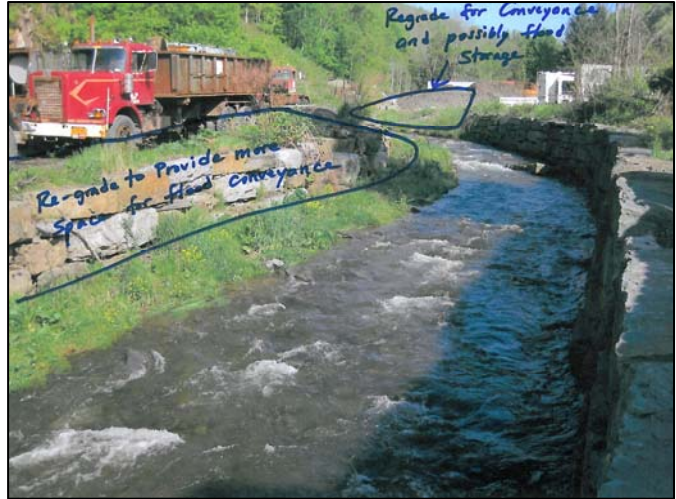
Potential area of floodplain benches behind Harold Neale Excavating and on Del-Ton Sanitation site

- ❑ Del-Ton Sanitation occupies a long, narrow strip of property along Third Brook that would be ideal for creating a floodplain bench. The benefits of using this property are both logistical (it would be easier to work with one property owner rather than many) and hydrologic (the site is well positioned to be converted to a floodplain bench). Creation of floodplain on the Del-Ton site may provide relief to those properties immediately across the brook, including Frontier Communications, the Walton Fire Department, the backyard of 57 West Street, and the home at 8 Ogden Street, or may cause lower shear stress on the rock and concrete walls on the left bank.

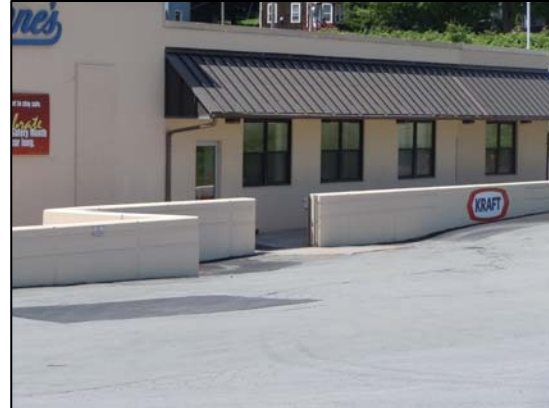
A low floodwall was built on the Kraft site after the flooding of 2006, but the purpose of the wall is to prevent debris caught in floodwaters from damaging the facility. The wall will not prevent flooding and is not continuous around the facility.

Existing Low Wall at Kraft Facility
