East Branch Delaware River

Stream Corridor Management Plan

Volume 2

December 2007

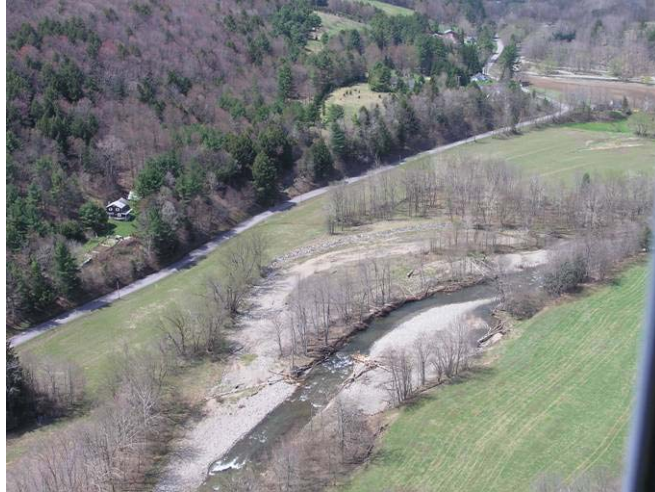
Figure 1.3 Dry Brook Mainstem

Generally speaking, Dry Brook is unstable with large and extensive sediment deposits and many raw eroding streambanks and slope failures. **Figure 1.3** shows a section of the Dry Brook mainstem with excess sediment and channel migration. A review of the 2001 aerial photographs will show many areas of deposition, including side bars and center bars. The depositional features are frequently found downstream of reaches where degradation and downcutting appear to be the trend. Overall, the stream system has actively downcut

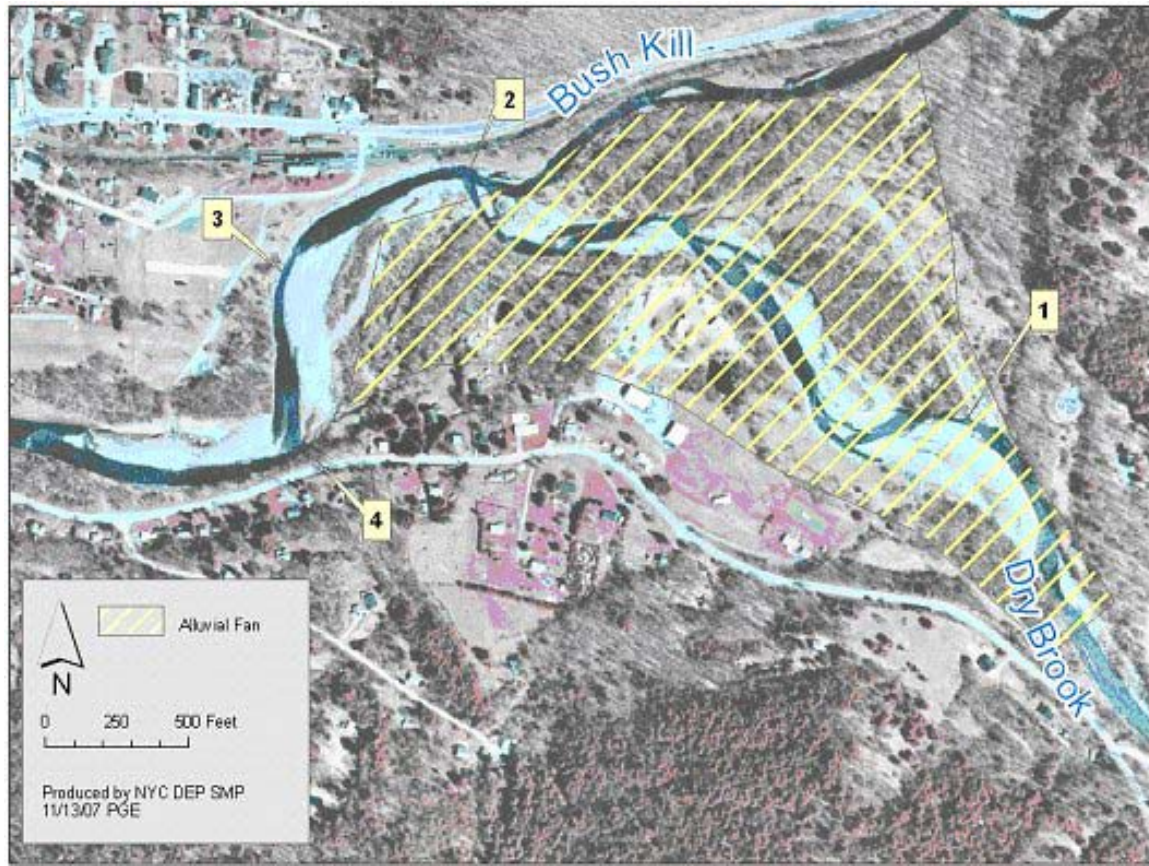
Figure 1. 4 Stream Alignment at Bush Kill Confluence in 2001

Alluvial fans, delta like settings at the outlet or confluence of a river or stream, are areas of stream instability where the channel can laterally adjust rapidly as bedload exceeds the transport capacity of the stream. One significant and problematic alluvial fan on Dry Brook is located at the confluence of Bush Kill. At the upstream point of the fan on Dry Brook there is a series of four bends that are characterized by wide gravel point bars and long side bars. At point 1 in **Figure 1.4**, the stream exhibits a tendency to *braid* or break into multiple channels that interweave through the gravel deposits.

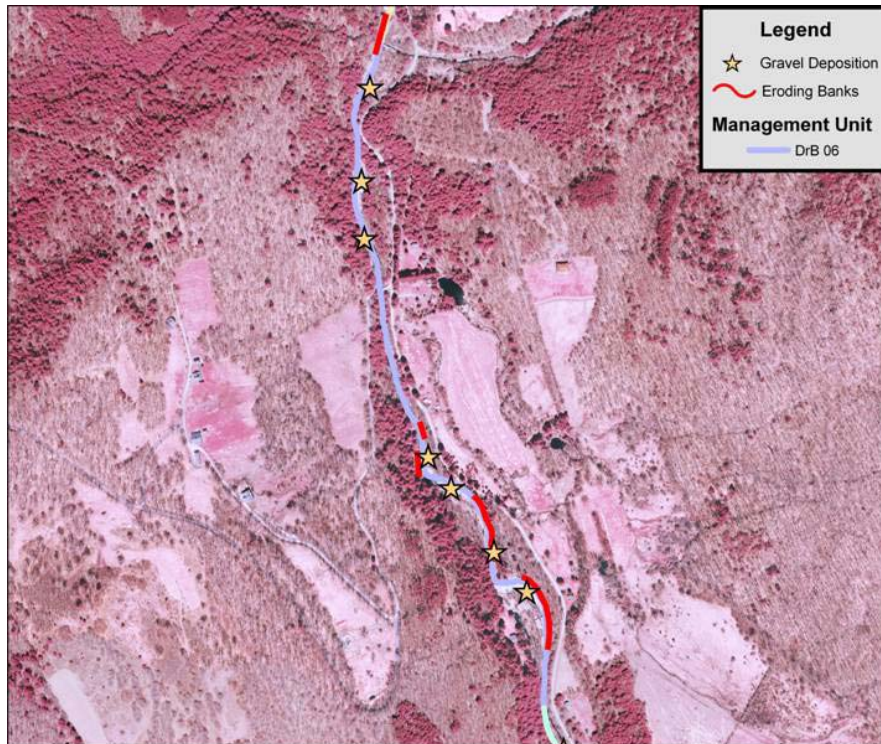
DrB 06

This reach is approximately 4,368 feet long and runs through a broad valley. The stream here is steeper than the other downstream reaches, being about 2% in slope. There are two foot bridges and two private bridges in this section. The stream corridor is 86% forested, 6% agricultural land, and 5% residential/roads. Most of the eroding streambanks located in this reach consist of cobble material except for the mass failure that consists of glacial till. The eroding streambanks are found in the upstream portion of the reach. Depositional features cover about 31% of the reach length. These are mostly side bars located where the stream is widening. They consist of gravel, cobble material, and no vegetation. About 12% of the reach is protected by revetment, consisting mostly of sloped stone on the streambanks against roads and stacked rock wall at the toe of the mass failure bank. A narrow riparian vegetation buffer between 0-25 feet wide occurs on 35% of reach length, all on the right bank where the stream and the road are close together. A more detailed survey was conducted in the mid-portion of the reach, which included cross sections, profiles, and pebble counts. This section of the reach is classified as a B3 stream type.

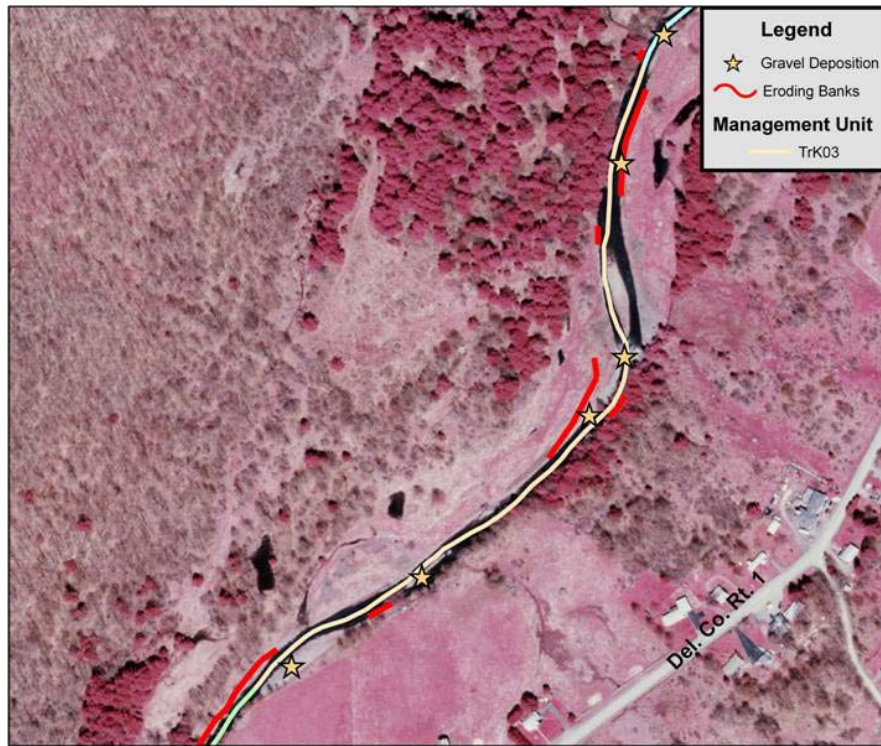
TrK 03

This reach is approximately 2,180 feet long. The valley is narrower through this section and the stream is fairly straight with a sinuosity of <math><1.1</math>. There are no bridges or tributaries located in this reach. About 40% of the entire reach has eroding streambanks. All of the eroding streambanks have no streamside vegetation. About 70% of the right streambank and 50% of the left streambank has little to no vegetation. The root systems of streamside vegetation hold the bank material together and slow the rate of erosion. Depositional features are large and affect about 40% of the reach length. Along the upstream portion of this reach, the channel is very wide and continues to widen resulting in full-channel deposition and stream channel migration. The lack of riparian vegetation in this area is causing the streambanks to erode quickly. Cattle access to this section of stream could also be impacting the stability of the streambanks due to hoof shear. There is a Conservation Reserve Enhancement Program (CREP) project pending to exclude cattle from the stream and plant trees along the floodplain.

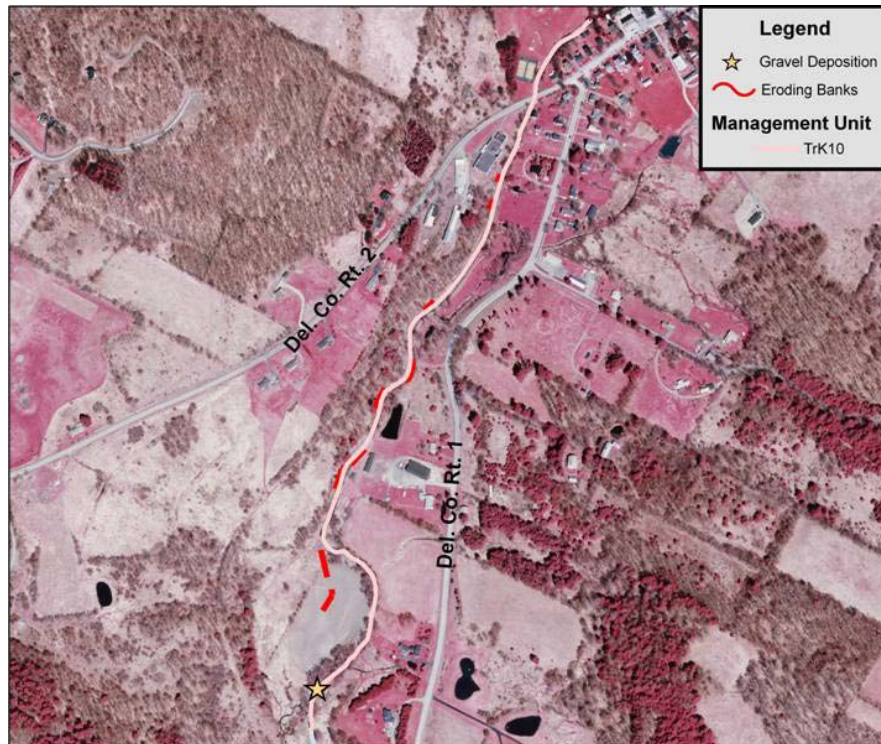
TrK 10

This reach is approximately 4,240 feet long and ends at the confluence of Liddle Brook and Gladstone Hollow in the hamlet of Andes. The valley is very broad with the upstream portion containing more residential and commercial land use than the rest of the sub-basin. Within this reach, there is an unnamed tributary and one bridge on Cabin Hill Road. About 30% of the reach has some sort of rock revetment along the streambanks. The majority of the revetments are located in the straightened upper portion of the reach. Eroding banks cover only 21% of the reach. Two sections of eroding banks are categorized as mass failures on high streambanks and account for nearly half of the total area of eroding banks: 3,000 square feet of 6,400 square feet. About 52% of the total length of eroding banks has no streamside vegetation buffer. Deposition seems to occur only in the downstream portion of the reach. In 2005, the stream made a sharp turn left at a wide point in the stream bed about 400 feet downstream from the Andes fire house. During a high flow event, the stream dropped sediment in this wide area and then broke through the right bank into a corn field, creating a new channel and abandoning the old channel. There is no root mass to hold the streambank together in the corn field, so the stream is meandering through this unstable area.

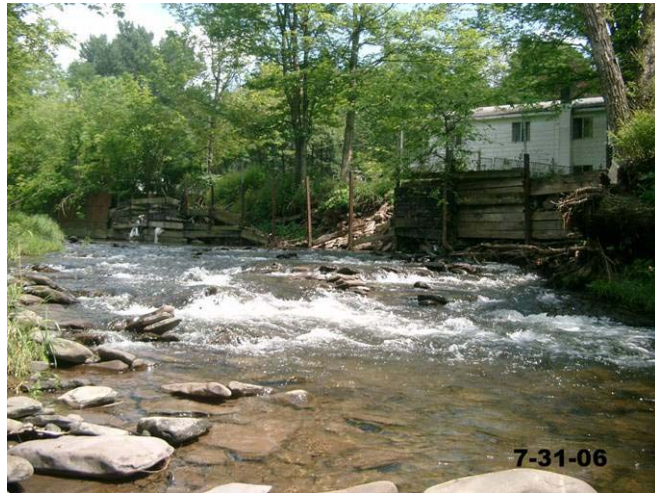
Figure 1.8 Failing Revetment Wall

The Village of Fleischmanns is built along the mainstem of Bush Kill. Revetment was used along the stream to protect development areas. The revetment is in poor condition and in need of repair in many locations. **Figure 1.8** shows a failing revetment wall protecting a developed area in the Village of Fleischmanns.

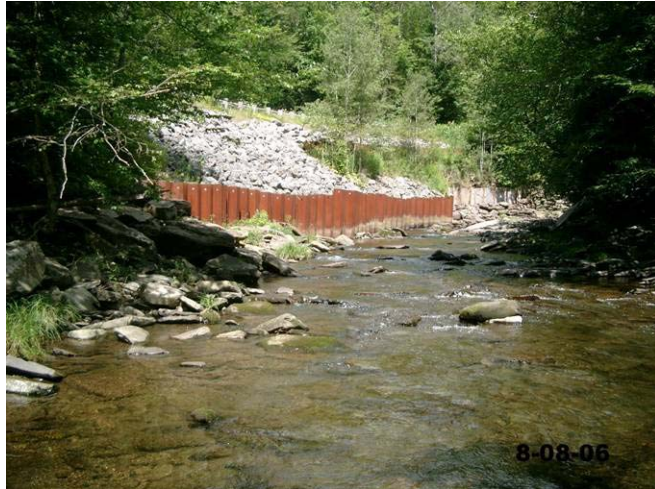
Figure 1.9 Revetment for Road Protection

Roads built in close proximity to streams are generally found to encroach on the floodplain. During the SGAT protocol Phase 1 assessment, it was difficult to determine if a road was in the floodplain or on a terrace above the floodplain. Many portions of the floodplain could be affected by roads cutting off available floodplain area. New York State Highway 28 and Old Route 28 run parallel to the Bush Kill mainstem. Several private driveways enter perpendicular to the stream and have an impact on stream access to the floodplain during high flow events. Delaware County Route 37 and Greene County Route 3 run parallel to the Vly Creek mainstem. There are a few areas in which the road is close to the mainstem where revetment was placed in order to protect the road (see **Figure 1.9**).

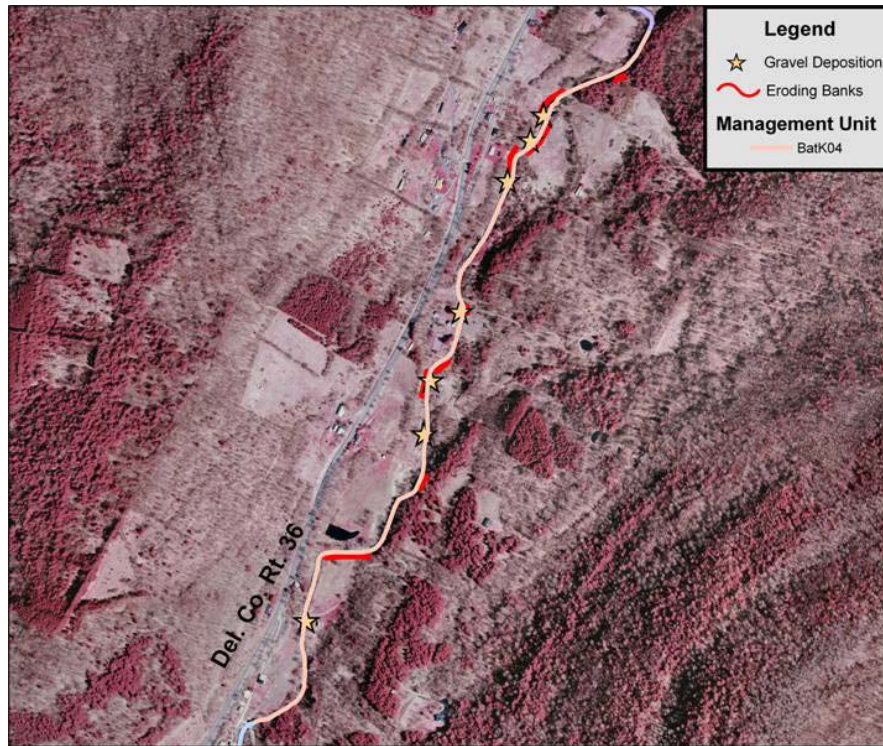
BatK 04

This reach is approximately 5,770 feet long and ends at a sharp bend in the stream. This section of the valley is also steep (1.7%), but the valley is wider and only two small sections of bedrock were observed. There are two private bridges located in this reach. Both bridges have side bars forming just downstream of each structure. Just upstream of one of the private bridges is a section of severe erosion on the left bank where the bridge approach is washed out. Bridge abutments are exposed, making the bridge unusable. This information was obtained from the helicopter video and it is currently unknown whether conditions at the bridge have been addressed.

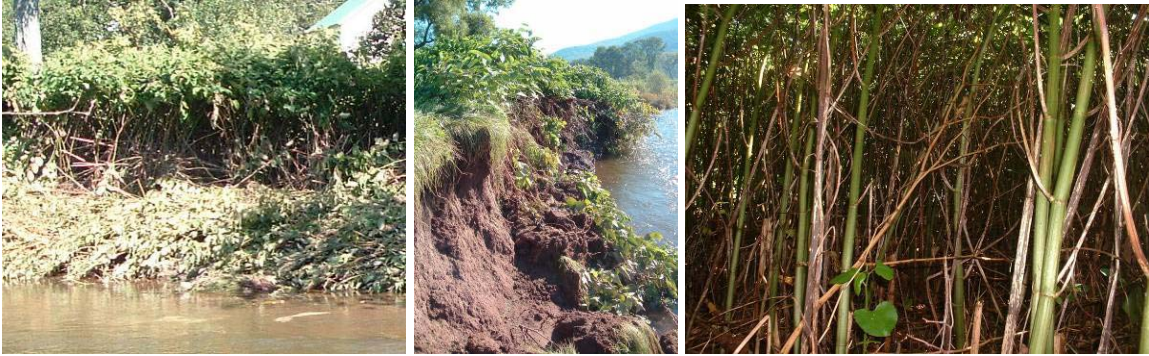
Figure 5.8 From left to right:
Knotweed flattened by a high flow event
A stream bank slump where only grass and knotweed bordered the streambank
The shade created by the dense canopy of broad knotweed leaves.

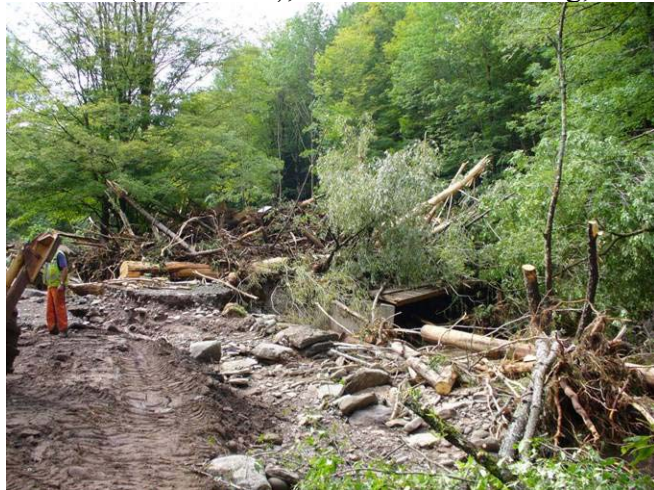
Figure 9.1 Flood aftermath on Holliday Brook on City Property

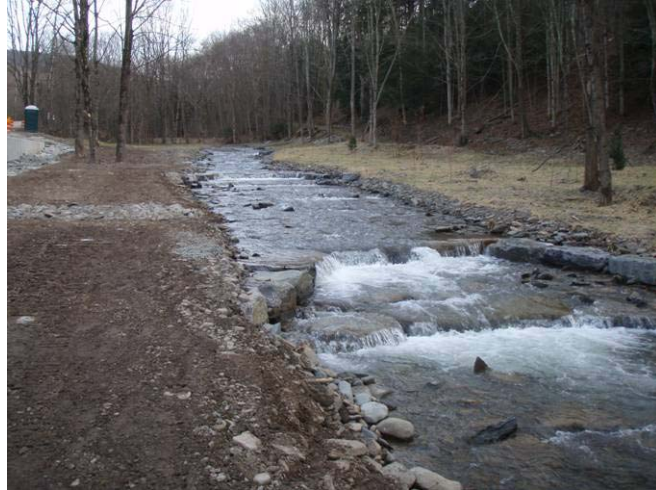
Figure 9.3 Holliday Brook After Construction with Cross Vane Structure
