West Branch of the Delaware River Stream Corridor Management Plan

May 2006

Prepared by:
Delaware County Soil and Water Conservation District

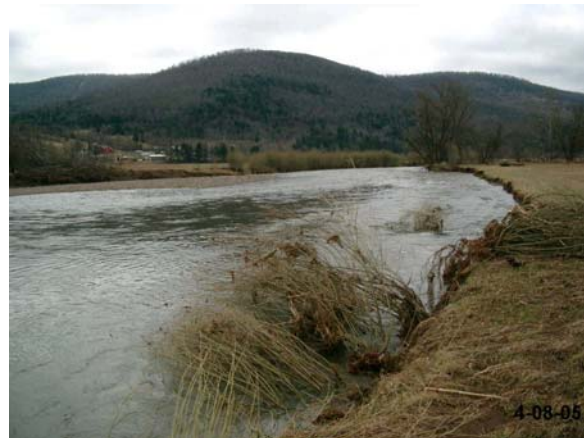
Figure 2.1 Example of rapid lateral migration near Hamden resulting from the April 3, 2005 storm. This section of stream is one of the 3 sites located in the 4.35 mile stream reach.

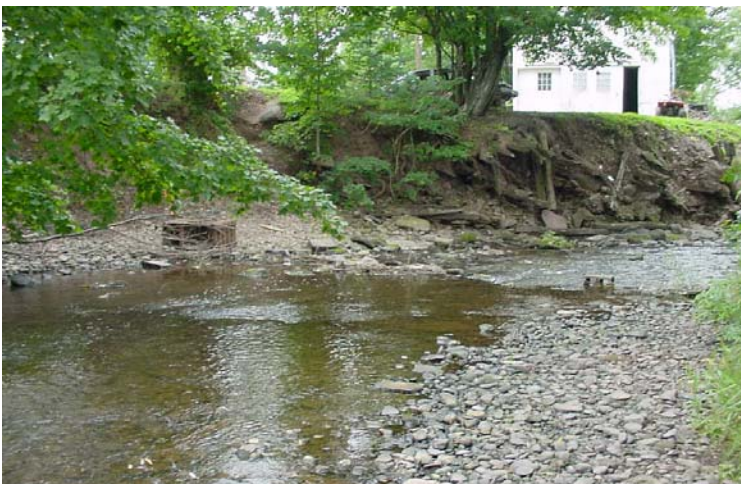
Figure 2.3 Example of site that could benefit from individual landowner stewardship.

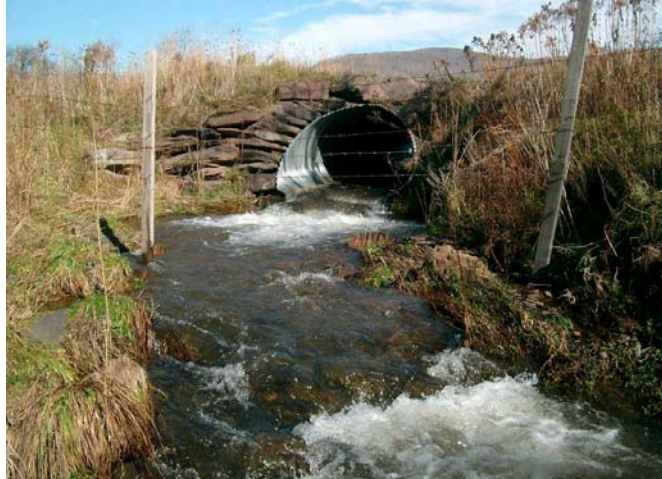
Figure 2.4 Culvert installation that could benefit from improved alignment, fish passage, outfall dissipation, headwall installation and top cover.

The SCMP should work in cooperation with other interested parties such as the CWC and DCDPW to develop a protocol to expand assessments of existing culverts to include geomorphic assessments, and work collectively where necessary in the prioritization of culverts for replacement and on the designs for retrofitting existing culverts. This technical assistance could be provided through recommendations made during the development of individual Town Highway Management Plans (HMPs) currently being developed by the DCDPW and Delaware County Planning Department (DCPD) Special Flood Hazard Areas as identified on Flood Rate Insurance Maps should also be included in this protocol (see **Section 5.14**).

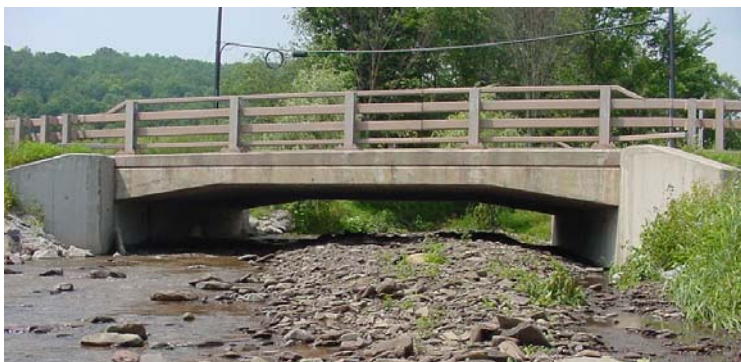
Figure 2.5 Gravel deposit under McMurdy Brook bridge on NYS Route 10 near Hobart. Note restriction of the waterway.

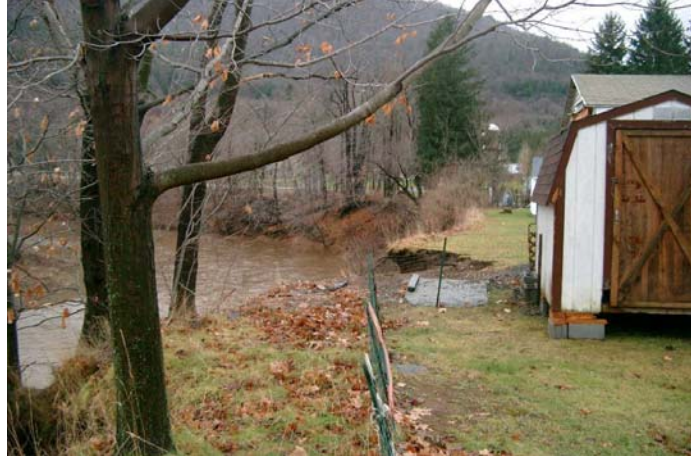
Figure 2.6 View of relocated shed along severely eroding bank at the Terrace Avenue site. Note area near center of photo where upstream edge of shed was located (December, 2004).

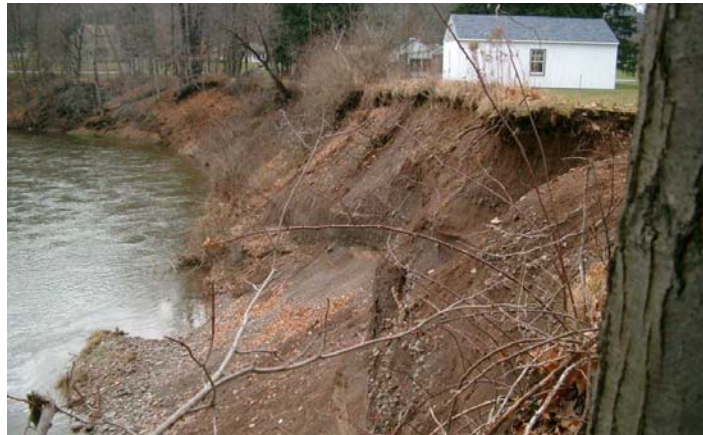
Figure 2.7 Closer view of the unstable embankment at the Terrace Avenue site (December, 2004).

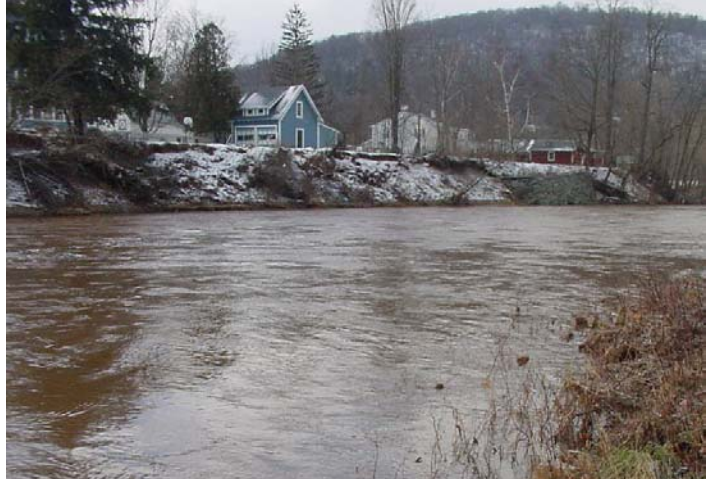
Figure 2.8 South Street location showing condition of embankment (December, 2000).

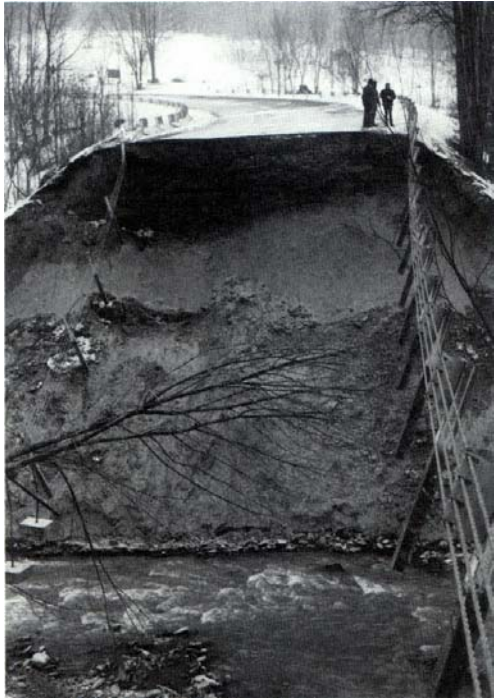
Figure 5.7 Washout on Chase Brook Road over Chase Brook near Cannonsville Reservoir, January 19, 1996

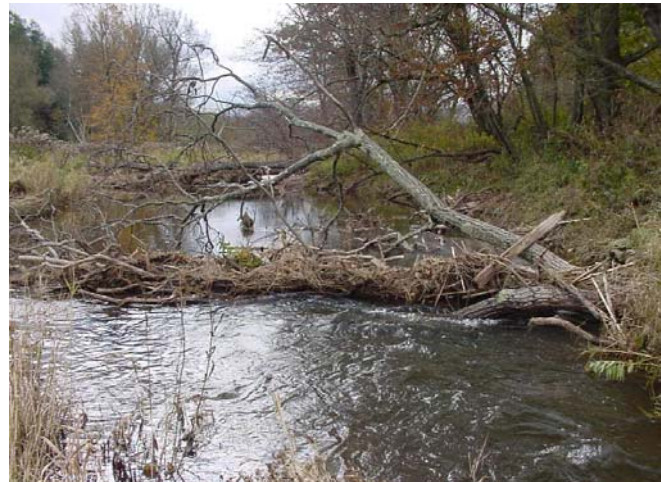
Figure 5.20 A channel-wide debris jam.

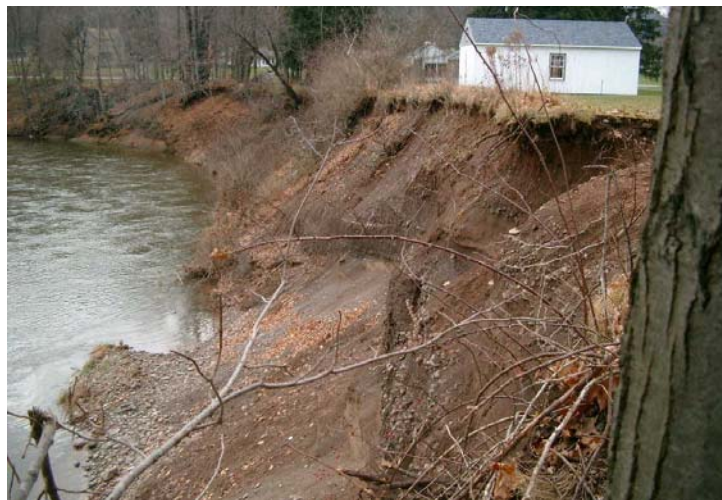
Figure 6.4 Severely eroding bank in the Village of Walton (December 2004).

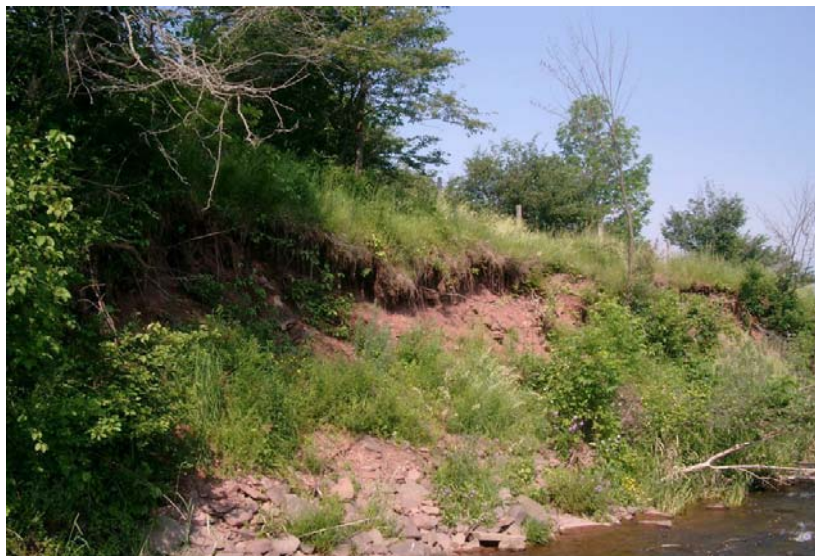
Figure 6.15 High eroding bank on Town Brook just below cross-section 10.

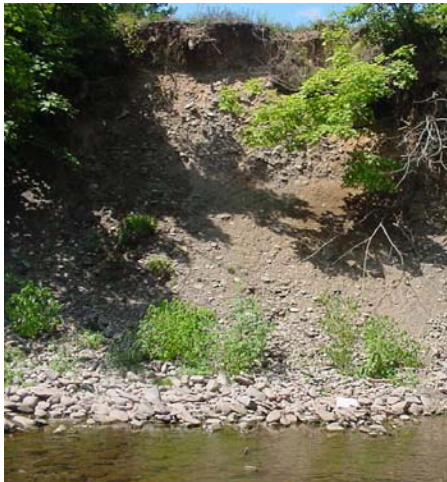
Figure 7.3.10 High eroding bank located approximately 3,300 feet upstream from private bridge.

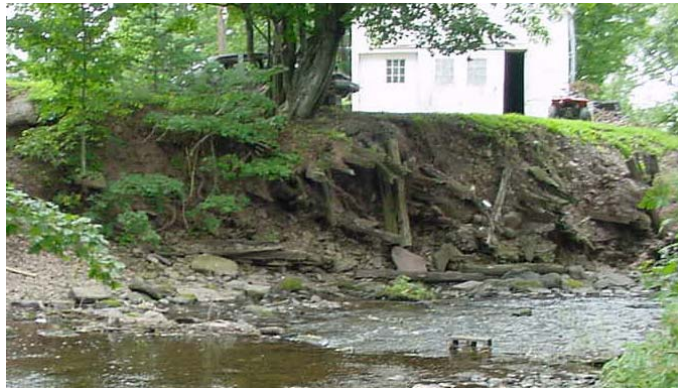
Figure 7.3.13 Looking downstream at an eroding bank located approximately 1,750 feet upstream from County Bridge 18-6.

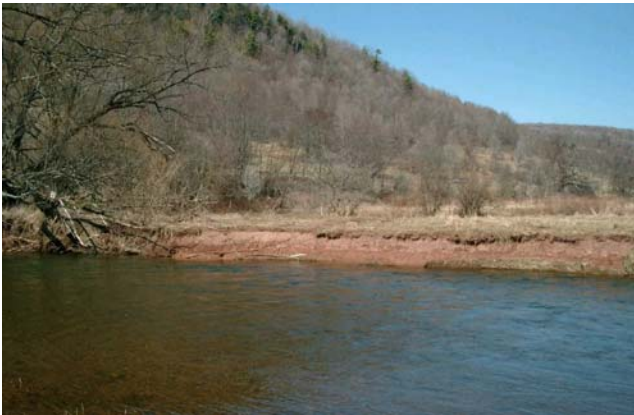
Figure 7.3. 15 An eroding bank downstream of railroad bridge where bank pin #34.3 is located.

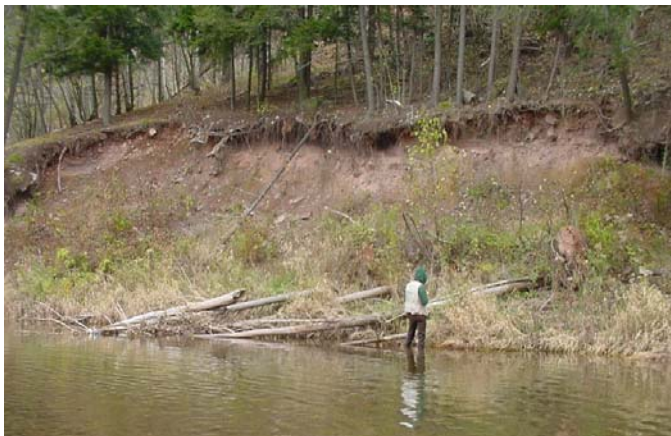
Figure 7.4.2 High eroding right bank located approximately 2,600 feet upstream from County Bridge 33.

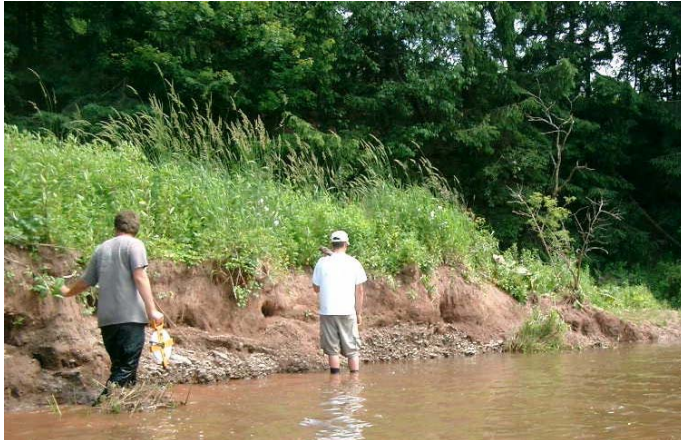
Figure 7.4.5 Eroding bank on the left bank located at the end of Management Unit 15.

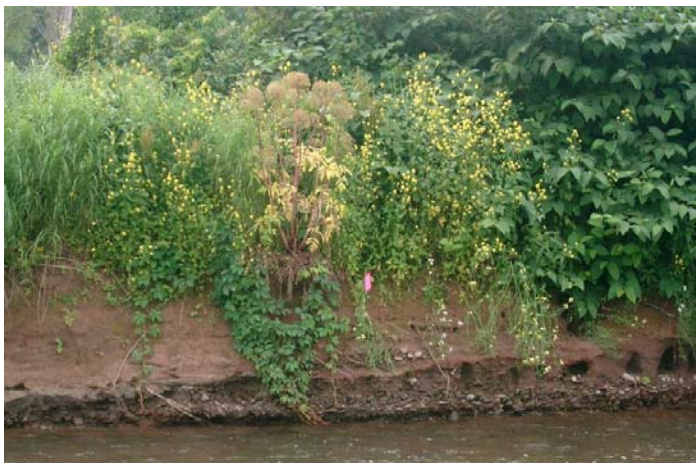
Figure 7.4.10 Poorly vegetated bank and a section of Japanese knotweed located approximately 2,000 feet upstream from County Bridge 10.

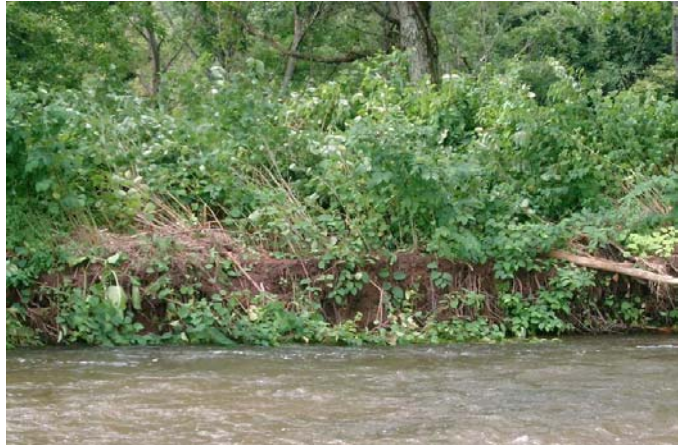
Figure 7.4.12 Section of Japanese knotweed and eroding bank found near the Delhi college agricultural land.

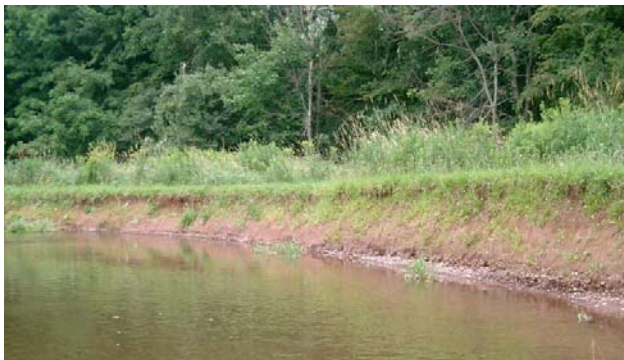
Figure 7.4.13 Poorly vegetated eroding bank located upstream from Peaks Brook confluence.

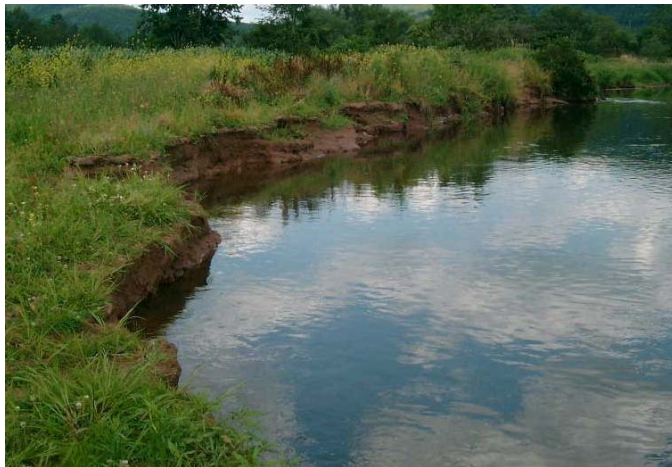
Figure 7.5.3 Eroding bank upstream from Bagley Brook confluence.

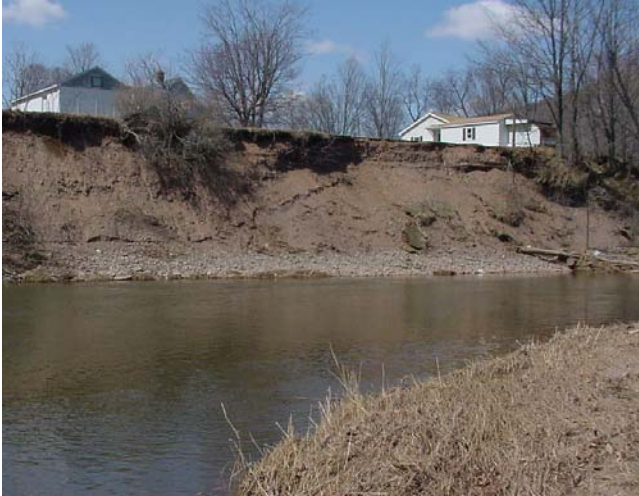
Figure 7.6.6 Looking at a high eroding bank on the left side at Terrace Avenue potential project site.
