THIRD BROOK WATERSHED MANAGEMENT PLAN

December 2013

MMI #4444-01

MILONE & MACBROOM, INC.
99 Realty Drive
Cheshire, CT 06410
(203) 271-1773
www.miloneandmacbroom.com

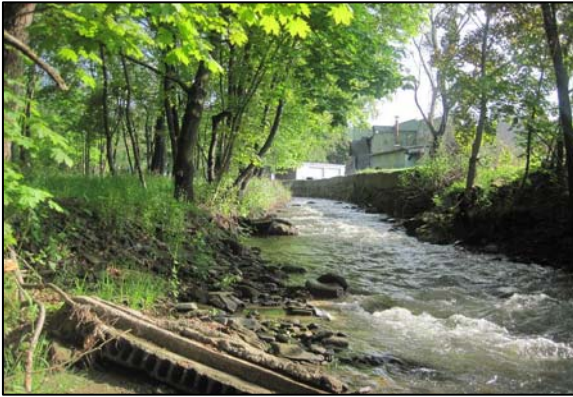
Downstream of station 19+00, a variety of berms, walls, and riprap line both sides of the brook until the Delaware Street bridge. Downstream of the Delaware Street bridge, berms and stacked rocks are found along the brook from station 4+00 to station 5+00. Failing slopes and cross vanes were not observed in segment 1.

Rock wall bank revetment behind Klinger facility and Jake's Garden Supply

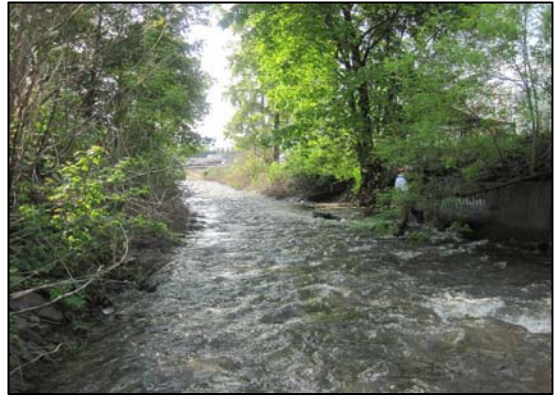
Incised channel above Delaware Street bridge

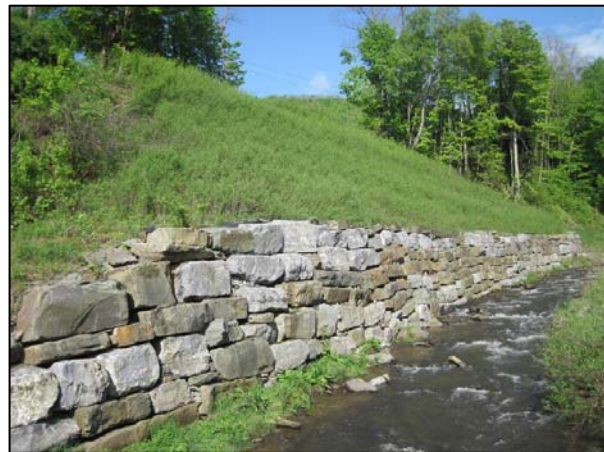
Stacked rock wall bank revetment near station 36+00

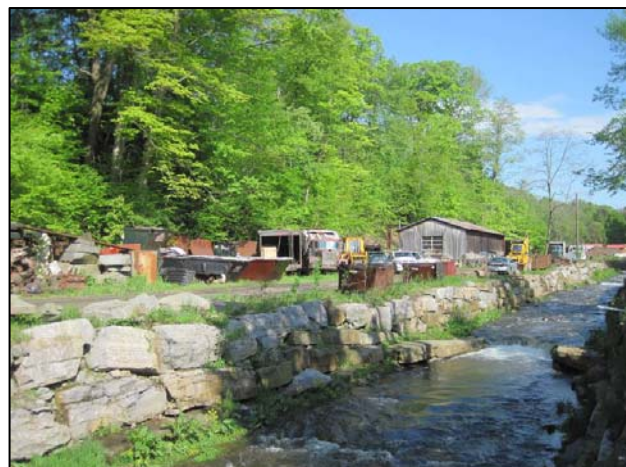
Rock cross vane grade control structures extending from the Ogden Street bridge to station 32+50

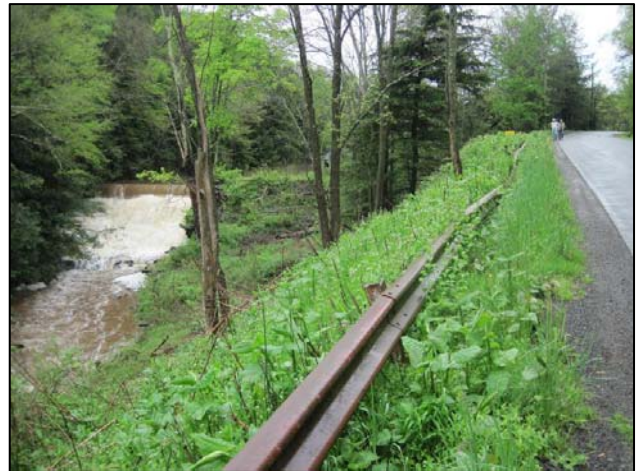
Old Village Reservoir dam

Stacked rock walls, cross vanes, and failing slopes were not observed in segment 5. However, stream bank erosion was observed immediately downstream of the dam on the east side of Third Brook at the base of the road embankment.

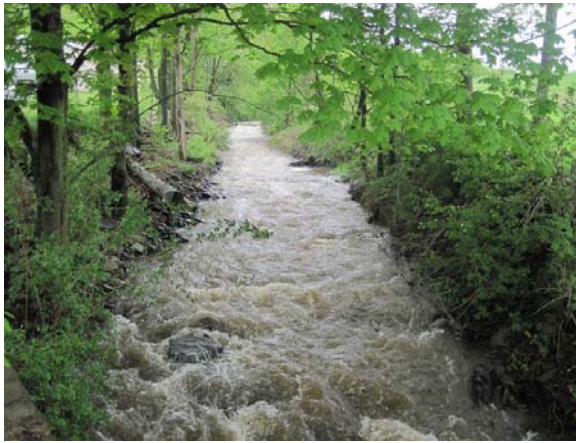
Third Brook approaching Gosper Road culvert near station 192+00

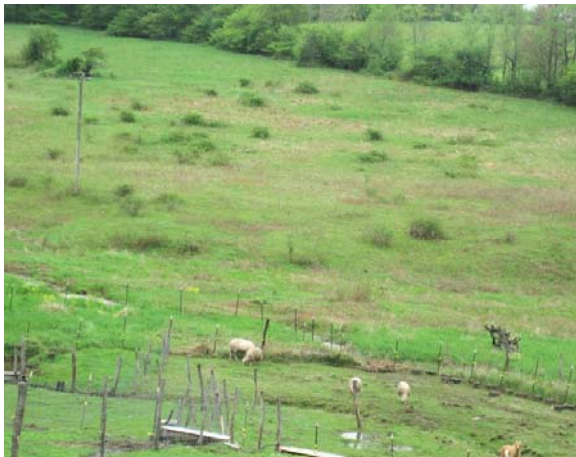
Third Brook main stem near station 205+00 viewed from State Route 206

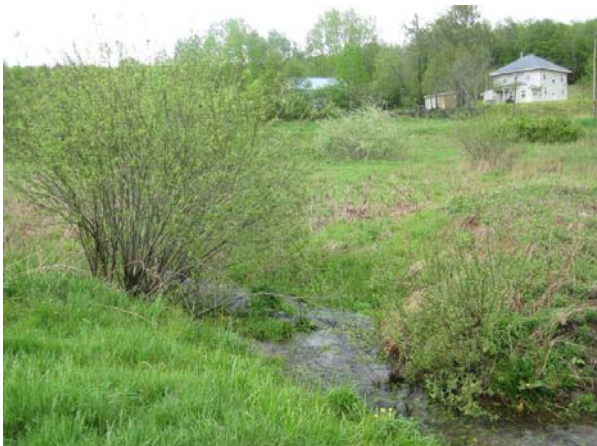
Third Brook flowing through wetland just downstream of earthen dam and Armstrong Road crossing near station 295+00

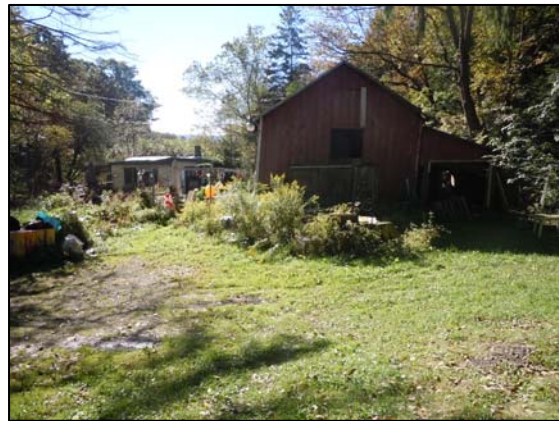
The barn at 757 Lower Third Brook Road is located in the SFHA and should be considered for removal. The home on this property is adjacent to the SFHA and lies low on the property. As such, it should be elevated or removed if it is floodprone at the more frequent flood discharges.

Barn at 757 Lower Third Brook Road is one of the few structures in the FEMA SFHA.
