East Branch Delaware River

Stream Corridor Management Plan

Volume 2

December 2007

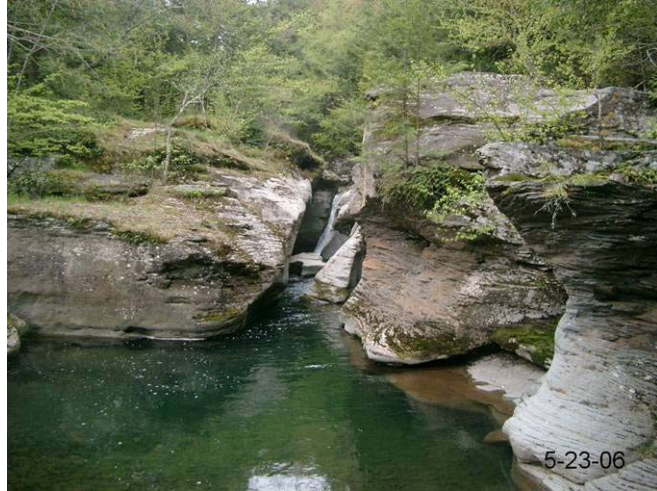
Figure 1.1 Bedrock Outcrop on Dry Brook Mainstem

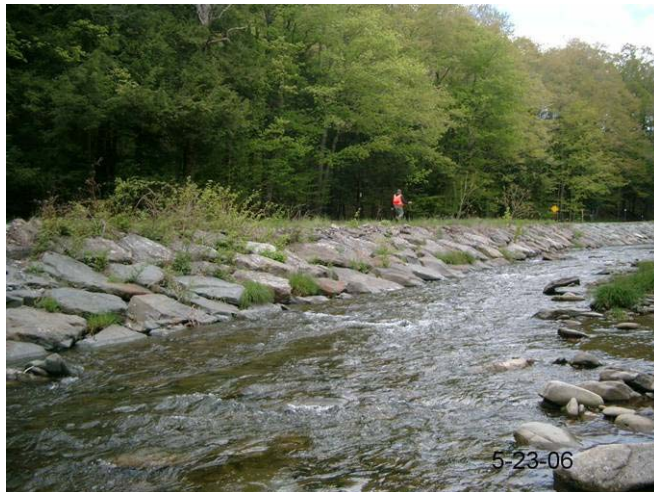
Dry Brook Road and Ulster County Route 49 run parallel to the Dry Brook mainstem and have some impact on the stream health. Stormwater runoff from the road ditches adds excess water and pollution directly to the streams without time for the ground and vegetation to absorb the pollutants. There are several locations where the stream is close to the road and revetment was placed along the streambanks in order to protect the road from channel migration (see **Figure 1.6**). There are eight municipal bridges and five private bridges located within this *sub-basin*.

Figure 1.6 Rock Revetment Along Ulster County Route 49

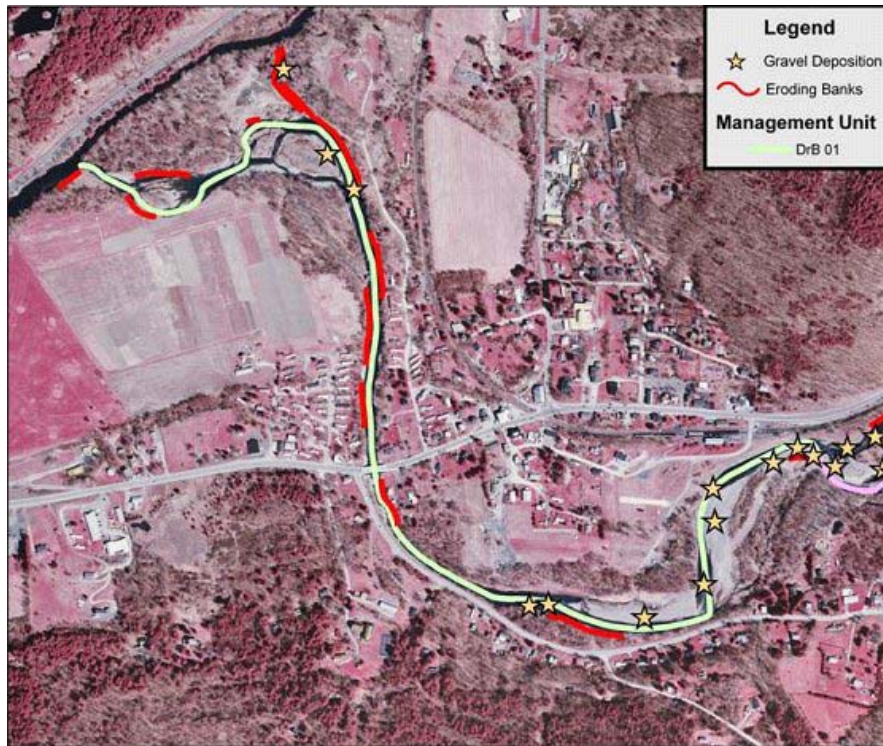
Management Unit DrB 01 is approximately 7,615 feet long with a very wide valley as it joins the East Branch Delaware Mainstem. United States Geological Survey (USGS) stream gage 01413408 (Dry Brook at Arkville NY) which is located on the left bank 80 ft upstream from bridge on State Route 28. The drainage area at the stream gage is 82.2 square miles. The period of records that are available for this gage is December 1996 to current year.

The lower portion of DrB 01 is the alluvial fan of the Dry Brook mainstem and the upper portion from New York State Highway 28 Bridge upstream is narrowed by the valley walls. This area of the stream is entrenched due to the revetment on the left bank, higher velocity, and the stream has down cut to bedrock. Bedrock in the streambed located just upstream of the bridge acts like a grade control for the bridge. There is no aggradation located immediately downstream of the bridge. There is some development along the floodplain on the upper portion of the reach in Arkville. The lower portion of DrB 01 has a trailer park on both sides of the floodplain and agricultural field on the lower left side. A box culvert located east of the Route 28 bridge acts as a floodplain drain for high flows on the right bank floodplain. An eroding bank, approximately 10 feet high, is located on the right streambank upstream of the NYS Route 28 bridge. Revetment bank protection is in place at this location but it is in poor condition. A house and a garage are located in this area and there is little to no riparian buffer along the property.

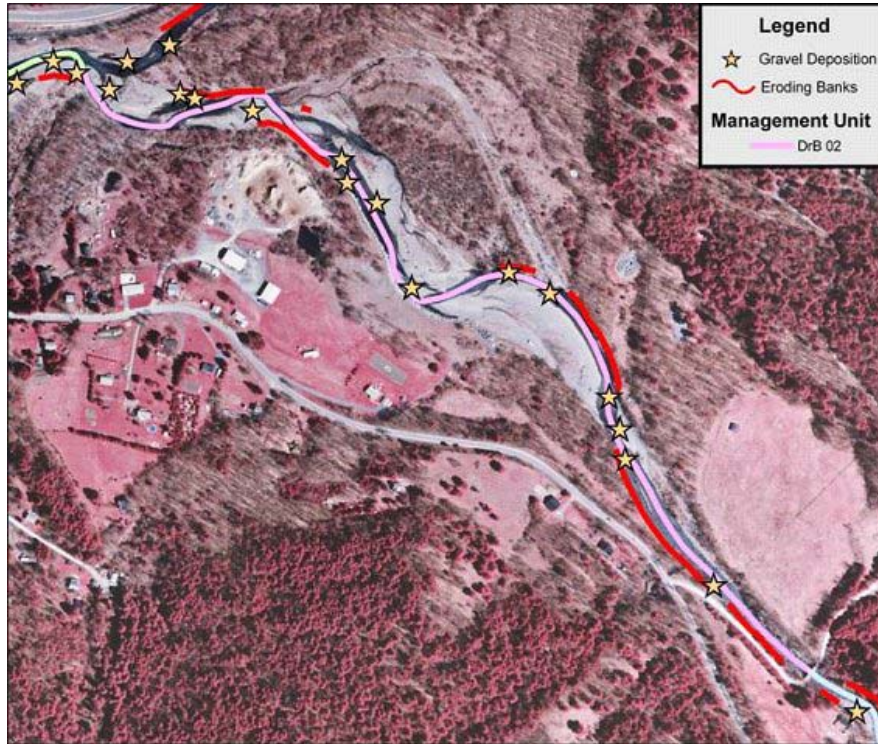
Management Unit DrB 02 is approximately 4,175 feet long with a very broad valley. Dry Brook has access to its floodplain in the lower portion of the reach, but is confined to the stream channel downstream of Erpf Road. Dry Brook comes in contact with the left streambank approximately 620 feet downstream of Delaware County Bridge 21 (Erpf Road). To protect the road infrastructure, the streambank was stabilized in this area during the summer of 2006. Historically, upstream of Bush Kill confluence, Dry Brook has been meandering on its floodplain. Areas of aggradation/bypass channels are numerous in this reach. The river is continually adjusting and depositing sediment on the floodplain and within the channel especially in the lower portion of the reach. One of the bypass channels is blocked with debris, limiting water access during high flow events. Delaware County Bridge 21 is located in this reach and has minimal impact on the stream. There is no aggradation downstream of the bridge and the stream has a planar bed shape. Rock rip rap is protecting the bridge abutments upstream and downstream of the infrastructure. Additional revetments are mainly located on the left bank where most of the development is encroaching on the floodplain. Reservoir Hollow enters Dry Brook in this reach, which may have some impact on the streambank erosion that is occurring.

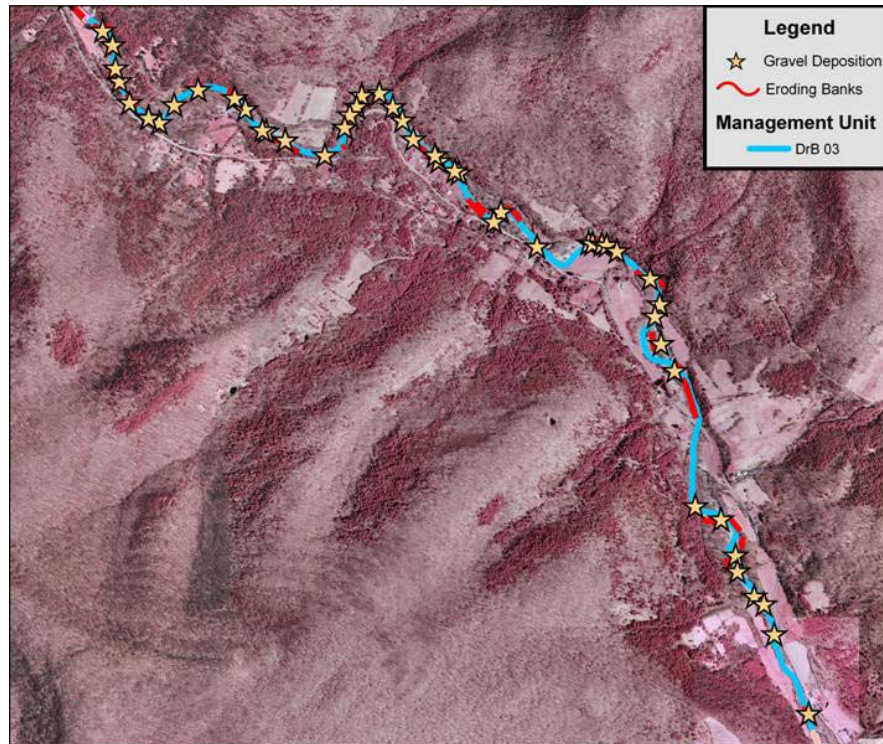
DrB 03

This reach runs upstream from the Erpf Road bridge for about 20,406 feet (3.8 miles) and ends at the confluence of Rider Hollow. In addition to Rider Hollow, there are about seven small unnamed tributaries that enter this reach. The two bridges that cross the river are Delaware County Bridge #151 on George Road and County Bridge #20 on Dry Brook Road. The river corridor consists of about 75% forest/wetland, the remainder being a mix of agricultural land, brush and residential. The river runs through a broad valley and regularly changes its location as the water makes its way through the many gravel depositional features. About 46% of the reach length is experiencing gravel deposition. These areas are unvegetated and change with each high flow event. Most depositional features are very large and located in an over-widened section of stream. The total deposition area is approximately 760,000 square feet, which is 37 square feet for every one foot of stream length. This is a lot of sediment that could eventually move downstream. Eroding streambanks can be found in 35% of the reach, which is about average for Dry Brook. Typically vegetated riparian buffers protect streambanks from excess erosion and help to stabilize gravel deposits. Unfortunately the riparian buffer vegetation is compromised in many sections of this reach. One third of the eroding streambanks have only a narrow riparian vegetation buffer ranging from 0-25 feet wide. Also, 37% of the entire reach has only a narrow vegetation buffer on one streambank or the other. Only 9% of stream length has revetment, which is mainly sloped stone to protect agricultural land and road embankments in areas where the river is making major shifts in stream alignment.

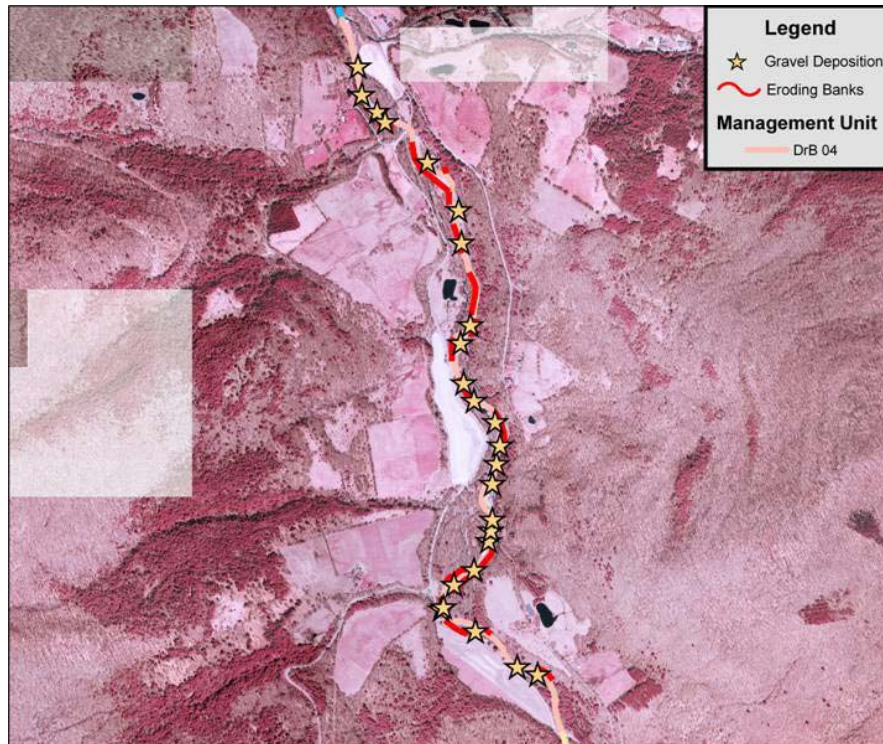
DrB 04

This reach is approximately 10,791 feet long and ends at a bridge on Dry Brook Road near Martin Road. There are seven tributaries including Tompkins Hollow and two bridges on Dry Brook Road that cross the stream. This reach is very similar to DrB 03, running through a broad valley, frequently changing course as it is affected by deposition. Large unvegetated gravel/cobble bars are formed within this reach and make up 52% of the reach length. The gravel/cobble bars cover an area of 395,000 square feet, which is the equivalent 37 square feet for every one foot of stream length. About 51% of the stream length contains eroding streambanks on one side or the other, totaling approximately 60,000 square feet of exposed bank. Much of this exposed area is from mass failures on high banks. Of all the eroding banks, only 12% have a narrow vegetation buffer width ranging from 0-25 feet and these are sections where the stream and Dry Brook Road are very close. About 23% of the entire reach has a narrow riparian vegetation buffer on one streambank or the other. There is little revetment in this reach, being short sections of rip rap for road embankment protection, totaling 37% of the reach. Large woody debris is abundant in this section, either already washed out and sitting on a gravel deposition bar or having fallen over from an eroding streambank where the stream is widening and temporarily held in place by a few roots. This debris could cause problems during high flow events and cause obstructions in the stream channel or at bridges. Debris management, slope stabilization and riparian buffer protection should be considered for sections of this reach.

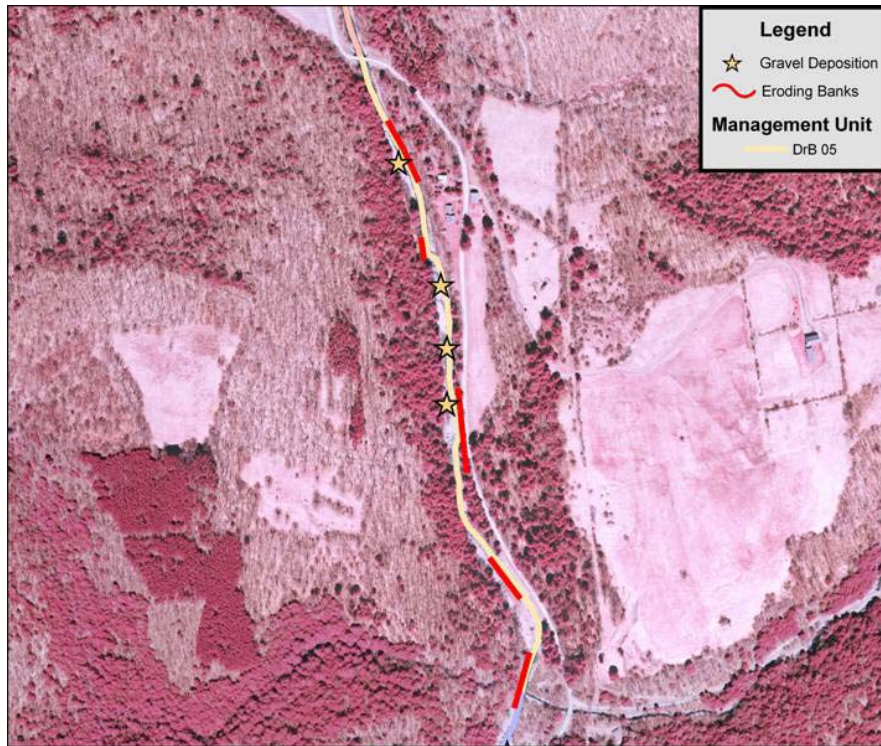
DrB 05

This reach is approximately 2,887 feet long and ends at the confluence of Haynes Hollow. This straight stream runs through a broad valley. There are three tributaries entering into this reach, including Haynes Hollow and two unnamed tributaries. Land cover in the stream corridor is about 85% forest and 10% residential/roads. Eroding streambanks make up 40% of the reach length. The bank material consists mostly of round cobbles that could easily be moved during high flow events. Gravel deposition covers about 38% of the reach length. This material is also large round cobble similar to the bank material. About 33% of the reach contains streambank revetments, most of this total consisting of two separate sections of revetment. One is a section of old log cribbing in poor condition, but there is some woodland vegetation buffer just behind the cribbing. The other section is made of recently placed sloped stone to protect Dry Brook Road from further bank erosion. A narrow riparian buffer between 0-25 feet wide on one bank or the other can be found in about 46% of the reach. The majority of this narrow buffer is located in areas where the road and stream are close to each other. As with DrB03, strengthening the riparian buffer along this reach may help reduce streambank loss and the mobilization of sediments from eroding streambanks.

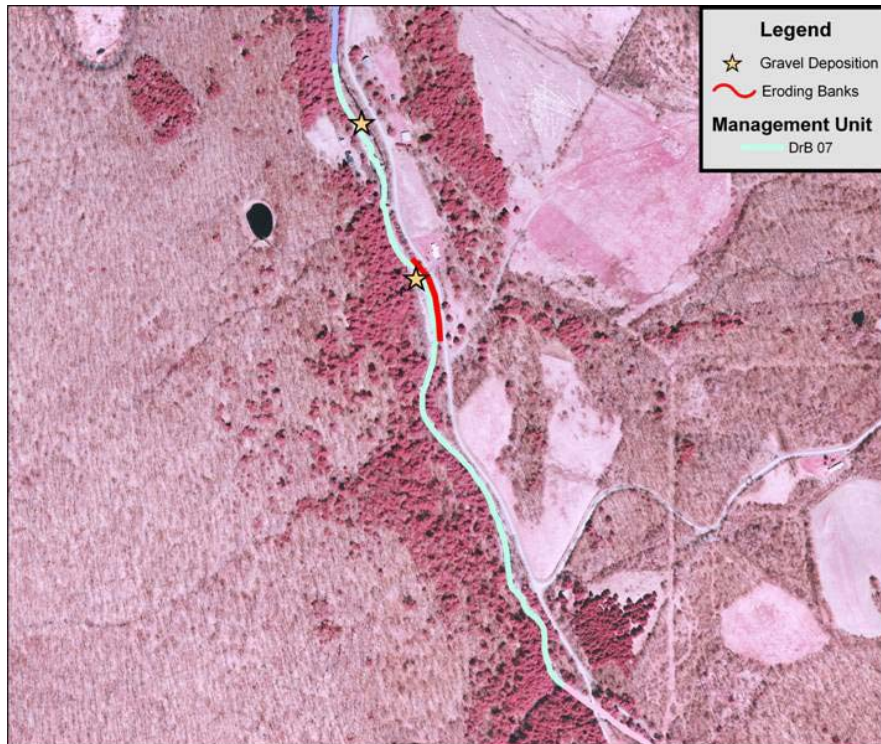
DrB 07

This reach runs for approximately 2,943 feet and ends at the confluence of Turner Hollow, the only tributary in this section. The valley is fairly broad, but in some sections of the reach the channel appears to be entrenched. Approximately 26% of the stream length contains exposed bedrock in the channel. There is one bridge in this section located on Erickson Road. Land cover in the stream corridor is about 80% forest, 10% agricultural land and 5% residential. About 13% of the length has an eroding streambank consisting of one long stretch at an area where the stream and Dry Brook road are very close to each other. The only revetment in this section covers about 13% of the reach which is also in a location where the road and river are close together. Two large depositional features make up 21% of the reach length. About 68% of the right streambank has a narrow vegetation buffer between 0-25 feet wide which is due to Dry Brook Road running parallel to the stream.

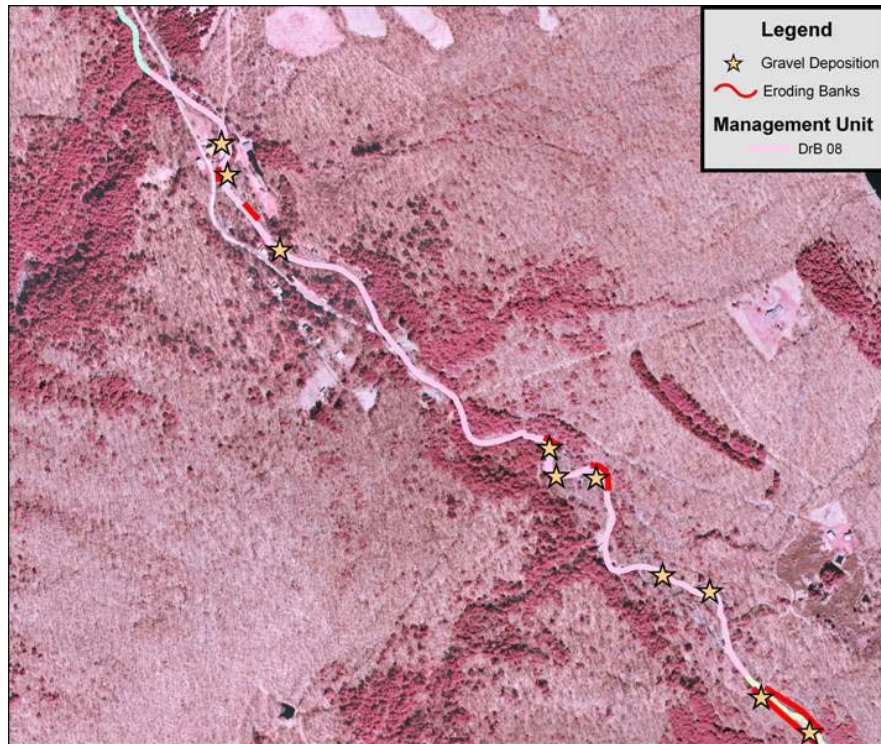
DrB 08

This reach is approximately 4,984 feet long. The valley is relatively broad compared to the smaller stream width. There are two bridges on Dry Brook Road that cross the stream in the downstream portion, and there are two unnamed tributaries that enter Dry Brook in this reach. Over 90% of the stream corridor is forested and about 4% is residential/roads. Bank erosion is occurring in 9% of this reach and the streambank material consists mainly of cobble within the valley and glacial till along the valley wall. Depositional features consist of point bars with cobble material deposits. There is one short section of revetment where the stream has previously eroded the bank along MacFarland Road. Narrow riparian vegetation buffer widths between 0-25 feet make up 27% of the reach. These narrow vegetation areas are in the downstream portion and are mostly where the road and stream are close together. Dry Brook Road ends about mid-way through this reach and therefore will not impact the upstream portion of the reach. The upstream portion still experiences erosion and deposition issues even though the road is no longer a factor and the area is all forested

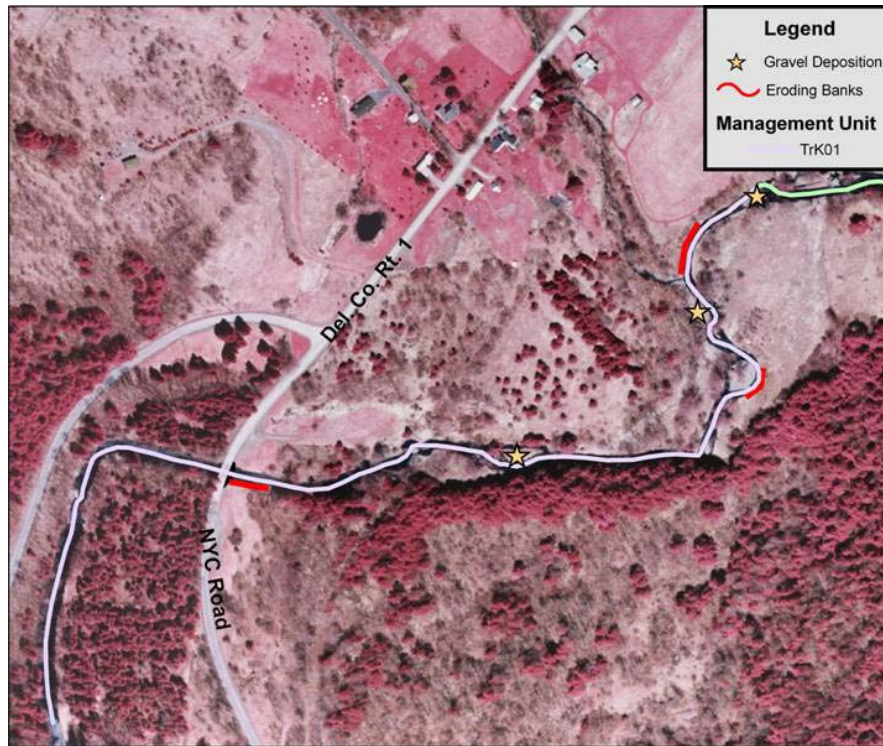
TrK 01

This reach starts approximately at the highwater mark of the Pepacton Reservoir and is about 3,677 feet long, ending about 360 feet upstream from the Bussey Hollow confluence. The stream runs through a broad valley but the upstream portion is greatly influenced by an alluvial fan deposited by Bussey Hollow. As the stream cuts through the highly erodible soil of the alluvial fan, it is constantly meandering and changing course. This creates a very unstable area. Bussey Hollow is the only tributary in this reach and is a significant sediment source to the Tremper Kill. As the stream meanders around the alluvial fan, it is pinched against the left valley wall and forced to make a right angle bend. This could eventually lead to mass bank failure in this area. Delaware County Bridge 1-5 is the only bridge in this reach. Upstream from the bridge is USGS Gage Station #0145000 (Tremper Kill near Andes NY), which is located on the right bank 500 feet upstream from the bridge on Delaware County Route 1. It is about 1,700 feet upstream from the Pepacton Reservoir and 5 miles south of Andes. The drainage area at the stream gage is 33.2 square miles. The period of record that is available for this gage is from February 1937 to the current year. There is a concrete dam at the gage station, which serves as grade control and may have some fish passage issues. There were no observed revetments in this reach, and eroding banks were found in the unstable upstream section of the reach.

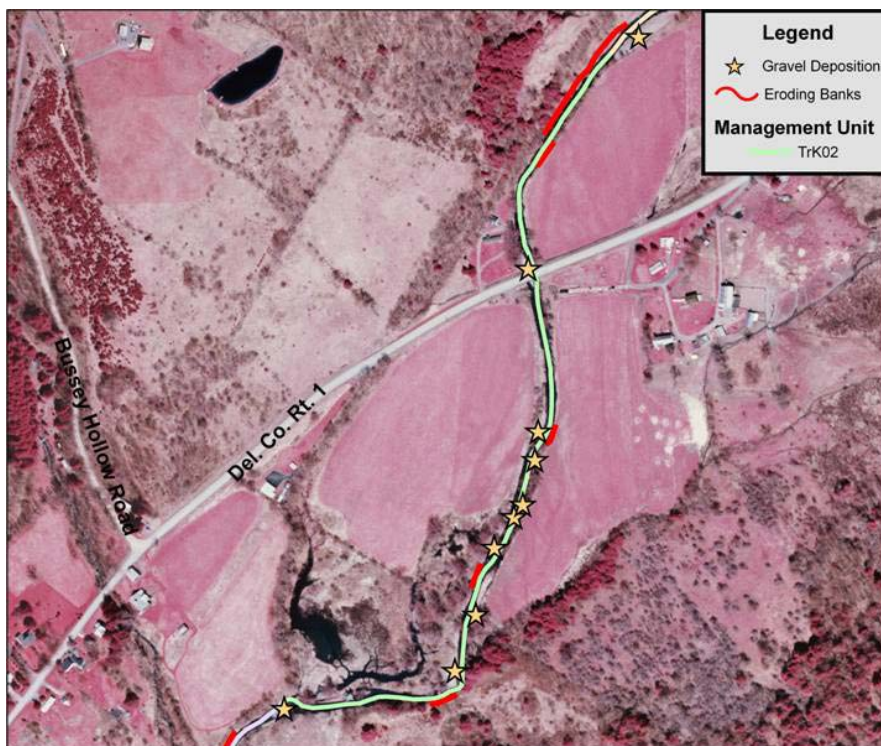
TrK 02

This reach is approximately 2,985 feet long and ends 860 feet upstream from Delaware County Bridge #1-3. The floodplain is very wide and the stream slope is approximately 0.5%, which is the flattest slope in this sub-basin. Above the bridge, the floodplain was cut off in a small upstream section by the old railroad bed. This section of stream appears to be incised for about 700 feet. Delaware County Route 1 bisects the floodplain as it crosses the valley. The elevated roadway and bridge constrict flood flows and results in deposition upstream of Delaware County Bridge #1-3.

Following the 2005 and 2006 flood event, dredging occurred downstream of the bridge and the gravel was stockpiled on the streambanks as a berm to minimize flooding. The stream continued to scour the left bank and floodplain below the bridge. To address the stress on the bank and restore floodplain function, a streambank stabilization project was designed and constructed for this area. The stream bank has been restored with live cribbing and an enhanced riparian buffer. All gravel berms were removed to allow flood flows to spread out onto the floodplain and reduce stress on the streambanks. This streambank project has been implemented by Delaware County SWCD Stream Corridor Management Program (SCMPr) along with the Watershed Agricultural Small Farm Program. A narrow strip of trees has been planted as part of the streambank stabilization project. Prior to the project, 70% of the entire left bank had very little (0-25 feet) woody vegetation.

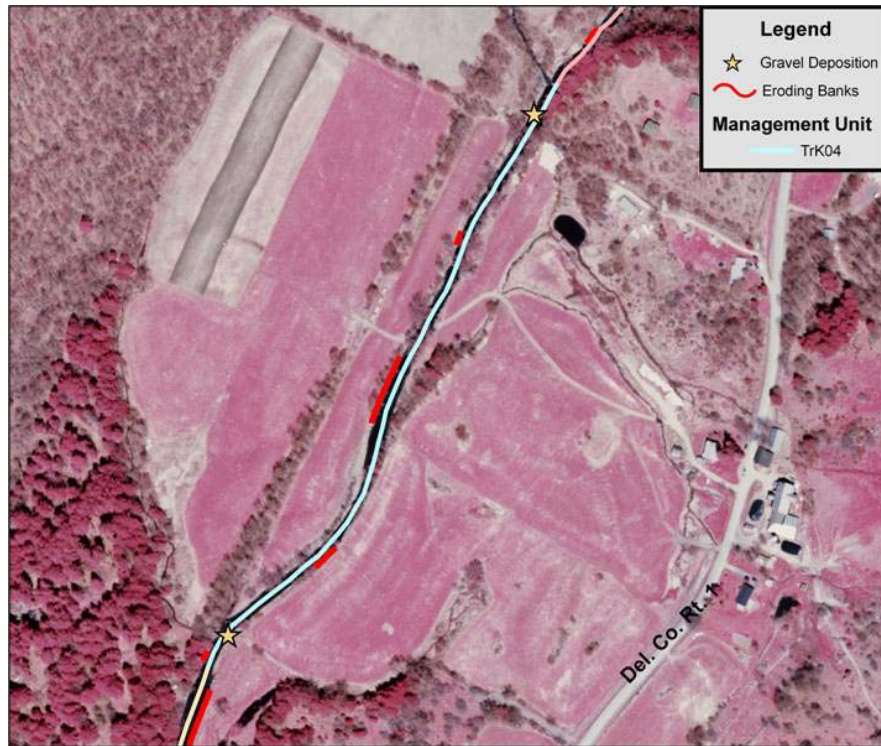
TrK 04

This reach is approximately 1,860 feet long and ends at the confluence with Wolf Hollow. The stream is straight in a very broad valley, but a large part of the floodplain has been cut off by the old railroad bed. The stream corridor land use/land cover is almost entirely agricultural fields. The streambanks generally do have some streamside vegetation, but the buffer is narrow along the top of the banks. About 59% of the left streambank and 45% of the right bank have less than 25 feet of vegetation buffer width. About 18% of the reach has eroding banks that are somewhat protected by the root systems of existing trees, but as mentioned this is a narrow strip of buffer. There is a potential for increase in erosion rate if even a short section of this buffer were to be removed by flood damage, continued erosion, or human activities. There is a 400 feet long berm in the downstream portion of this reach as a result of channel dredging and point bar removal. The stream is trying to put a bend in this location in order to increase the stream sinuosity and decrease the slope. This reach would benefit additional land along the stream set aside as a vegetated riparian buffer. Two tributaries enter into this reach, one unnamed and the other being Wolf Hollow. Wolf Hollow flows through its own alluvial fan, but there appears to be no problem with deposition at the confluence. There is a small delta bar here, but the main channel is transporting the sediment efficiently.

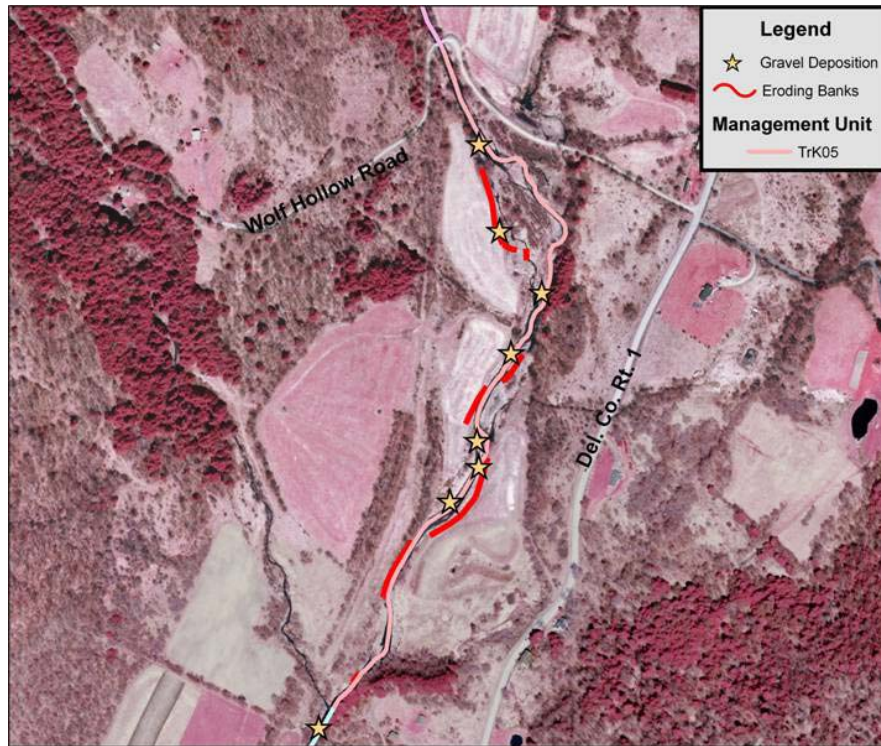
TrK 05

This reach is approximately 3,375 feet long and ends at the Wolf Hollow Road bridge. The valley is generally very broad except for a short section at the downstream end where the alluvial fan of Wolf Hollow pushes the stream up against the left valley wall. The stream is changing its planform in this area by widening its belt width via streambank erosion on the outside of bends and deposition on the inside of the bends. Bank erosion is extensive in this area; about 45% of the reach is experiencing bank erosion. Approximately 80% of the eroding banks have no streamside vegetation, and most of these are in agricultural areas used as corn fields. Deposition features are common in this reach, with transverse bars and side bars that are adjacent to the eroding banks. Stream channel movement and widening will continue to be an issue here due to the lack of streamside vegetation buffers.

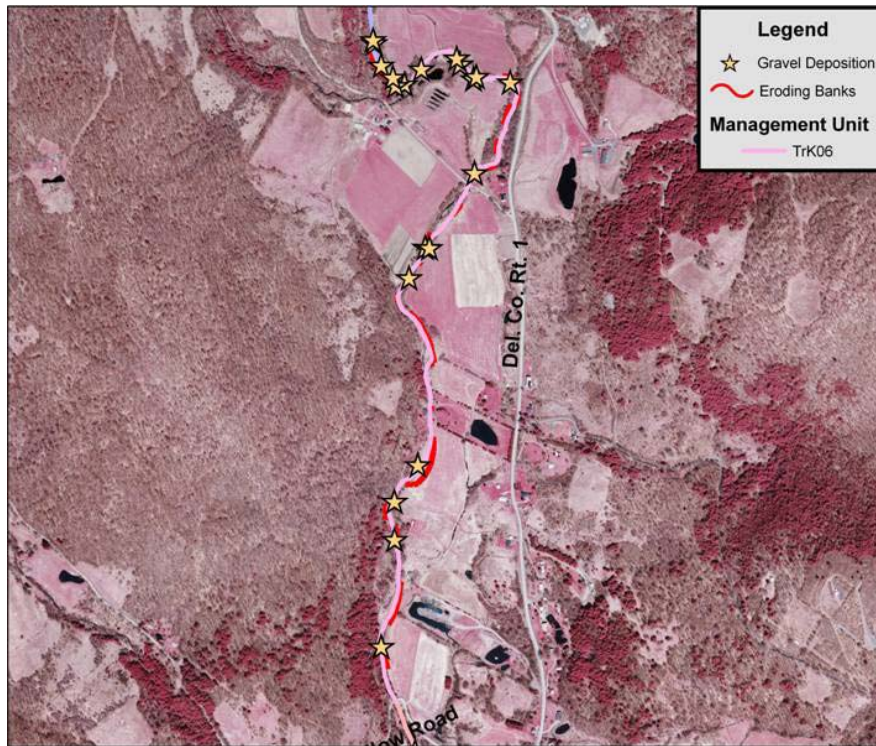
This reach is approximately 7,113 feet long and ends at the confluence of State Road Hollow. The valley is very broad with the stream following the right valley wall along most of the reach. The exception is for the upper portion of the reach, where the stream meanders on the alluvial fan from the State Road Hollow tributary. There are five tributaries that enter within this reach; State Road Hollow and four unnamed tributaries. There are three bridges: one private, the Wolf Hollow bridge, and the State Road bridge. TrK 06 exhibits characteristics similar to the TrK 05 reach. About 43% of the reach contains eroding banks, with 50% of these having a streamside vegetation buffer width less than 10 feet. One large eroding bank is located on the Tubb's property along a cornfield that has no streamside vegetation buffer. The stream is becoming wider and eroding into the corn field, which contains very erodible soil material. Depositional features affect 23% of the stream length, generally including side bars and point bars. Point bars are common in stable C stream type, but the bar forming opposite the Tubb's eroding bank is excessively large. Agricultural land consisting of hay and corn fields is the dominant land use/land cover in the entire reach. Therefore, woodland buffers are narrow or non-existent along the streambanks. About 64% of the stream has 0-25 feet of buffer on one or both banks.

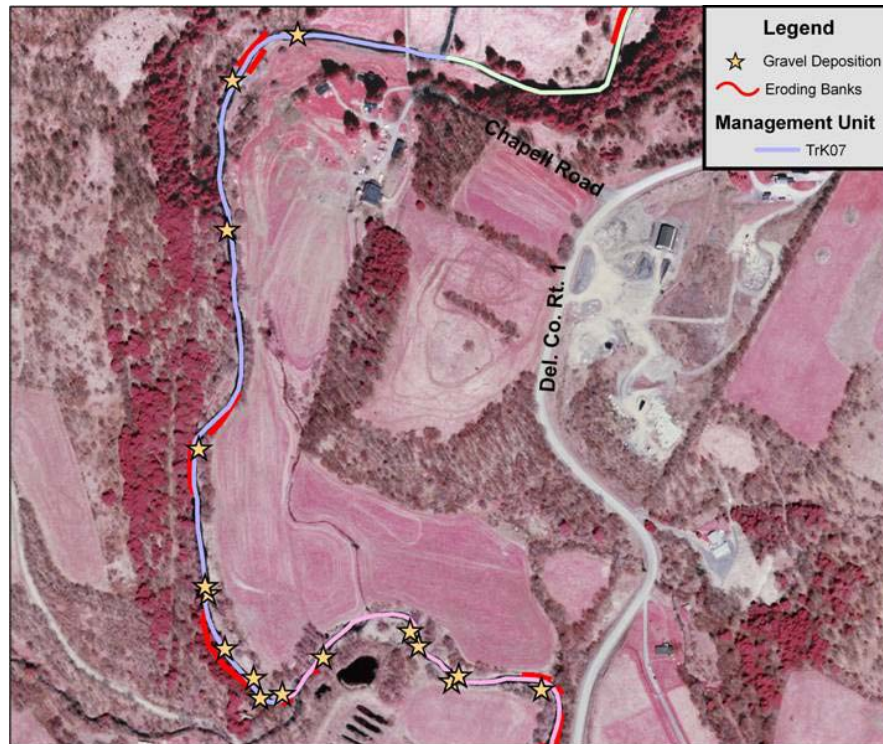
TrK 07

This reach is approximately 3,171 feet long and ends at the confluence with Biggar Hollow, which is the only tributary entering this reach. The stream runs through a very wide valley and is consistently against the right valley wall. The stream appears to have been historically moved against the valley wall and straightened for the agricultural land. There is one private bridge in this reach. The land use/land cover in the corridor is agricultural on the left side of the stream and forested on the right side along the steep valley wall. About 30% of the reach length exhibit eroding streambanks. In terms of area of eroding banks, 78% of the area contains mass failures on high streambanks near the valley wall. About 44% of the stream reach has streamside vegetation buffer widths between 0-25 feet on the left streambank. Depositional features can be found along 29% of the stream length and consist mainly of side bars and center bars in the downstream portion of the reach. One area of deposition across the entire channel allows high flow water to easily access the left floodplain and flow through a corn field. The transverse bar associated with this full-channel deposition is sending normal flow water into the high right bank, causing erosion. The toe of this high bank is being weakened, which could lead to mass failure of this bank. A Rosgen Level II survey consisting of a long profile, cross sections, and pebble counts has been done on about 900 feet of the stream in the middle portion of this reach. This data confirmed that this reach is a C4 stream type, which was originally determined via the SGAT protocol.

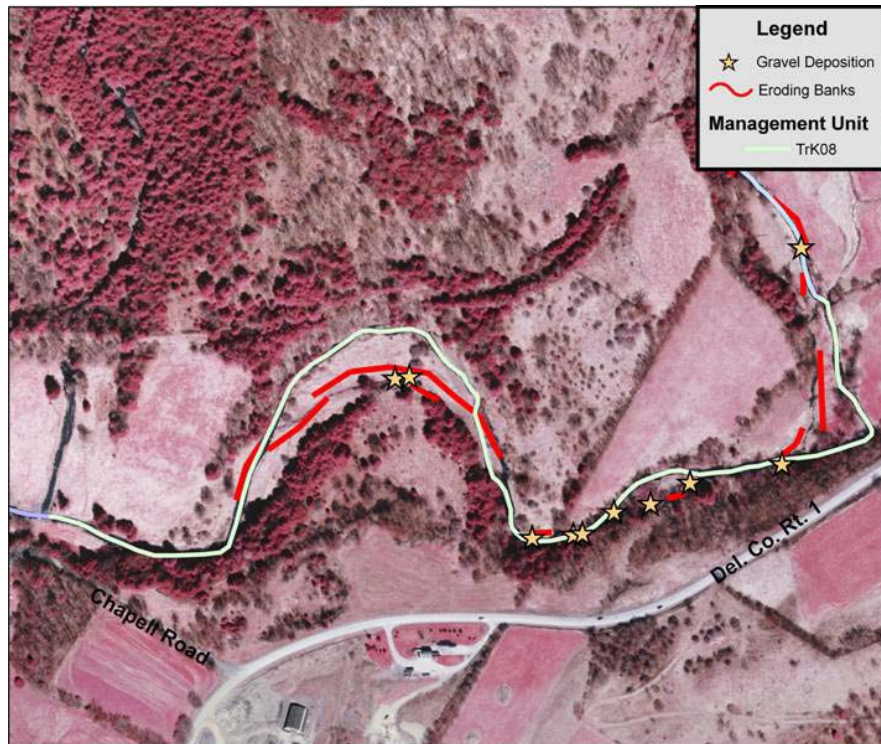
TrK 08

This reach is approximately 3,948 feet long and ends at the confluence of an unnamed tributary near Upper Dingle Hill Road. The valley is much narrower here, but not enough to confine the stream. The land cover within the corridor is forest along the steep streambanks/valley walls and brush/pasture along the floodplain. The stream has recently been changing course within the floodplain which is creating increased streambank erosion. About 44% of the reach length has an eroding bank occurring along it, while about 84% of the eroding banks have no streamside vegetation buffer due to stream channel movement through pasture areas. Depositional features cover 18% of the reach, all of which occur in the upper portion. The types of depositional features consist of a mixture of center bars, side bars and full-channel deposits. The unnamed tributary at the upstream end of this reach has brought large amounts of sediment into the Tremper Kill. Most deposition is just downstream of this point. The areas of the full channel deposition are susceptible to channel migration. There are no structures in the floodplain to protect, so the widely meandering stream is not an issue in that respect.

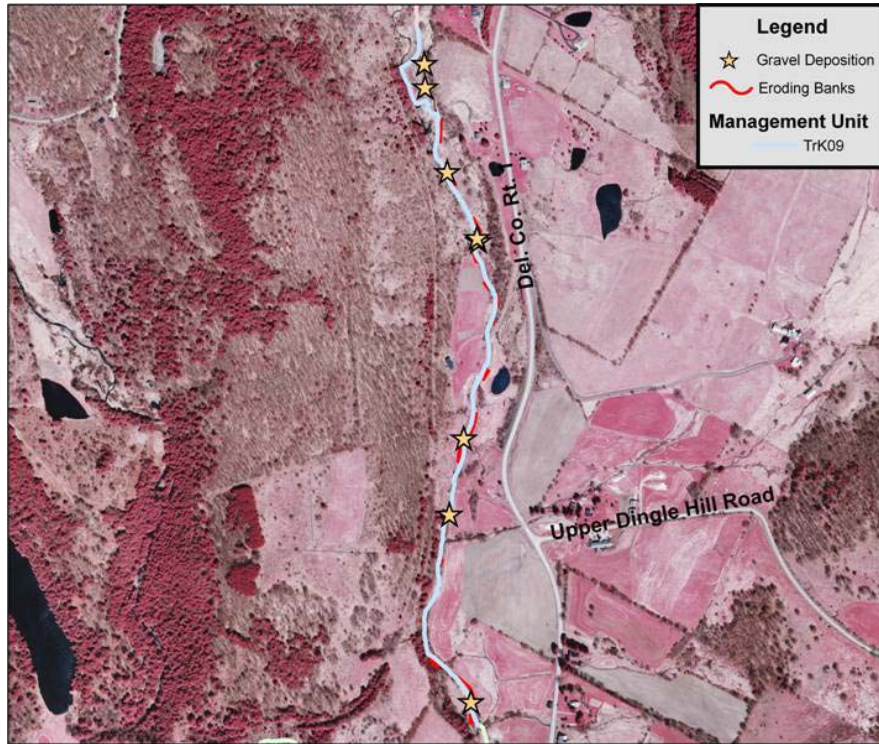
TrK 09

This reach is approximately 5,133 feet long and runs through a broad valley. Campbell Hollow and two unnamed tributaries enter Tremper Kill. There are two private bridges along this reach. The corridor is a mix of forest, brush land, agricultural land and wetland. The floodplain is primarily cropland, pasture and some wetland. Almost 60% of the reach has a narrow streamside vegetation buffer of less than 25 feet wide or none at all, most of this being on the left streambank. Eroding banks can be found in 31% of the reach length and about 88% of the eroding banks have no streamside vegetation buffer. Deposition is not a major problem in this reach and only 10% of the reach has a depositional feature present. The depositional features consist mostly of side bars. In the upper portion of the reach, the stream has changed course many times since 1963 and has moved across the entire floodplain. The floodplain was once an agricultural field.

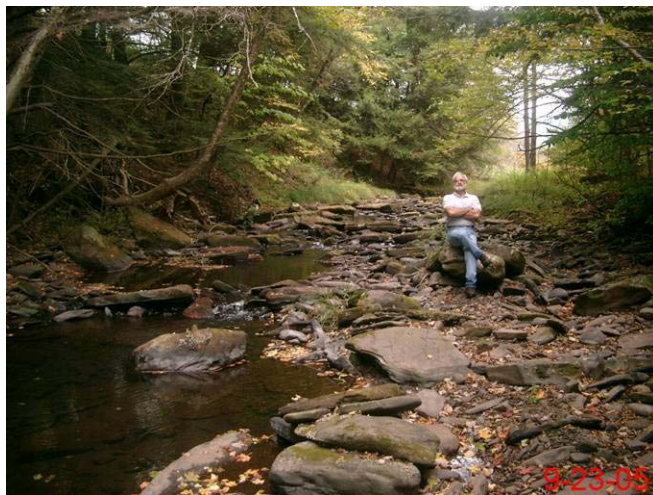
Figure 1.7 Vly Creek Step Pool Sequence

Level II resulted in an F stream type for the study reach. This area was identified as a possible reference during the Project Advisory Committee (PAC) visioning session processes. **Figure 1.7** illustrates a step pool sequence on Vly Creek.

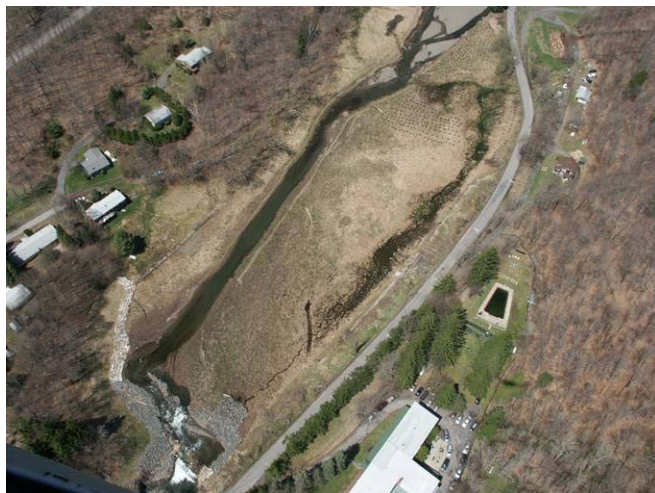
Figure 1.10 Lake Switzerland Post-Dam Removal

Lake Switzerland is located in VIC 02 on Vly Creek. The dam was partially removed due to public safety concerns, leaving a short section intact to serve as grade control. The DCSWCD SCMP received a grant to plant trees to stabilize the newly created stream channel flowing through highly erodible soil. Cross sections were placed in this reach in order to monitor the movement of the stream

and photo documentation is extensive for this area. **Figure 1.10** is a helicopter picture (04/28/05) of Lake Switzerland after the dam removal project. The lower left corner of the picture depicts the water spilling over the remnants of the dam.

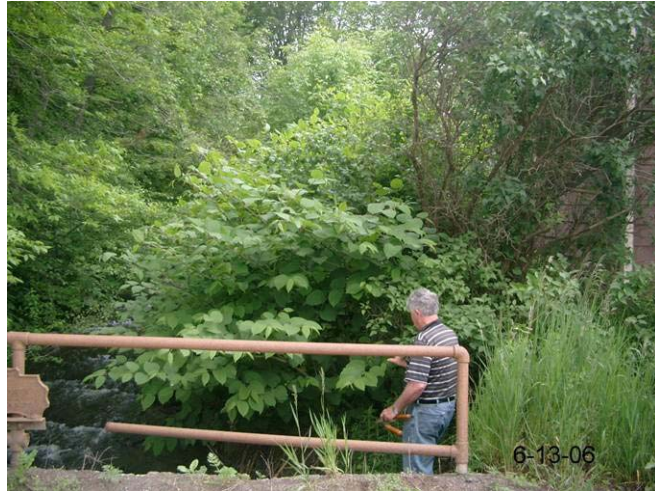
Figure 1.11 June 2006 Knotweed Growth

A demonstration project for Japanese Knotweed eradication was identified in the Town of Halcott at the intersection of Greene County Route 3 and County Route 1. A volunteer group is working closely with the DCSWCD SCMP staff to eradicate a patch of knotweed in the headwaters of the Bush Kill on the West Settlement Creek tributary. There are few knotweed patches along Vly Creek and this site was a good candidate for a project.

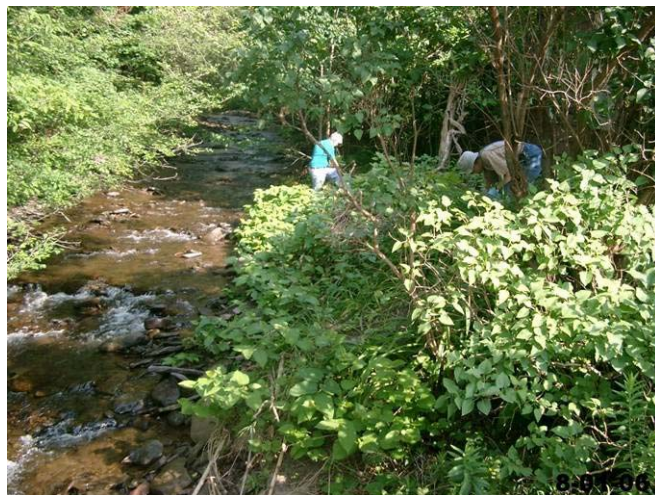
Figure 1.12 August 2006 Knotweed Growth

The group has named the project site “Knot-A-Lot”. The area of the project is approximately 990 square feet on the left bank and 640 square feet on the right bank. An area of knotweed continues up onto the floodplain and the right side of the stream. This area was determined to be the control site for the demonstration project and identified as a possible candidate for a future eradication project. The knotweed height was approximately 8 feet tall when the first cutting was completed in June 2006. **Figure 1.11** shows the height of the knotweed prior to the first cutting, while **Figure 1.12** shows the knotweed re-growth in August 2006 after several cuttings. Every three weeks the plot was cut, the stalks were dried, and then burned. The height of the new growth in August and September was approximately 1-2 feet tall. September was the last cutting of the year and by then the knotweed plants were fewer and easier to pull out by hand. During the last visit, it was noticed that other types of vegetation were starting to grow in place of the knotweed.

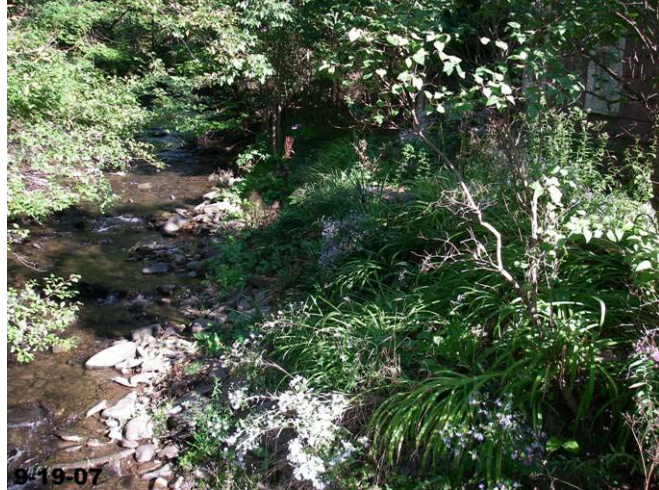
Figure 1.13 September 2007 Knotweed Growth

The project continued in 2007 growing season. The knotweed was found to be sparse and the height was approximately 12 inches high. The group planted lilies and irises on the left streambank to help fight the knotweed. **Figure 1.3** shows the left streambank after the second season of the eradication project. Education is a key role in knotweed awareness, so it was important to notify the community about the project. An article was written and published in the Halcott Times and a poster was on display at the Halcott Community Fair on July 21, 2007.

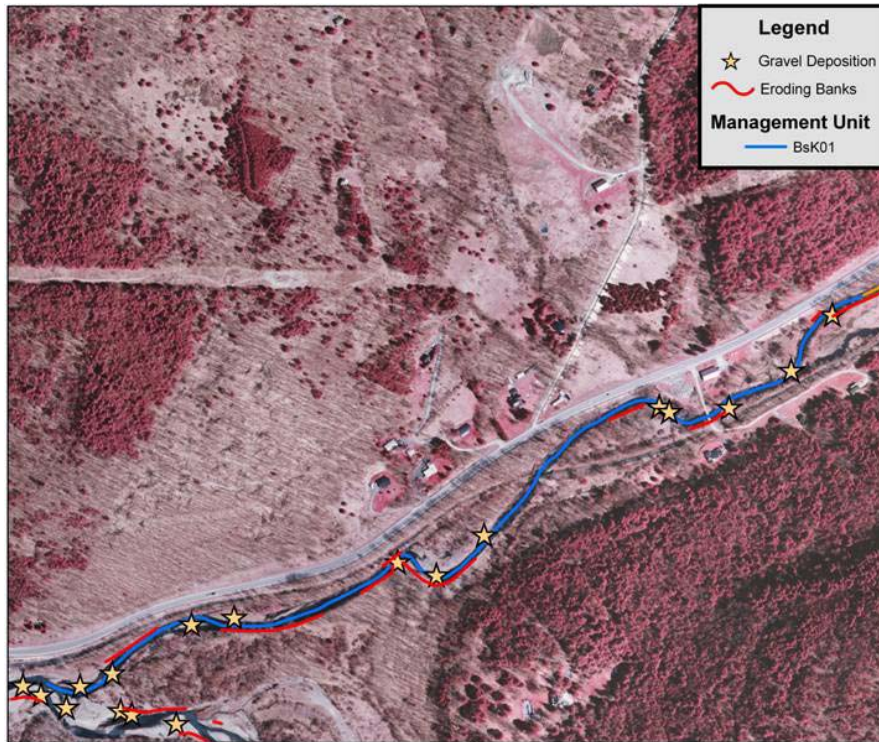
BsK 01

This reach begins at the confluence of Dry Brook and runs upstream for about 5,059 feet. One unnamed tributary enters into the upstream portion. Two bridges (a railroad and a private bridge) are in the reach along with USGS Gage Station #01413398 (Bush Kill near Arkville NY), which is located on the left bank 60 feet upstream from the private bridge. It is 0.7 miles upstream from the confluence and 2.35 miles east of Margaretville. The drainage area at the stream gage is 46.7 square miles. The period of records that are available for this gage is from October 1997 to the current year. The channel slope is fairly flat 0.004 (0.4%) and the stream's limited sinuosity (1.07) reflects the narrow valley setting and valley's principle land use as a major transportation corridor. The corridor is primarily forested, but about 20% of the corridor area is considered "built-up" due to impervious surfaces (NYS Rt. 28). Impervious surfaces lead to accelerated stormwater run-off. About 43% of the reach has a streamside vegetation buffer of less than 25 feet wide. This high percentage is due to the stream being close to the railroad bed or NYS Rt. 28. About 44% of the reach length has an eroding bank on one side of the stream bank or the other. Most of these eroding banks have streamside vegetation buffers and the tree roots on the streambanks are helping to slow the rate of erosion. There are 12 gravel depositional features in this section that make up 26% of the reach length. Four of these are identified as point bars which are expected in this "C" stream type. The rest of the gravel depositions are identified as side bars and center bars. The floodplain in the area of the railroad bridge is cut off by the raised railroad bed. During high flow events, water on the floodplain must funnel under the bridge. This concentrated flow may be creating too much energy and may be causing the odd meander bend downstream. Further study will be needed to determine if the stream function would benefit from an alignment adjustment in this area.

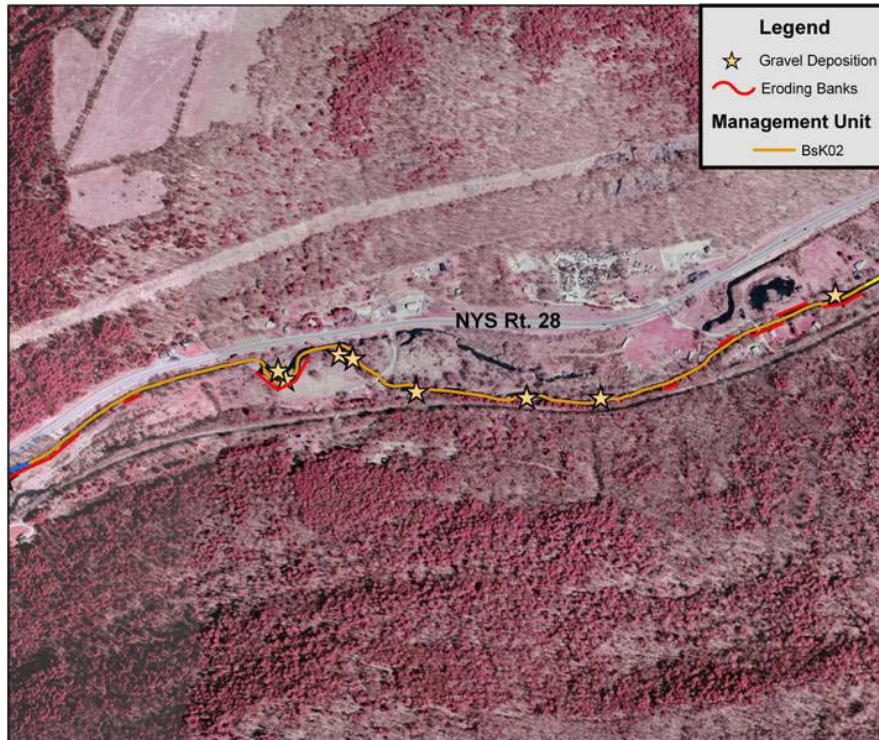
BsK 02

This reach is about 5,820 feet long with a slope of 0.0031 (0.31%) and a low sinuosity of 1.1. The stream appears to have historically been straightened through this narrow valley. There are two private bridges crossing over the stream. The corridor land cover is about 70% forest/brush, while 24% is considered urban partially due the impervious surface of NYS Rt. 28. About 93% of the reach length has a 0-25 feet wide riparian buffer on at least one side of the stream. This large percentage is because the stream is so close to NYS Rt. 28 and the railroad bed. Approximately 30% of the reach has streambank erosion on at least one bank. 72% of these eroding banks have no riparian vegetation buffer. Depositional features, consisting of side bars and center bars, can be found in 12% of the reach length. Streambank revetment is limited to the downstream portion of this reach where about 1,700 feet of sloped stone protects NYS Rt. 28. One small section of stream near this revetment has created a sharp meander bend. The stream has widened considerably at this point and formed two large center bars. From historic aerial photos, the stream has moved at least 160 feet since 1983. The eroding bank has no streamside vegetation and is an area that is maintained as a lawn.

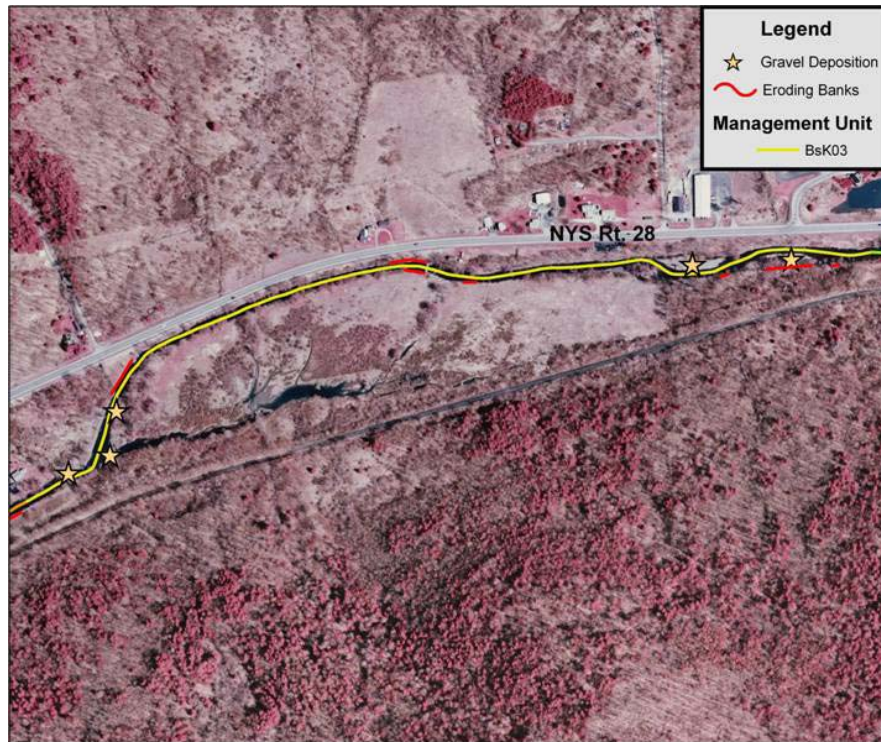
BsK 03

This reach is approximately 4,402 feet long, with characteristics similar to BsK 02. The straight stream runs through a broad valley. There is one unnamed tributary that enters the Bush Kill and one private bridge. The corridor is 60% forest/brush and about 23% urban or impervious. About 15% of the reach has an eroding bank and 42% of these banks have little to no woodland buffer for stabilization. About 13% of this section's length contains side bars and center bars as depositional features. There are 1,500 feet of sloped stone revetment placed along the right bank where the stream runs parallel to NYS Rt. 28. This section of stream is meandering in a fashion similar to BsK 02. According to historical aerial photography, there is a small meander and a side bar that has formed sometime since 1983 opposite of Kleis Road. One difference here is that the left bank on the outside of the bend has a sufficient riparian vegetation buffer.
