East Branch Delaware River

Stream Corridor Management Plan

Volume 2

December 2007

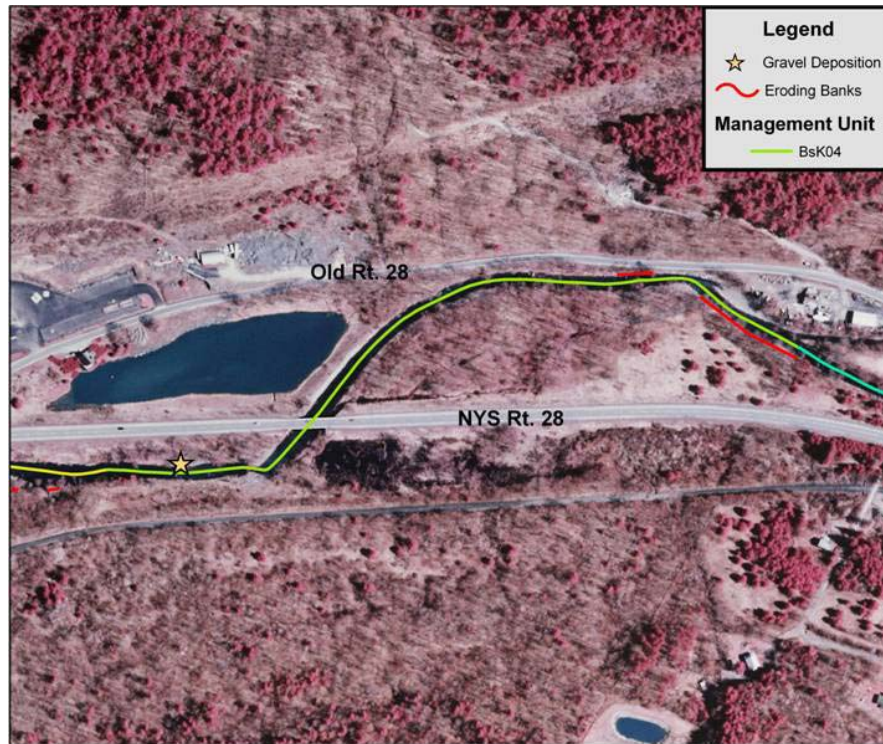
BsK 04

This reach is approximately 2,408 feet long and ends at the confluence with the Big Red Kill tributary. The valley is broad, but restricted by NYS Rt. 28 running parallel to the Bush Kill. The Red Kill has a delta bar forming downstream of its confluence with the Bush Kill. An unnamed tributary also enters the Bush Kill. Downstream of where the Bush Kill flows under the NYS Rt. 28 bridge, there is a side bar forming. The land cover in this stream corridor is about 60% forest/brush and 17% urban. Eroding banks are along approximately 18% of the reach and are mainly located in the area of the Red Kill confluence. The longest two eroding banks have a riparian vegetation buffer and the roots are helping to hold the bank soil material together. This reach was significantly impacted by the loss of access to a substantial floodplain with the re-alignment of NYS Rt. 28.

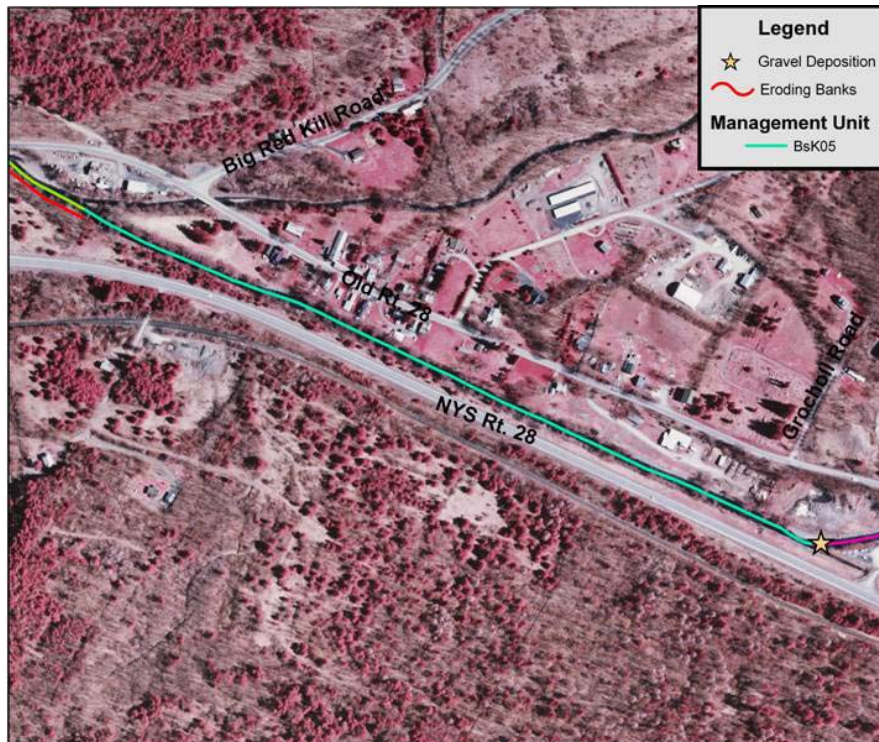
BsK 05

Situated in a narrow valley, this reach is approximately 3,097 feet long and nearly perfectly straight as it runs parallel to NYS Rt. 28. The straightened stream is steeper (1.0% slope) than upstream and downstream reaches. The narrow valley, steep slope, straight alignment, and confined channel contribute to accelerated stream flows through this reach. Land use in the corridor is primarily residential on the right side of the stream in the hamlet of Clovesville while NYS Rt. 28 occupies the left side. About 57% of the corridor is considered urban area, the impervious surface of which contributes to accelerated stormwater run-off rates. Approximately 80% of the left bank and 87% of the right bank have narrow riparian vegetation buffers between 0-25 feet wide. Riparian vegetation buffers, in addition to their roots holding the bank together, help to filter stormwater run-off pollutants and enhance water quality. There is extensive revetment in this reach. About 97% of the left bank along NYS Rt. 28 consists of sloped stone and almost 50% of the right bank has stone revetment. There were no observed eroding banks or depositional features. Residences along this reach were significantly impacted by flood waters and debris in the 1996 flood with several structures considered or approved for the flood buyout program. This reach should be considered for future flood hazard mitigation measures.

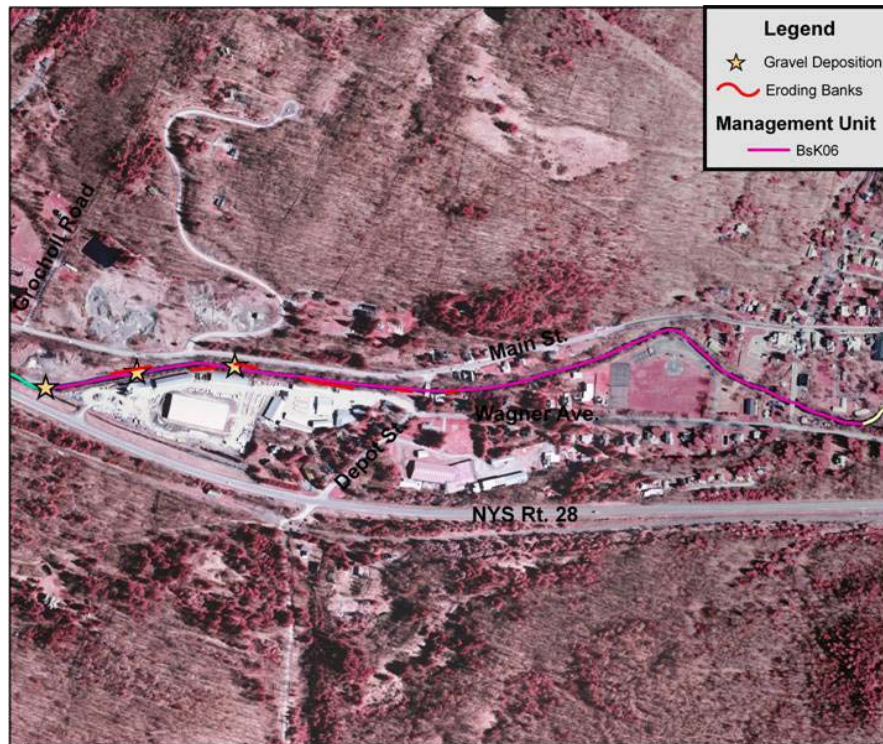
BsK 06

This reach is approximately 4,627 feet long and ends where both Vly Creek and Emory Brook enter the Bust Kill mainstem. This channelized stream runs through a broad valley and through the Village of Fleischmanns. The Little Red Kill is the only tributary entering in this reach. There are two bridges that cross over the Bust Kill, both within the village on Depot Street and Bridge Street. The corridor is “built-up,” with 60% considered urban area. Narrow riparian vegetation buffers that are 0-25 feet wide run the entire length of the left bank and almost 80% of the right bank. Eroding banks in this reach account for 19% of the entire stream length. There are only a few gravel deposition features in this reach due to the inability of the channelized stream to meander. Roughly half of the reach has a berm on at least one streambank. The downstream portion of this reach has a berm on the left bank and the right bank is a steep valley wall. The stream has no access to its floodplain in this area during high water events. This creates a very entrenched channel that puts more shear stress on the streambanks. About 95% of the eroding banks are located in this part of the stream. Revetments of many different types cover 41% of the entire stream reach length. This stream reach, like any stream that runs through a populated area, has been channelized, manipulated, and maintained for a long time. Through the Village of Fleischmanns, different types of walls were built to prevent the stream from meandering. Many of these walls are in poor condition and should be repaired or modified in places where there is potential for failure. This reach was severely impacted in the 1996 flood. The continued development and material storage within the floodplain since this event will only exacerbate damages in future similar sized floods. Flood hazard mitigation and improved floodplain management should be a priority for this reach.

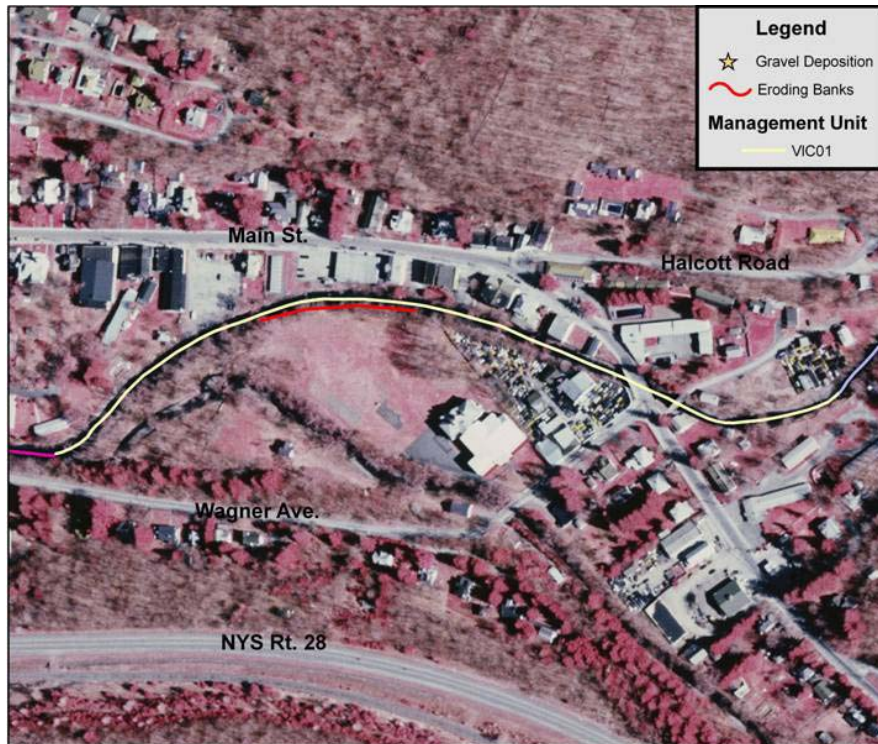
VIC 01

This reach is approximately 1,994 feet long and starts where both Emory Brook and Vly Creek flow into the Bush Kill mainstem. This section of stream is in a broad valley and runs through the Village of Fleischmanns. The stream corridor is built-up and is 67% urban. Two bridges, located on Main Street and Mill Street, cross the stream in this reach. There is one section of eroding bank that accounts for 18% of the reach length. The lower half of this area is an entrenched stream channel that shows slight erosion along the banks. The upper portion of the reach has a narrow woodland buffer where the roots are reinforcing the streambank soil materials. About 82% of the reach length has some form of revetment along the streambank through the Village of Fleischmanns. Many of these walls are in poor condition and should be repaired or modified in places where there is potential for failure. This reach is similar to BsK 06 in that it is entrenched and contained in its channel.

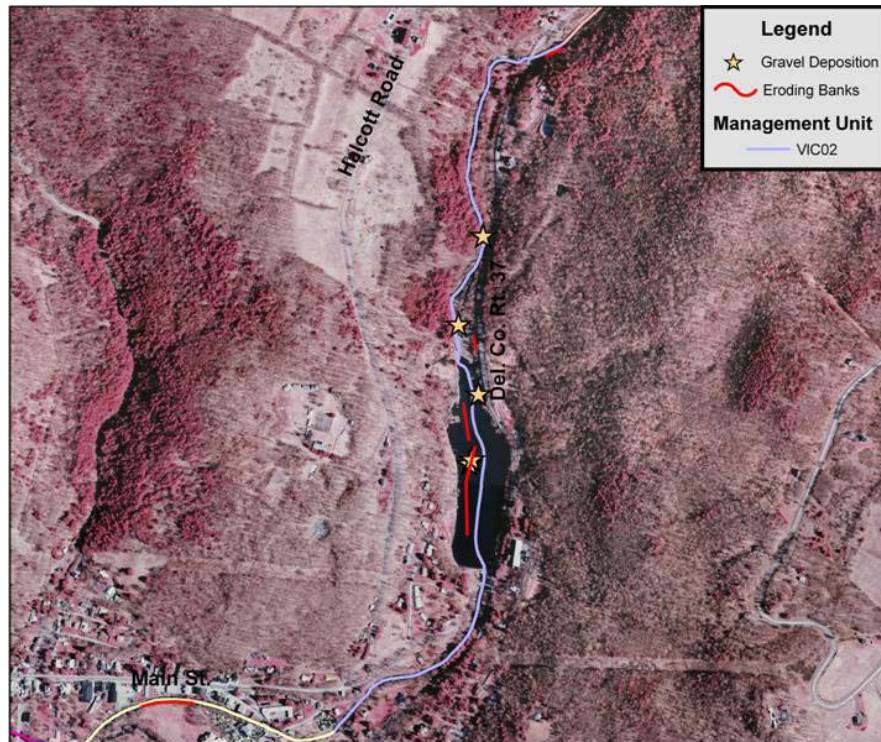
VIC 02

This reach is approximately 5,871 feet long and ends just upstream of Delaware County Bridge #37-1. The stream runs through a narrow valley with a slightly steeper channel slope (1.5%) than other stream reaches in this sub-basin. Almost 40% of the reach length has exposed bedrock on the streambank or in the channel bed, found mostly upstream of the former Lake Switzerland. Forest/brush land account for 80% of the stream corridor land cover. About 18% of the reach has eroding banks, primarily within the former Lake Switzerland where the stream is working through fine sediment deposits from the old lake bottom. The DCSWCD SCMP staff planted willow fascines at the top of the streambanks to help hold the soil in place. Approximately 38% of the reach has a narrow riparian buffer due to the proximity of Delaware County Route 37 running parallel to the stream. One unnamed tributary enters at the upstream end of this reach and three bridges cross the stream: two foot bridges and Delaware County Bridge #37-1.

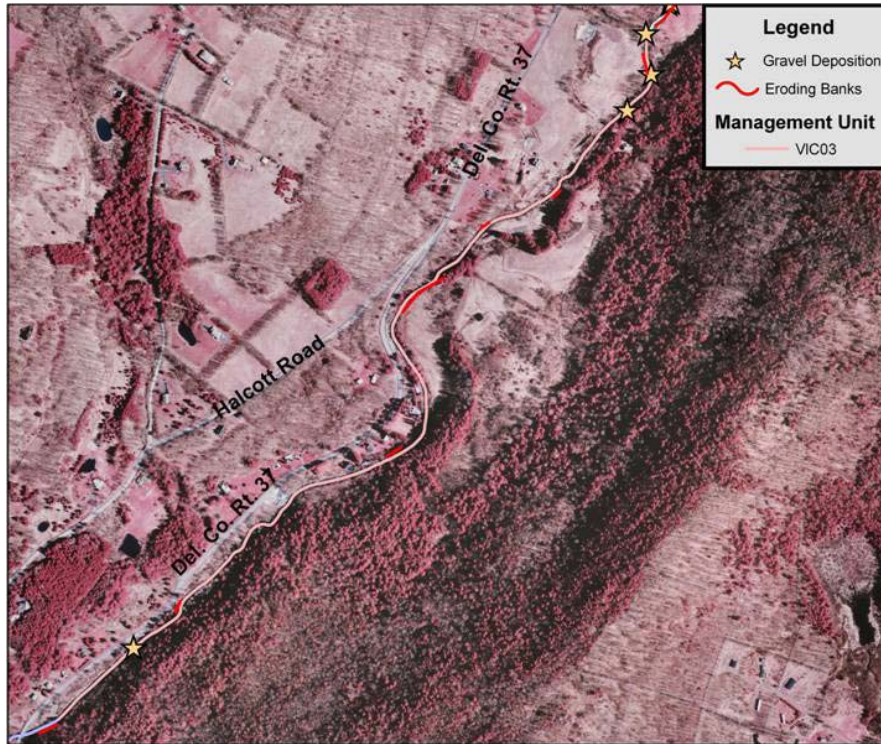
VIC 03

This reach is approximately 6,219 feet long and ends at the confluence with an unnamed tributary at Bruce Scudder road. There is one more unnamed tributary in this reach and one private bridge. The stream corridor is primarily 70% forested with residential areas and roadways covering another 10%. Old fields and brush also make up a small portion of land cover. Only 12% of the reach has an eroding streambank, but the majority of these banks are an average of 9 feet high and the streamside vegetation buffers are only 5 feet wide. Depositional features are few and are just downstream of the tributary at the end of this reach. Six sections of revetment make up 18% of the entire stream reach length. The largest section of revetment is located on Delaware County route 37 and consists of sheet piling, stacked rock wall, and riprap to protect the embankment near the intersection of Halcott Road.

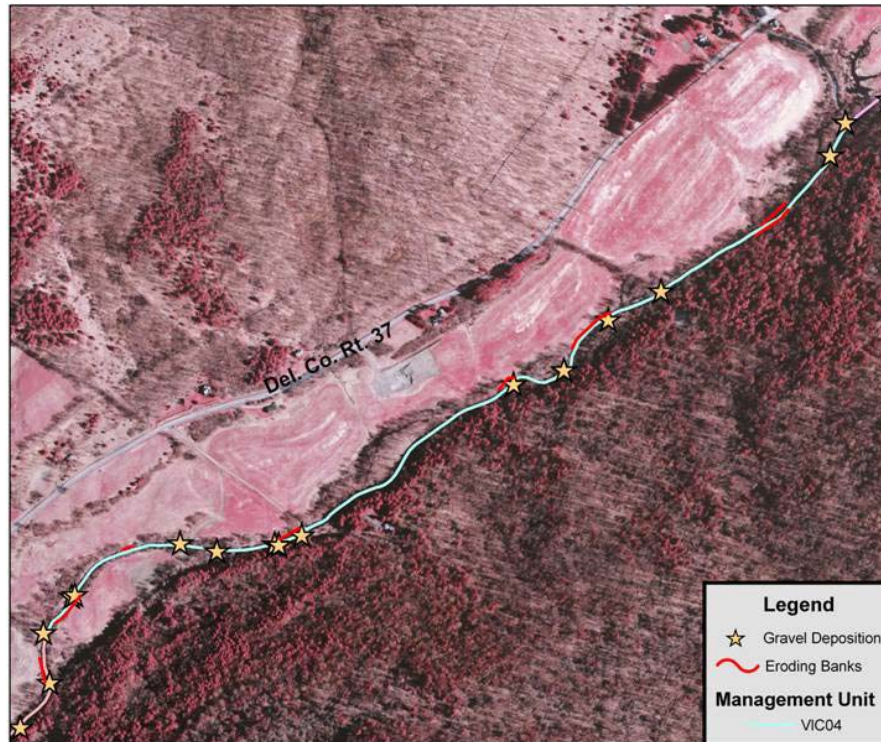
VIC 04

This reach is approximately 5,045 feet long and ends at the confluence with West Settlement Creek, the only tributary located in this reach. The stream generally hugs the left valley wall in a very broad valley. There is a small section of stream at the downstream end that leaves the valley wall and runs around an agricultural field. A full-channel deposition is causing high water flows to be directed toward this field. The stream corridor is forested on the left side, with a steep valley wall and a small crop field in the downstream portion of the reach. The right side consists mostly of hay fields. Riparian buffers on the right bank along the hay fields are better than many similar areas; only 10% of the right bank has a 0-25 feet wide buffer. About 20% of the reach has an eroding streambank, but these eroding banks all have some tree root protection. This reach has the greatest amount of deposition in the sub-basin, accounting for about 20% of the stream length. This reach has the flattest slope (0.9%) in the sub-basin, allowing for the extra deposition to take place. At this time there are no bank revetments located in this section of stream.

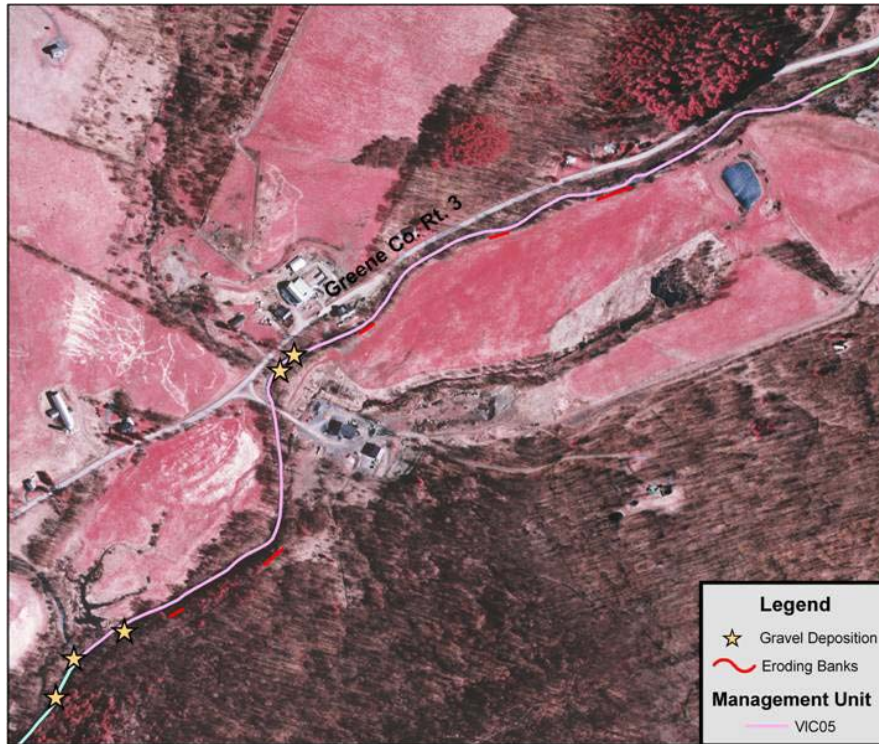
VIC 05

This reach is approximately 4,308 feet long and ends at the confluence with Elk Creek. There are two unnamed tributaries in this section of stream and one bridge. The valley is very broad and the upstream portion of the stream runs against the right valley wall then quickly crosses the valley and runs against the left valley wall. Land cover within the stream corridor is largely hay fields in the floodplain and forested on the valley walls. In the upstream portion, Greene County Rt. 3 is within the corridor on the right bank. About 11% of the reach has an eroded bank and there are two locations in the downstream portion that have been classified as mass failures on the steep left valley wall. Three locations of eroding stream were found in the upstream portion along the hay field on the left streambank. These three eroding banks will probably lengthen because of the narrow or non-existent woodland buffer. Approximately 63% of the reach length has a narrow buffer between 0-25 feet wide. Deposition features are few and only one short section of revetment was noted just upstream of the Halcott town barn bridge.

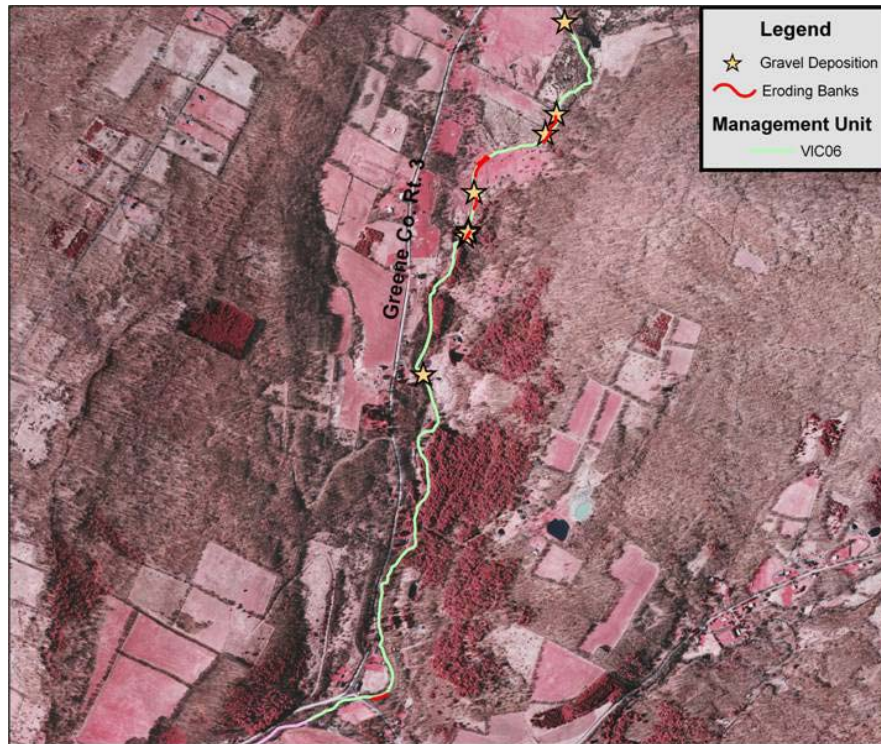
VIC 06

This reach is approximately 9,243 feet long. There are two bridges and one private driveway in this reach, both bridges being on Elk Creek Road. Turk Hollow and unnamed tributaries enter into this stream reach. The stream corridor is 70% forested with some areas of wetland and pastures. About 11% of the reach has an eroding streambank. Most of the streambank erosion is occurring in the upstream portion of the reach where the land use is pasture. Cattle have access to the stream channel and there are no riparian vegetation buffers on the streambank. About 3% of the reach length experiences deposition, mostly occurring in the same area as the eroding banks. Approximately 37% of the streambanks have a narrow (0-25 feet wide) riparian buffer. A more detailed survey was performed on a small section of this reach for classification. It was determined that this section of survey area was formerly a “Bc” stream channel and has evolved to an “F” stream type.

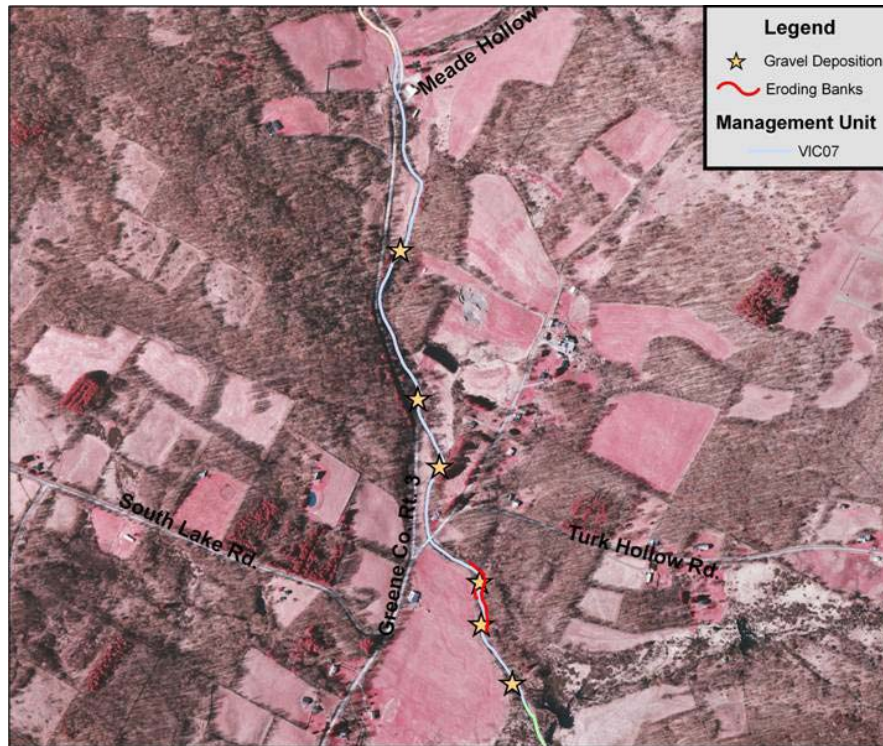
VIC 07

This reach is approximately 4,485 feet long and ends at the confluence of Se Meade Hollow, the only tributary in this reach. There are two bridges located on Greene County Rt. 3 and one on Bouton/Turk Hollow road. The stream corridor is slightly more than half forested and a large part of the land cover is hay field, abandoned field, and pasture. About 87% of the right bank has a narrow streamside vegetation buffer from 0-25 feet wide. In contrast, 24% of the left bank contains a narrow buffer. Only 12% of the reach experiences eroding banks, all of which are just downstream of Bouton/Turk Hollow Road Bridge and have a good riparian buffer. There is rock revetment at the bridge and a section of berm is located on the right bank downstream of the bridge. This area may experience problems with lack of stream access to the floodplain. As water is concentrated under the bridge, the water energy increases resulting in erosion. The eroding bank starts at the first bend just downstream of the berm.

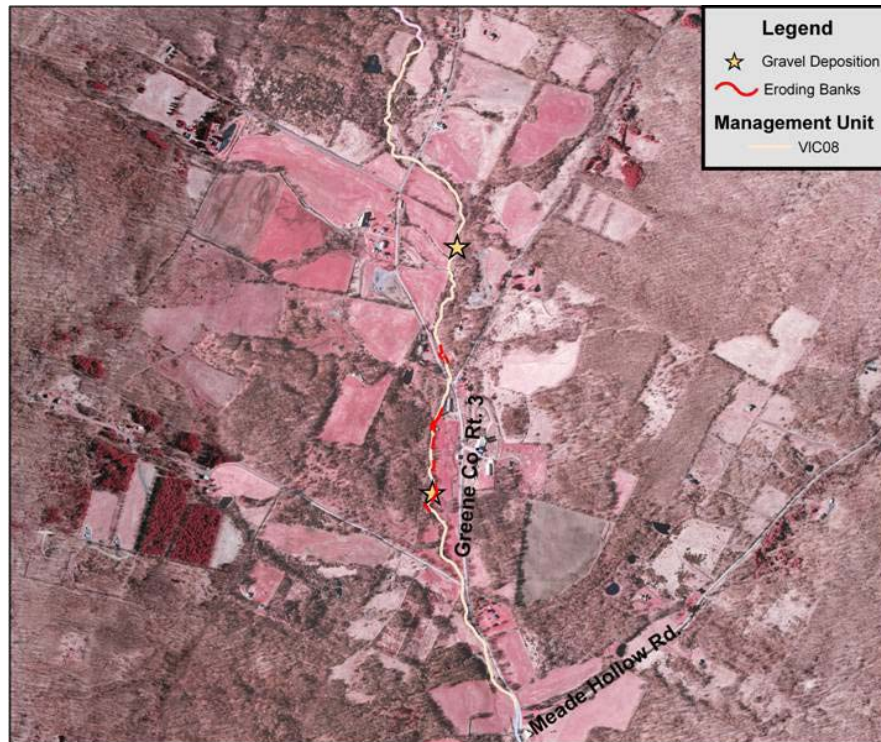
VIC 08

This reach is approximately 6,989 feet long. The valley is fairly broad and the stream is becoming steeper (2.2% slope) as it gets closer to the headwaters. There is one bridge and two culverts in this section. Five unnamed tributaries enter into this reach. The stream corridor is about half forested, with the remainder predominantly agricultural land in corn/hay fields and pastures. This reach corridor contains the most agricultural land in this sub-basin. Bank erosion exists in only 12% of the reach but most of these, about 84%, have no riparian buffer. About 50% of the streambanks have a narrow (0-25 feet wide) riparian buffer. Depositional areas are few in this steeper stream. Only two vegetated gravel deposition bars were seen from helicopter video. Revetments are limited to the downstream portion where the stream and Greene County Route 3 meet. Riprap revetment was placed in this location to protect the road from channel migration.

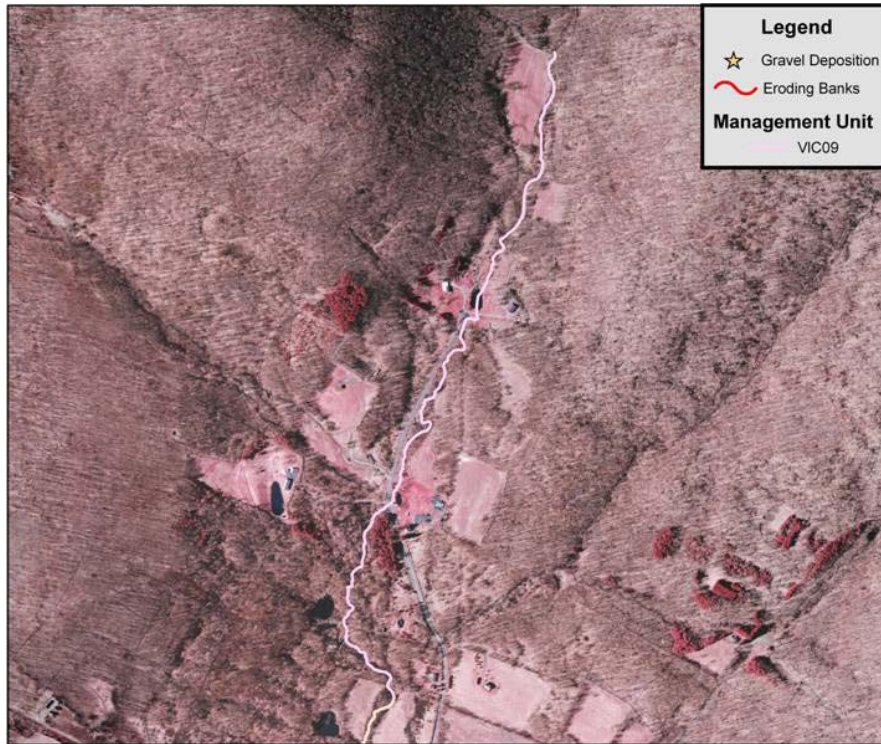
VIC 09

This reach is approximately 5,242 feet long and is the topmost reach of the Bush Kill watershed. It is a headwater stream with a 5% slope in a confined valley. The stream corridor is about 70% forested with other land uses such as hay fields, abandoned fields, and a few residential areas. There is one small tributary entering into the stream. The stream water is conveyed through two culverts under Johnson Hollow Road. Other data information for this reach is unavailable at this time because no GPS data was collected and this area was not included in the helicopter flyover.

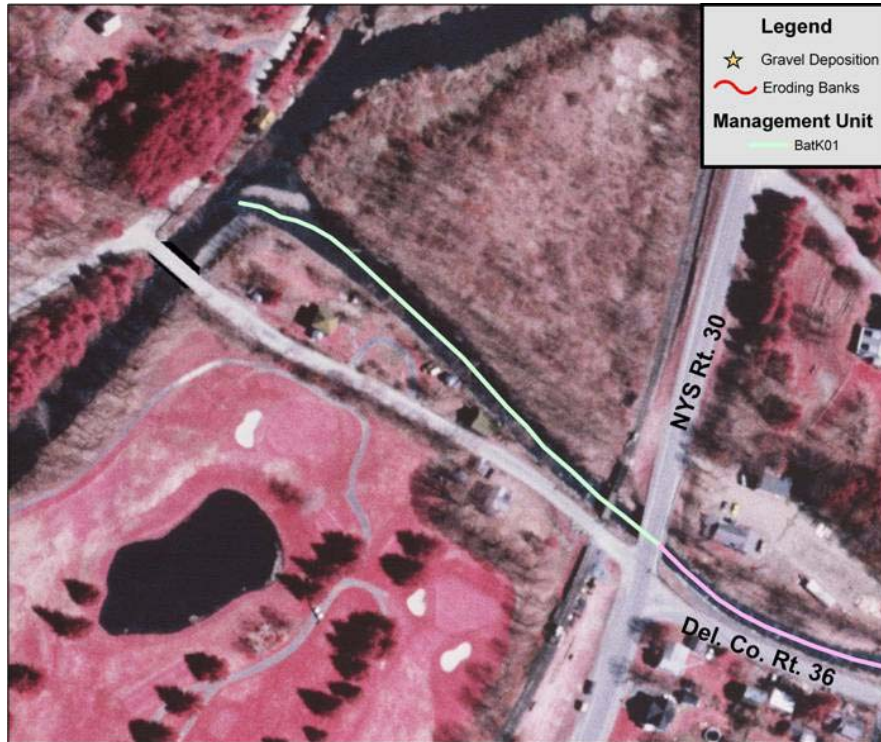
BatK 01

This is a short reach at approximately 706 feet in length. Starting at the confluence with the East Branch Delaware River, it continues upstream to the New York State Route 30 bridge. The NYS Rt. 30 bridge and a railroad bridge are in the upper portion of this reach. This section runs through the floodplain of East Branch Delaware River and was most likely channelized and straightened at one time. Soils in the corridor are hydrologic soil group A with a high infiltration rate. There are no eroding banks or depositional features at this time, but the banks of the channel in this reach are extensively revetted.

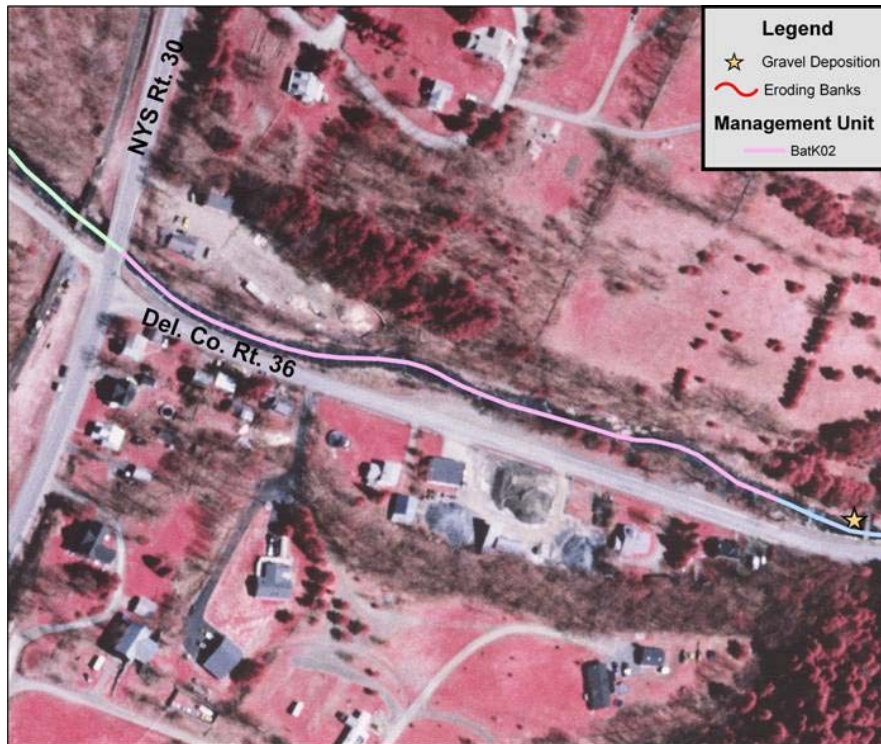
BatK 02

This reach is approximately 1,090 feet long and runs through a broad valley. Valley side slopes average about 24% on the right and 31% on the left. The stream is confined to the right side of Delaware County Route 36 and has some revetment to protect the road infrastructure. About 38% of the left bank has revetment to protect the road from stream channel migration. The corridor soils are hydrologic group A with a high infiltration rate. There are no eroding banks or deposition features within this reach. The stream is likely impacted due to its proximity to the road surface.

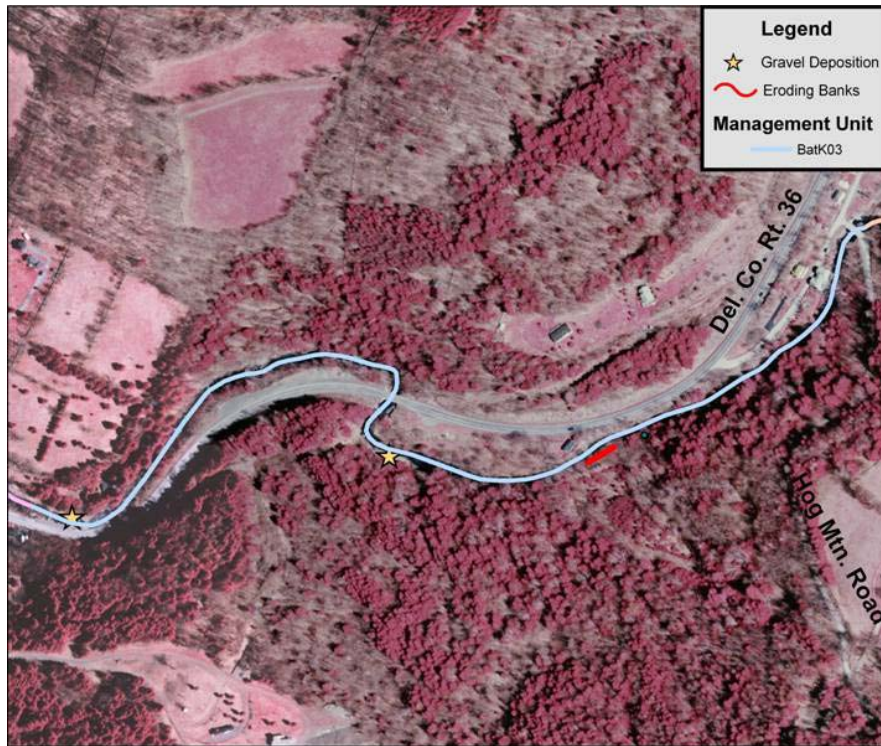
BatK 03

This reach is approximately 3,460 feet long and ends at the Delaware County Bridge #103 on Hog Mountain Road. The valley is narrow and twists as one progresses upstream. The stream slope is steeper (1.7%) than most reaches in this sub-basin. There are three bridges in this reach: Delaware County Bridge 36-1, Delaware County Bridge #103, and one private bridge. There is bedrock exposed throughout the upper portion, mainly on the left bank and in the bed of the stream. There is very little bank erosion since the bedrock protects the streambanks. Only small amounts of deposition can be seen, probably due to the steep stream slope and channel confinement. Hydrologic group C/D soils with undrained to high run-off rates are most often found in this area. Valley side slopes are an average of 16% on the right side and 22% on the left side.

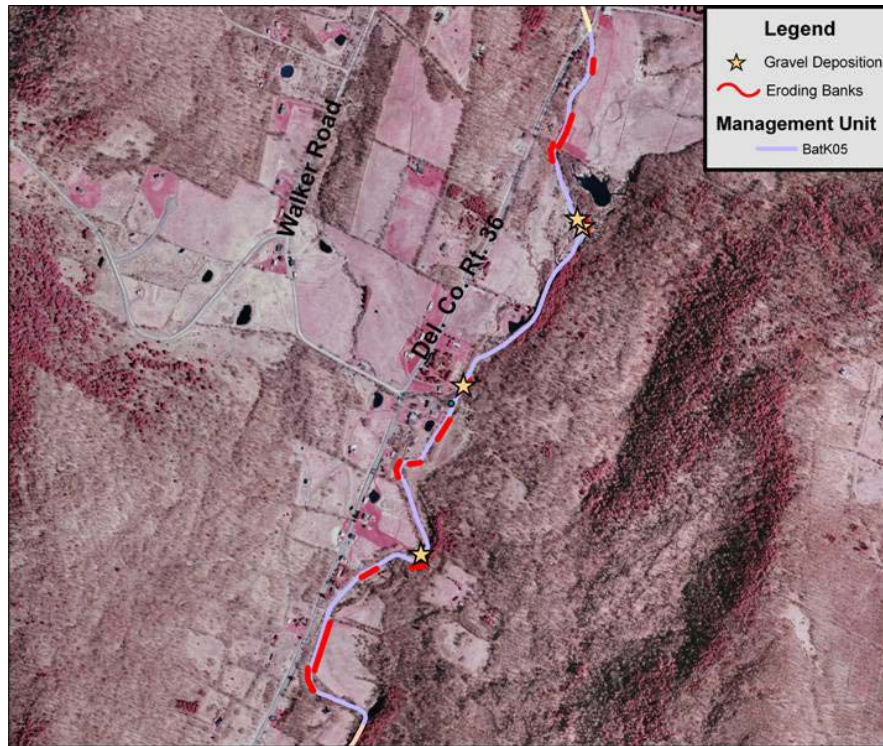
BatK 05

This reach is approximately 7,560 feet long and ends at Delaware County Bridge #36-3. The stream has a 0.8% slope and runs through a broad valley. With a sinuosity of 1.2, it is the greatest sinuosity in the sub-basin. There is one private bridge crossing in this reach. Similar to BatK 04, 28% of this reach length consists of eroding banks, with 60% of these eroding banks being mass failures on high streambanks (20 feet high). Almost 80% of all eroding banks have no riparian vegetation buffer. A narrow or absent buffer may lead to increase bank erosion and increase sediment supply, adversely affecting sediment transport. There are only four observed depositional features in this section. Two of these depositions consist of point bars, which are expected in a “C” stream type. From this we can assume sediment transport is not a problem through this reach. Surficial geologic material within the corridor is alluvium with high potential for erodibility. Hydrologic soil group B is dominant. Valley side slopes average 11% on the right and 20% on the left.

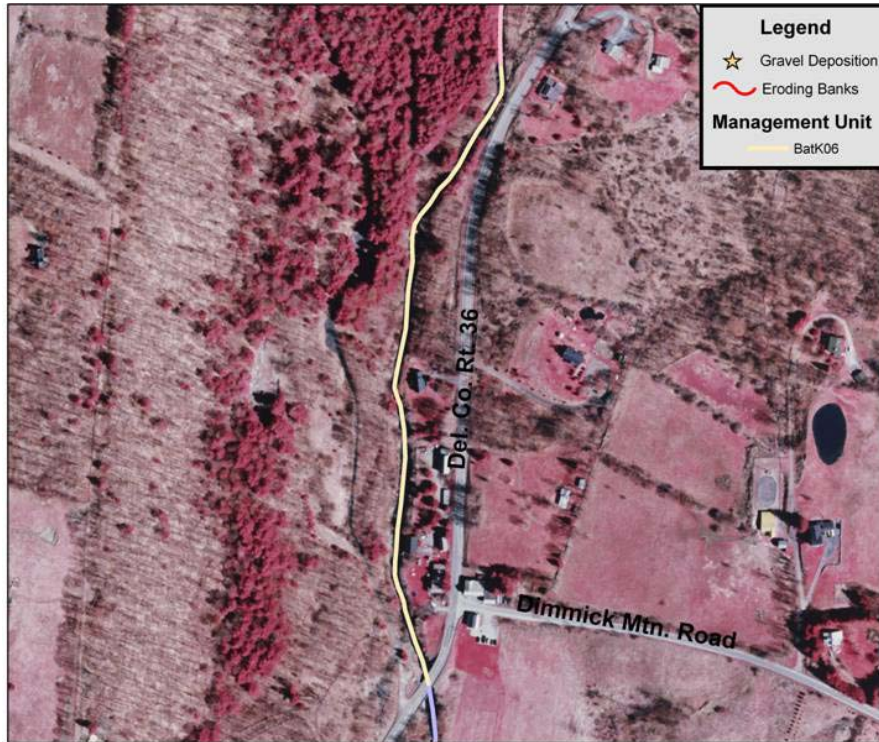
BatK 06

This reach is approximately 1,760 feet long and runs along the right wall of a narrow valley. Delaware County Route 36 travels the same narrow valley that the stream runs through, passing residential areas along the way. This doesn't allow for much room for a properly functioning floodplain or the channel migration normally associated with evolving streams. Delaware County Bridge #36-3 is located at the downstream end of this reach. One section of bedrock across the stream may be indicating that the stream has downcut in this section. No eroding streambanks or gravel deposition features were observed in this reach. Stream features were identified using observation of the helicopter video. Valley side slopes average 32% on the right and 19% on the left.

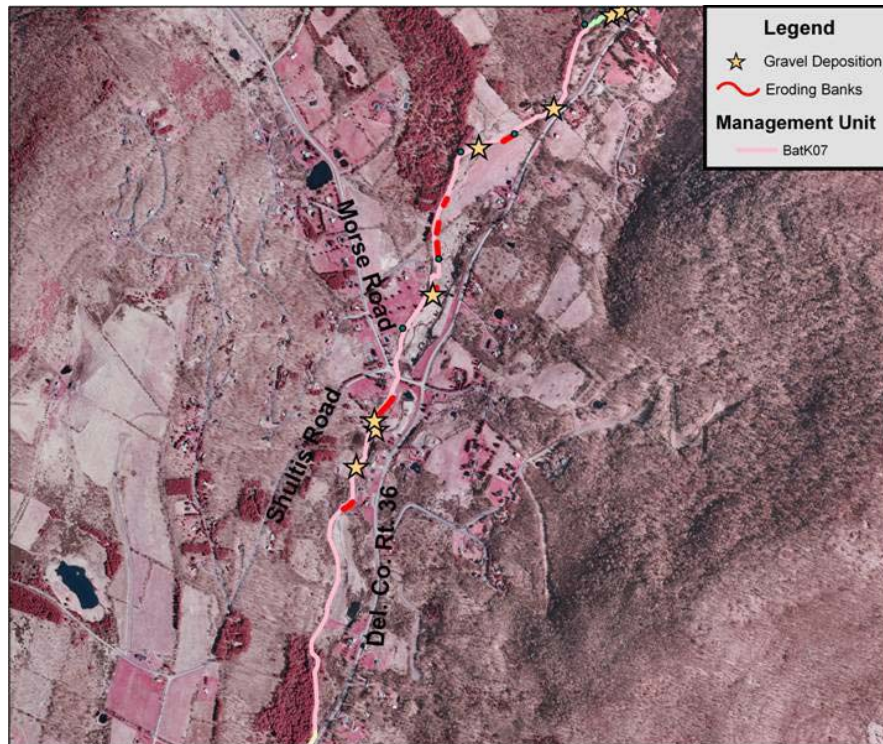
BatK 07

This reach is approximately 8,769 feet long and runs through a broad valley. The stream flows consistently against the right valley wall with a fairly flat overall slope of 0.7%. Delaware County Bridge #8-1 is the only crossing in this reach. Most of the stream has extensive areas of floodplain on the left side of the stream, but very little on the right side. A large wetland area is located upstream of Delaware County Bridge #8-1. There are five unnamed tributaries that enter the stream in this reach. Eroding banks account for about 12% of the total reach length, but 70% of the eroding streambanks have no riparian vegetation buffer. Six observed gravel deposition features are located within this reach, three of which are point bars that are normal for type C streams. The remaining three are not very large and consist of 1% of the total reach length. Valley side slopes average only 10% on the right, while the left is 24%.

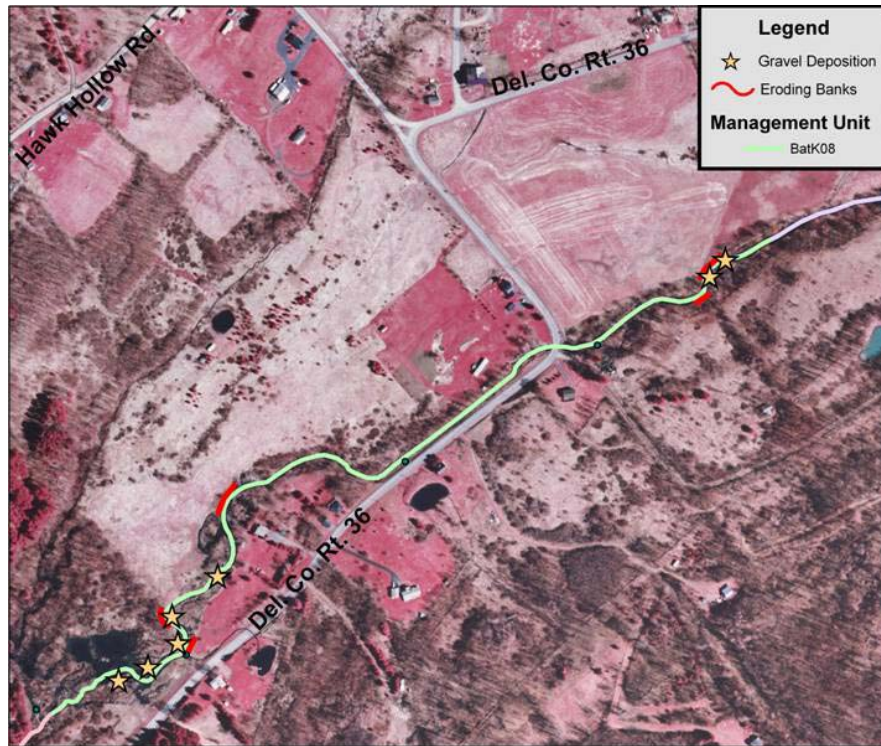
BatK 08

This reach is approximately 3,518 feet long and ends about 900 feet upstream of Delaware County Bridge #36-4, the only bridge in this section. There are three small unnamed tributaries that enter into this reach. In the upper half of this reach, the stream has historically been straightened and pushed to the left side of the very broad valley wall. The stream passes under Delaware County Bridge #36-4 and at times of moderate to high flow events, the stream jumps out of the bank just above the bridge. This floods Delaware County Route 36 and residences in that area. The stream meanders through many gravel depositional features at the downstream portion of this reach. This area looks like a braided “D” stream type reverting back to a stable “C” stream. There are some eroding streambanks in this area due to the evolution of the stream type from D to C. Valley side slopes average 23% on the left side and only 8% on the right.

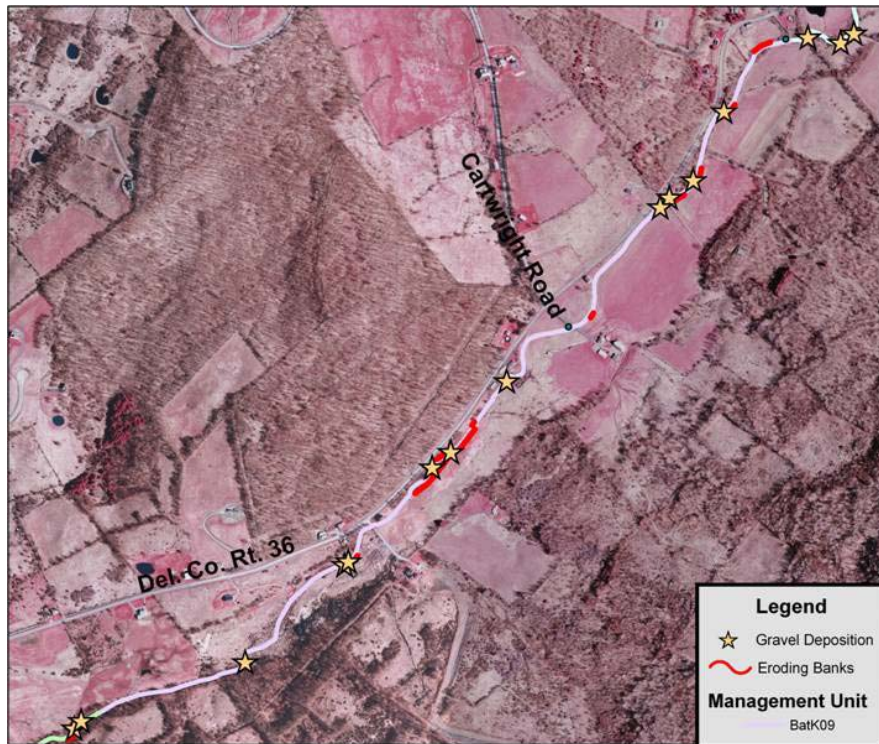
BatK 09

This reach is approximately 8,111 feet long and ends near the confluence with an unnamed tributary from the north. The valley is very broad, with floodplains being mainly along agricultural fields or abandoned fields. Judging from historic aerial photos, this stream appears to have been straightened and moved to the side of the valley floor long ago. There are three bridges/culverts in this reach and two unnamed tributaries that enter the mainstem. About 20% of the reach has an eroding streambank. Most of these banks are on the outside of a small bend, indicating that the stream is too straight and is trying to increase sinuosity. A problem area that is located about 1,400 feet downstream of Cartwright Road has a 700 feet long eroding streambank on the left side of the stream. It appears that the stream has been cleaned out recently (prior to helicopter video) and the gravel was used to build a berm on the left of the straightened channel. This area will have high erosive forces on the streambanks. This area should be documented to determine whether erosion problems continue. The stream channel may react to the gravel dredging and berming by widening, gravel deposition, and/or headcutting upstream/downstream of this area. All of the eroding banks have no riparian vegetation buffer on either side of the streambanks. About 75% of the entire reach has 0 – 25 feet of streamside vegetation buffer on both sides of the banks. Hydrologic group B soils, with a medium to high infiltration rate, cover about 84% of the corridor. Valley side slopes average between 15% - 19%.

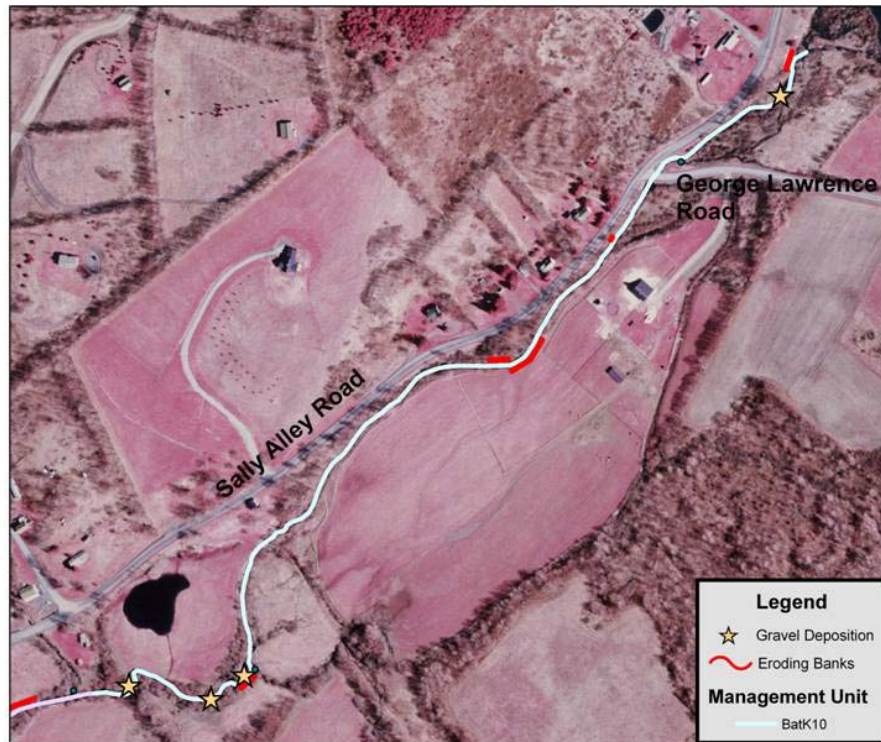
BatK 10

This reach is approximately 3,421 feet long and ends near the confluence of Bed Hollow and Buffalo Hollow. The valley is still very broad and the stream travels along both the right valley wall and the road near Sally's Alley. A short downstream section has some sinuosity and is also the area with the majority of gravel deposition (2 point bars and 1 center bar). About 9% of the reach has eroding banks of which almost 80% has no riparian vegetation buffer. About 91% of the left bank has a buffer width less than 25 feet. There is one culvert located on George Lawrence Road and two unnamed tributaries in this reach. Hydrologic soil group B is found in 94% of the corridor. Valley side slopes average 10% on the right side and 23% on the left. The dominant land use/land cover is agricultural.

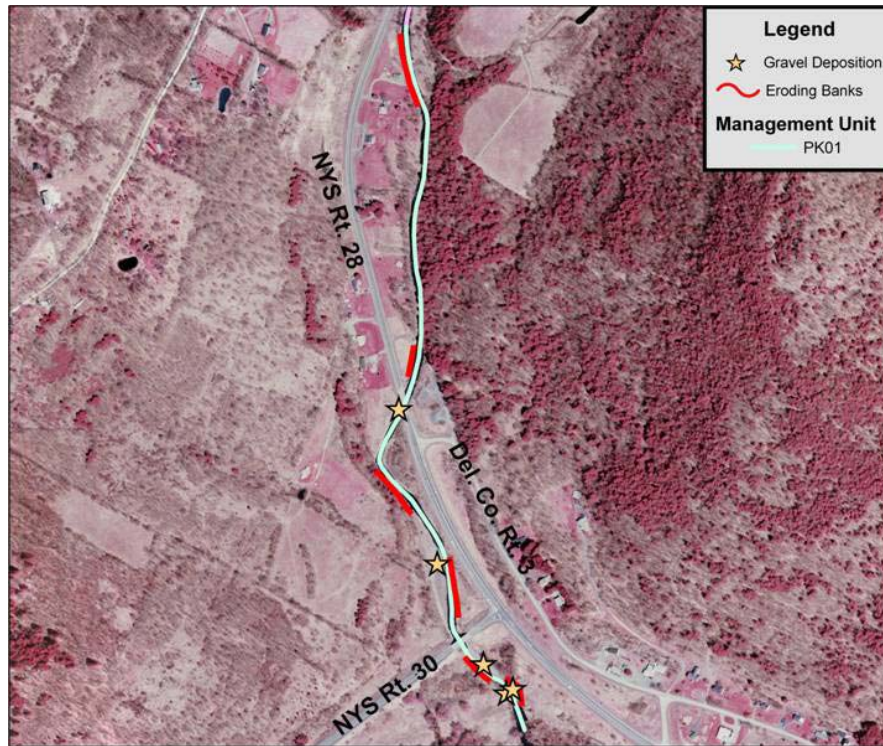
PK 01 begins near the high water mark of the Pepacton Reservoir, about 600 feet downstream of New York State Route 30. The upper portion of this reach is approximately 2,075 feet upstream of the New York State Route 28 bridge that crosses the Platte Kill. The upper portion of the reach is near the confluence with an unnamed tributary adjacent to Meekers Hill Road. The total length of this reach is about 4,125 feet. Bridges within this reach are located on New York State Route 28 and 30. Upstream of the NYS Rt. 28 bridge, the stream appears to have downcut to bedrock in some areas. Downstream of these bridges, the stream has widened and become a gravel depositional area. The dominant surficial geologic material in this reach corridor is alluvium, which can have high potential for erodibility. About 87% of the corridor soils are in hydrologic group B, which have medium/high infiltration rates. Valley side slopes average 18% on the right side and 33% on the left side. This reach has a broad valley width. The USGS Stream Gage 01414000 (Platte Kill at Dunraven NY) is located on the right bank, 200 feet upstream from the bridge on NYS Route 28 in Dunraven and 2.5 miles southeast of Margaretville. The drainage area at the stream gage is 34.9 square miles. The period of records that is available for this gage is from October 1941 to September 1962 and December 1996 to the current year.

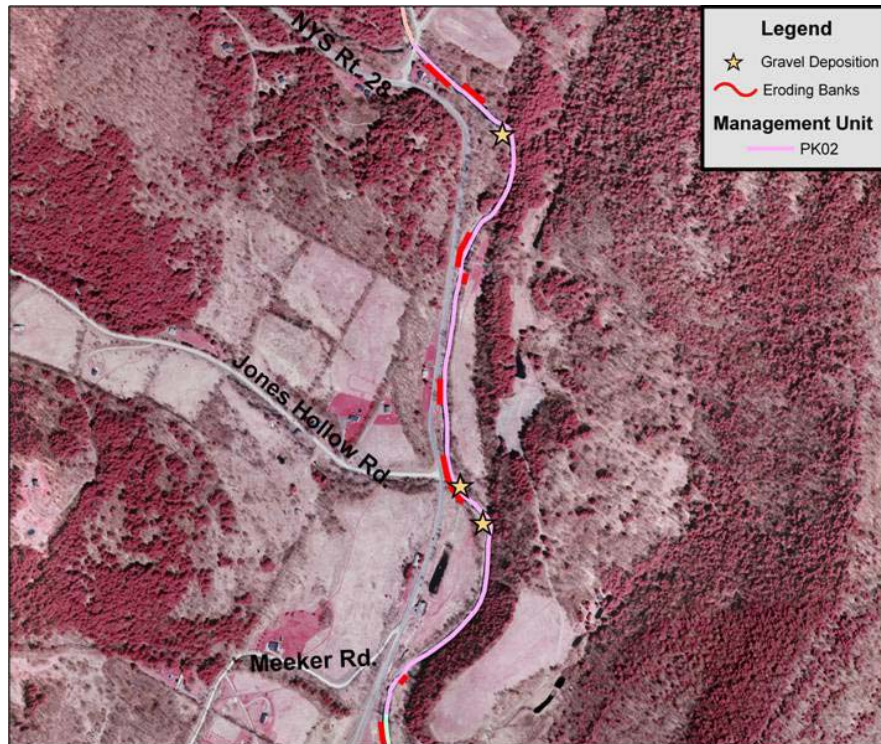
The most noteworthy problem in this sub-basin is located within the PK 02 reach. Bryant's Brook channel downcut into its bed during the June 2006 flood and sent large amounts of sediment into the Platte Kill. No deposition has been observed so apparently the Platte Kill is capable of moving this additional bedload. Debris also blocked the existing channel near James Hollow and diverted flows creating a new 1000 foot long stream channel through an unused pasture. To date, the stream is still located in this new channel.

PK 02 is approximately 4,850 feet long and ends at the confluence of Bryant's Brook, just upstream of Delaware County Bridge #6-1. Bridge #6-1 is the only bridge within this reach. Two tributaries that enter this reach are Bryant's Brook and Jones Hollow. Since June 2006, Bryant's Brook has downcut to bedrock and widened, sending large amounts of sediment into the Platte Kill. There is little gravel deposition in this area so far, indicating that the mainstem is able to transport this sediment. The large amount of woody debris and uprooted trees in Bryant's Brook may pose a threat to the Delaware County Bridge #6-1. If this debris should ever come downstream, it may become lodged under the bridge and cause problems during high flow events. Another problem area is near the confluence of Jones Hollow, where the stream channel has avulsed (changed course) through an abandoned agricultural field for approximately 1,000 feet before returning to the original stream channel.

The dominant surficial geologic material in this reach corridor is glacial outwash, which can have a high potential for erodibility. About 87% of the corridor soils are in hydrologic group B, which have a moderate to high infiltration rate. This reach has a narrow valley that limits the lateral movement of the stream. Valley side slopes average 13% on the right side and 33% on the left.
