East Branch Delaware River

Stream Corridor Management Plan

Volume 2

December 2007

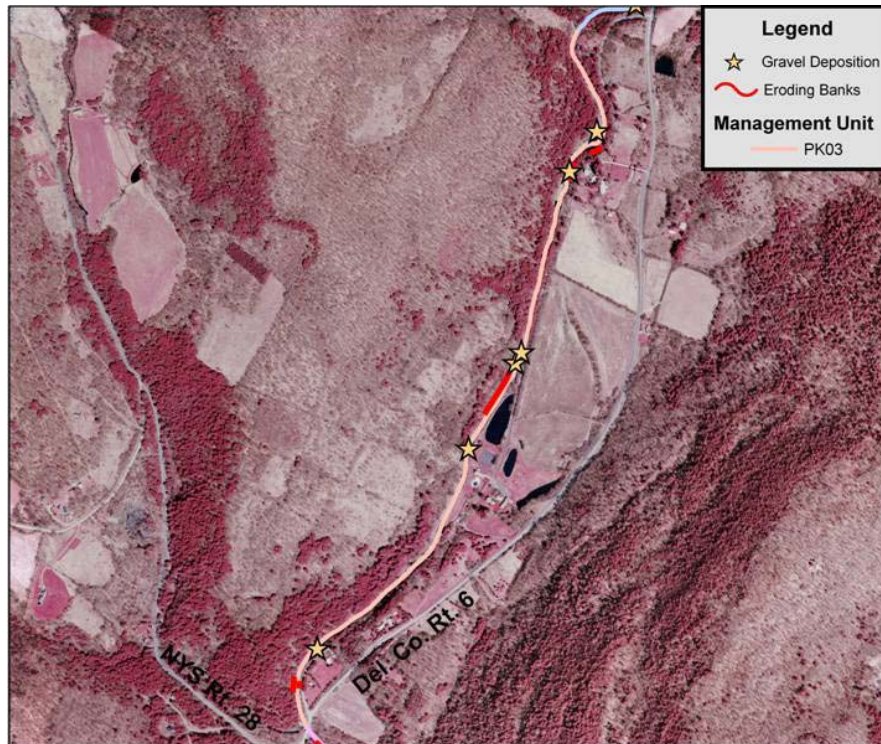
PK 03 is approximately 6,875 feet long and ends at the confluence of the Weaver Hollow tributary. There is one private bridge located in this reach. Weaver Hollow and a small unnamed tributary are the only tributaries that enter the mainstem. The valley is mainly narrow and there are many sections in the upper portion of the reach that contain bedrock on the streambank or in the channel bed (planform and/or grade control). There is also a concrete diversion dam in the middle portion of the reach. This dam appears (from helicopter video) to have trapped sediment behind itself, creating a large center bar upstream. Eroding banks are not a problem in this reach at present, except for a mass bank failure just upstream from Bryant's Brook. This once-wooded steep hillside has slid into the stream, creating a constriction of the channel and pushing water flows into the bank near the edge of Trow Bridge Road. Glacial outwash is the dominant surficial geologic material and has a high potential of erodibility. Hydrologic soil groups are more widespread in this reach, including B soils with medium/high infiltration rates, A soils with high infiltration rates, and C soils with medium/slow infiltration rates. Valley side slopes average about 22% for this reach.

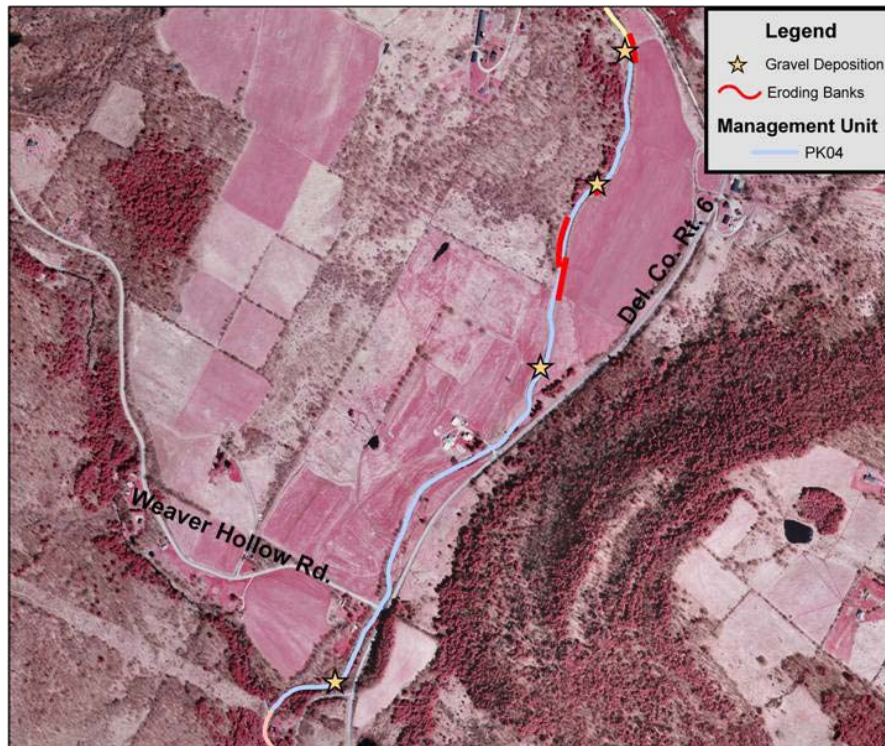
PK 04

This reach is approximately 6,236 feet long and the valley is very broad with agriculture as its dominant land use. Two bridges located in this reach include one private bridge and Town Bridge #16 on Weaver Hollow Road. Two small unnamed tributaries enter the mainstem in this reach. Eroding streambanks can be seen in the upper 1/3 portion of this reach. The middle 1/3 has extensive revetments along the streambanks to protect them from erosion. Most of this reach has no riparian vegetation buffer along the banks, creating a higher potential for streambank erosion. The dominant surficial geologic material is glacial till with a moderate potential for erodibility. About 70% of the soils are hydrologic group B, which has a medium/high infiltration rate. Valley side slopes on both sides average about 21%.

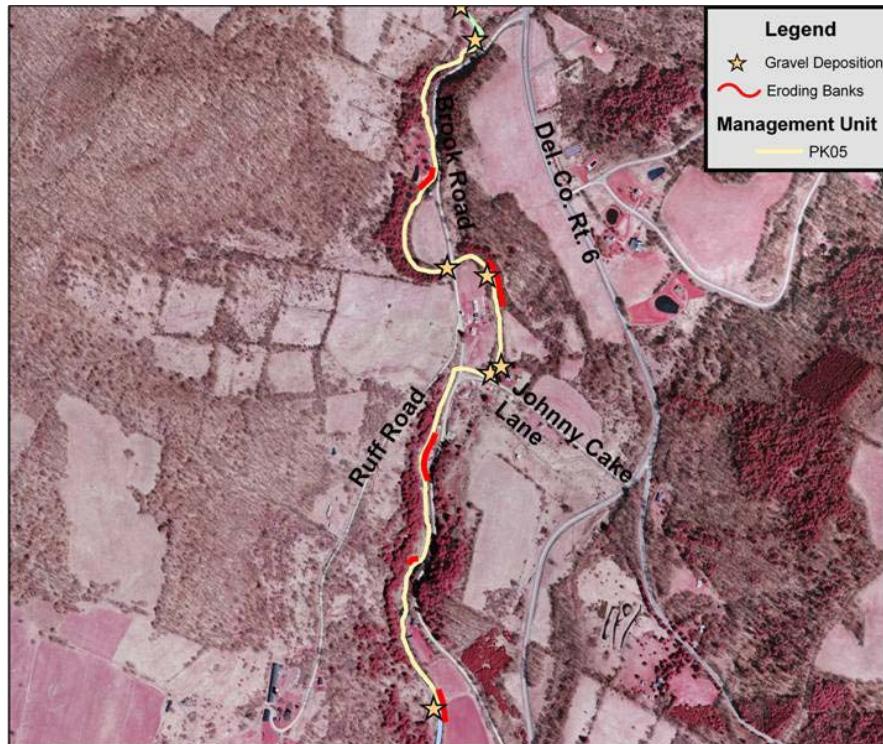
PK 05

This reach is approximately 5,905 feet long and ends upstream of the former bridge on Crawford Road. This point is also about 2,000 feet downstream from Town Bridge #170. There are three bridges in this reach: Bridge #86, #87, and a private bridge. This section of stream is in a narrow, twisting valley. Information taken from the helicopter flyover video shows that there is one area of exposed bedrock that is acting like a grade control. There may be more bedrock located along the streambanks than can be identified from the video. Because of the narrowness of the valley, the Platte Kill and Brook Road run close together most of the time. There appears to be minimal revetment placed along the streambanks in this reach suggesting that the stream may be relatively stable. Surficial geologic materials are made up entirely of glacial till and have a moderate potential for erodibility. About 72% of the soils are in hydrologic group B with a medium/high infiltration rate. Valley side slopes average 18% on both sides.

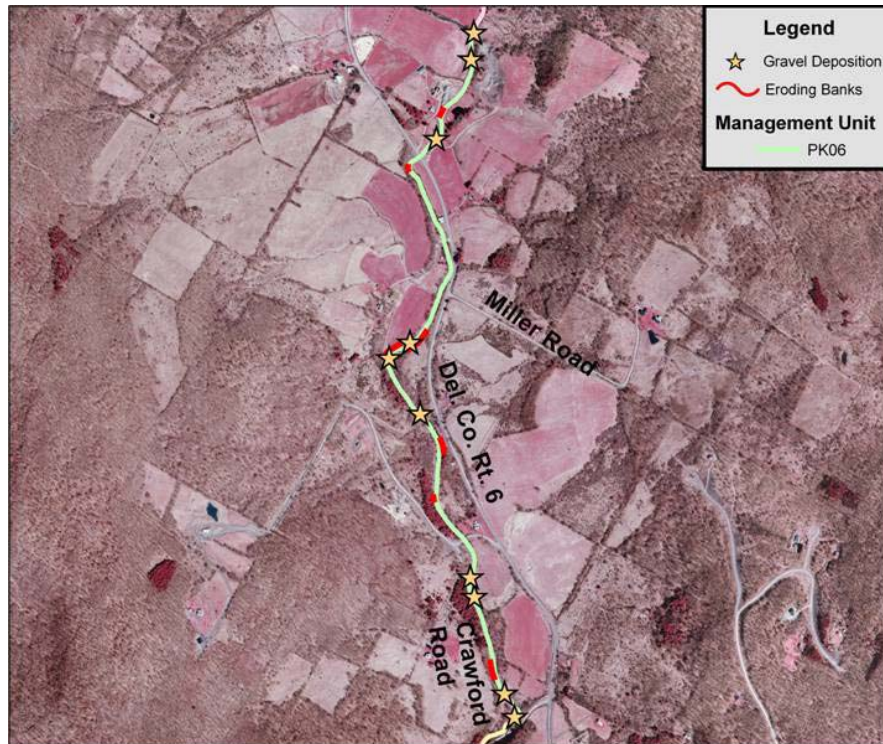
PK 06

This reach is approximately 7,390 feet long and ends at the junction of Winter Hollow and Thompson Hollow. There are at least five small unnamed tributaries that enter this reach. The stream flows under three bridges: Delaware County Bridge #6-2, Town Bridges #170 and #146, and one private footbridge. The valley is fairly broad in most locations. Valley side slopes average 21% on the right side and 18% on the left side. Almost 50% of the left bank has little or no riparian vegetation buffers due to agricultural uses. In some locations, the narrow buffer stems from Delaware County Route 6 being very close to the stream. Only 7% of the reach has observed revetments and 15% of the length contains eroded streambanks. There is an increase in the number of depositional bars located in this reach. Most of these deposition bars are vegetated, suggesting that they are stable and have been in existence for a long time. Surficial geologic material in the corridor is entirely glacial till that has a moderate potential for erodibility. About 73% of the soils are hydrologic group B with a medium/high infiltration rate.

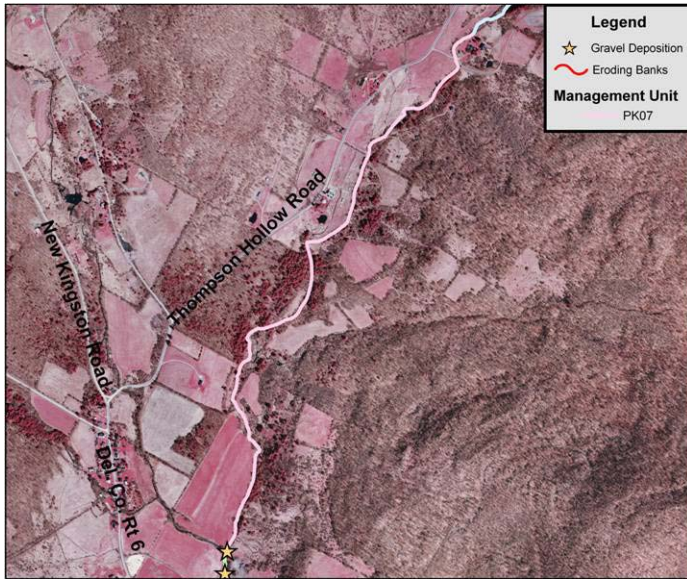
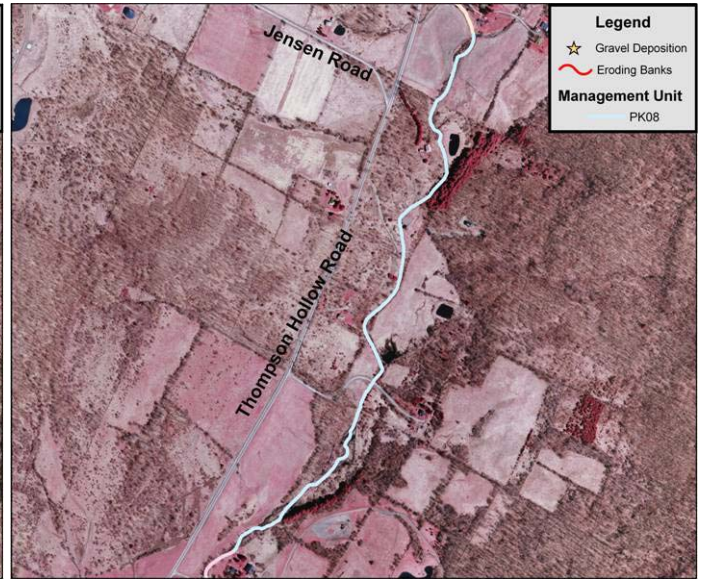
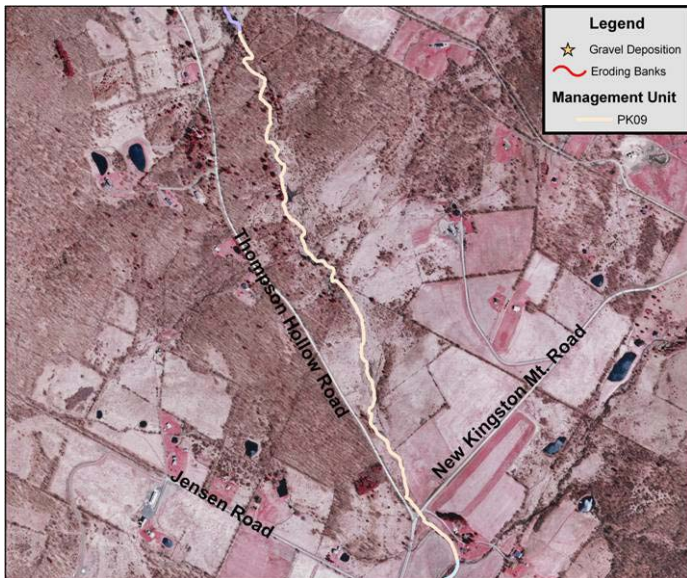
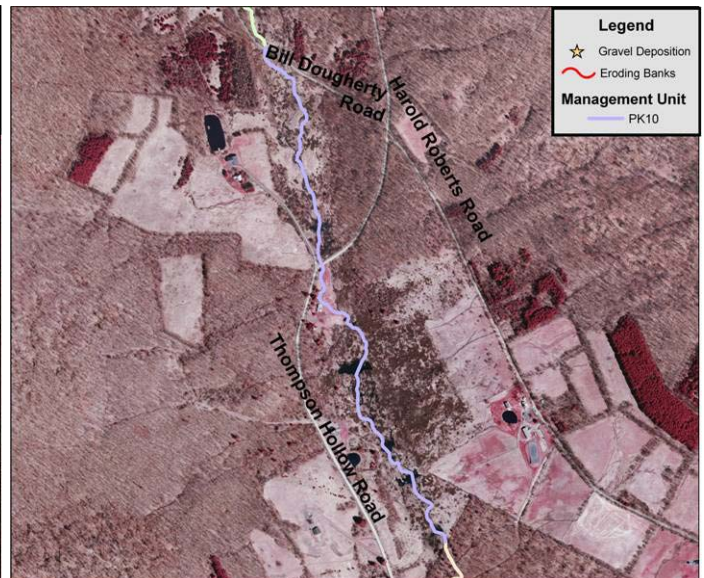
PK 07, 08, 09, 10

generally greater than 100 feet, except in PK 07 where 72% of that reach contains buffers less than 25 feet wide. Reach PK 08 has 48% of the left bank with less than 25 feet of buffer. Approximately 25% of PK 10 contains wetlands in the corridor. Many beaver ponds and swamps can be seen that create good storage areas for stormwater run-off and excess nutrients. The surficial geologic material in this unit is entirely glacial till that has a moderate potential of erodibility. These reaches have hydrologic group B soils with a medium/high infiltration rate. Valley side slopes average between 14% - 24%.

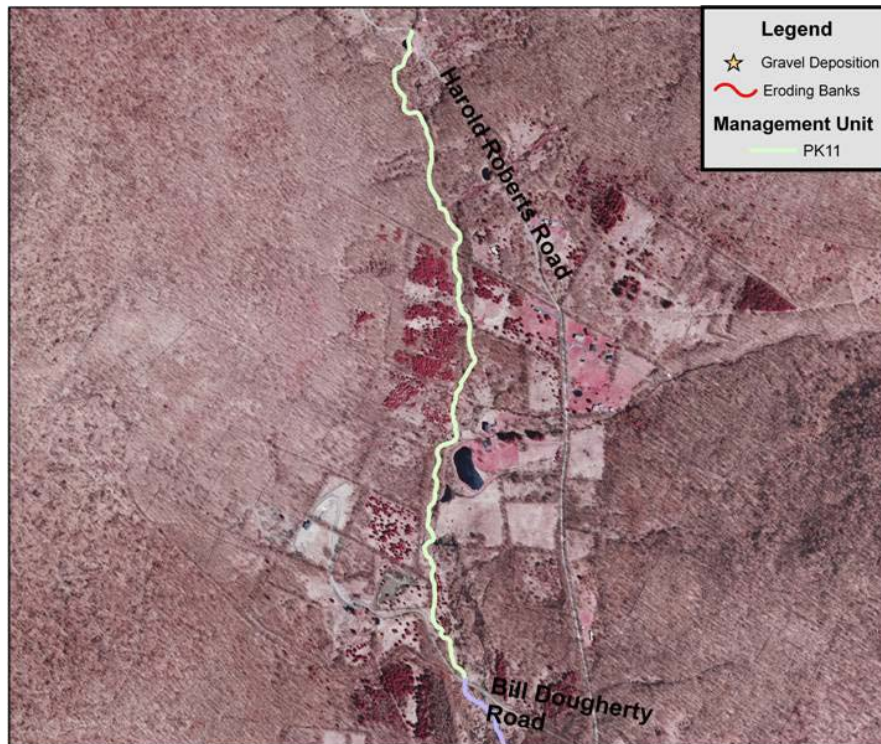
PK 11

This reach is located between Bill Dougherty Road and Harold Roberts Road and is approximately 5,130 feet long. This is a typical headwater section, somewhat confined within narrow valley side slopes and with a steep channel slope. Land cover in this corridor is 95% covered with forest and brush. Approximately 95% of the riparian vegetation buffer is greater than 100 feet wide on both sides of the streambanks. The surficial geologic material is mainly glacial till that has a moderate potential of erodibility. Hydrologic group C soils have a medium to slow infiltration rate, which is expected in the headwaters of a stream. On both sides of the valley, side slopes average about 25%.

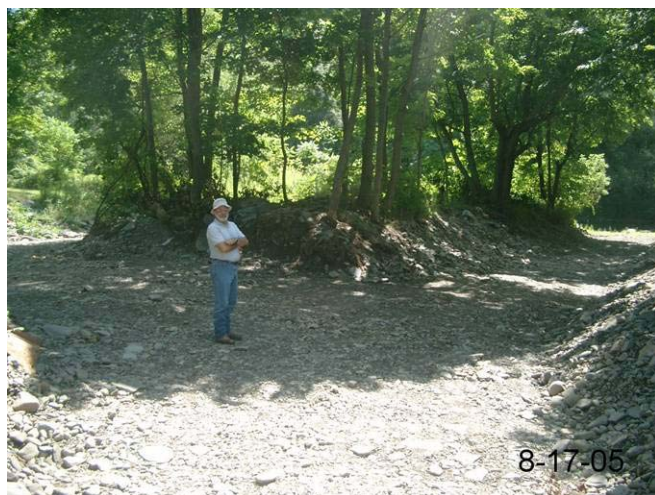
Figure 1.15 Binnekill and Bull Run Tributaries

The East Branch mainstem and tributaries have been maintained since the stream was confined within its banks in populated areas. **Figure 1.15** shows the Binnekill and Bull Run tributaries after gravel had been removed near the confluence with the East Branch mainstem. Gravel will continue to deposit in this location since the tributaries transport excess sediment and the slope is quite level.

In EBMS 02, a portion of the East Branch mainstem is diverted into maintained channel known as the Binnekill. This diverted water flows through the Village of Margaretville and is used by the community for fire control. Bull Run, a tributary from the north side of the village, and the Binnekill enter the East Branch Mainstem at the same location. Gravel deposits can be a problem at this location and are regularly removed to maintain flows.

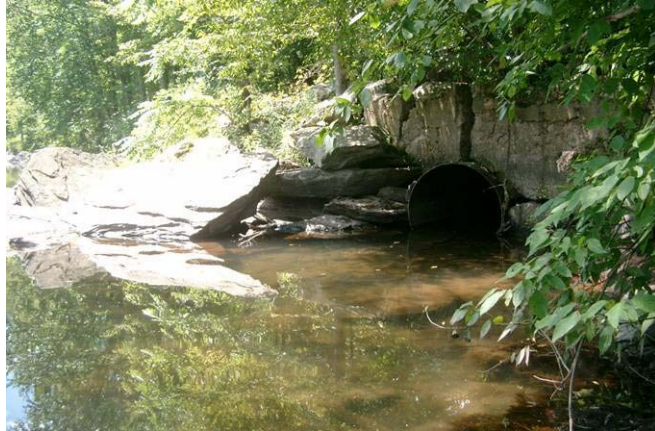
Figure 1.16 Binnekill Headwall

Figure 1.16 shows the headwall where the mainstem enters and becomes the Binnekill.

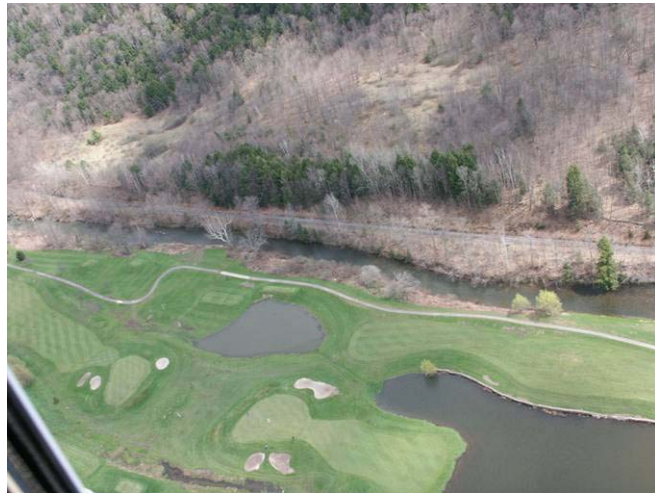
Figure 1.17 Golf Course

The upper portion of the sub-basin's floodplain is less developed with the exception of the Hannah Golf Course. While the course does not necessarily restrict the floodplain, the products used to manage the turf can impact water quality with the addition of excess nutrients, pesticides and herbicides. Stormwater runoff may pick up the excess nutrients and deliver it to the streams without a sufficient buffer to absorb the nutrients. This can result in algae growth and other related problems. Riparian vegetation buffers along the golf course may reduce the nutrient load. **Figure 1.17** is a helicopter photo of the golf course that depicts little to no riparian buffer. This area would be an excellent place for the development of a riparian buffer program to establish trees along the streambanks.

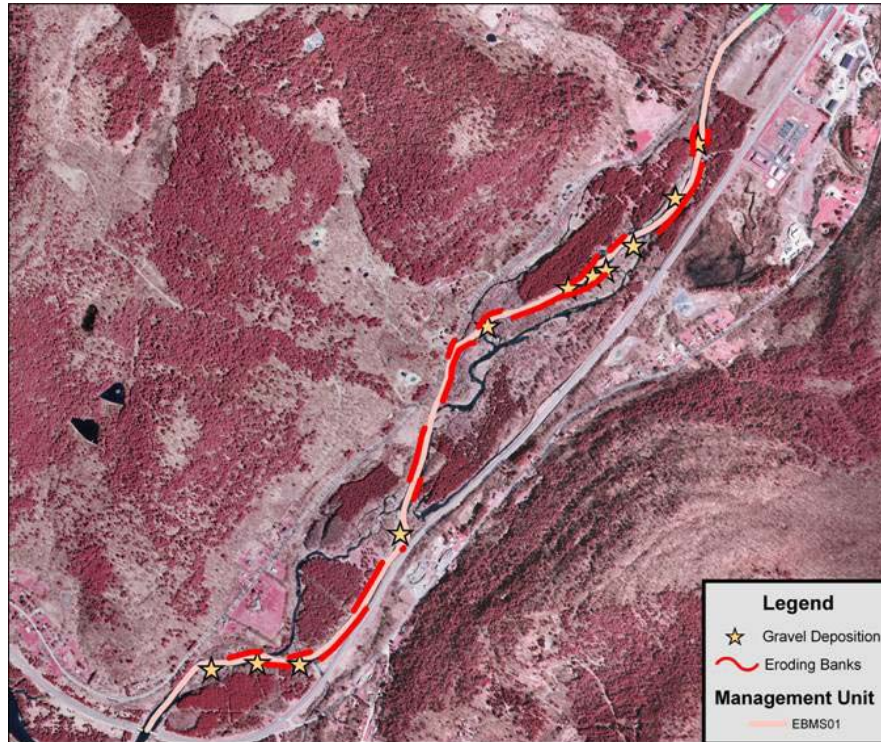
EBMS 01

This reach begins near the high water mark of the Pepacton Reservoir (at the NYS Route 28/30 bridge) and runs upstream for about 11,440 feet. In many parts of this reach, the stream contains multiple channels as it runs through a broad valley. Huckleberry Brook and at least two other unnamed tributaries enter into this reach. Land within the stream corridor is 70% forested and wetlands. About 20% of the land is considered built-up, which includes the paved roads of NYS Route 28/30 and Delaware County Route 3. About 59% of the reach has an eroding streambank along the main channel and 31% of these eroding banks have little to no riparian buffer. Approximately 34% of the reach length contains a narrow buffer of 0-25 feet wide. Most of these narrow buffers occur when a road closely parallels the river. At least 26% of the main channel experiences gravel deposition, mostly consisting of large side bars. Revetments affect only 6% of the reach length while protecting the streambanks near the road and bridges. This section of river has plenty of available floodplain and there are no residential areas in the floodplain area. There is a short section of confined stream near the confluence with Huckleberry Brook. The river's floodplain is restricted by NYS Route 28/30 at the bridge in the downstream end of the reach. The state road cuts across the floodplain and funnels all flow under the bridge during high flow events.

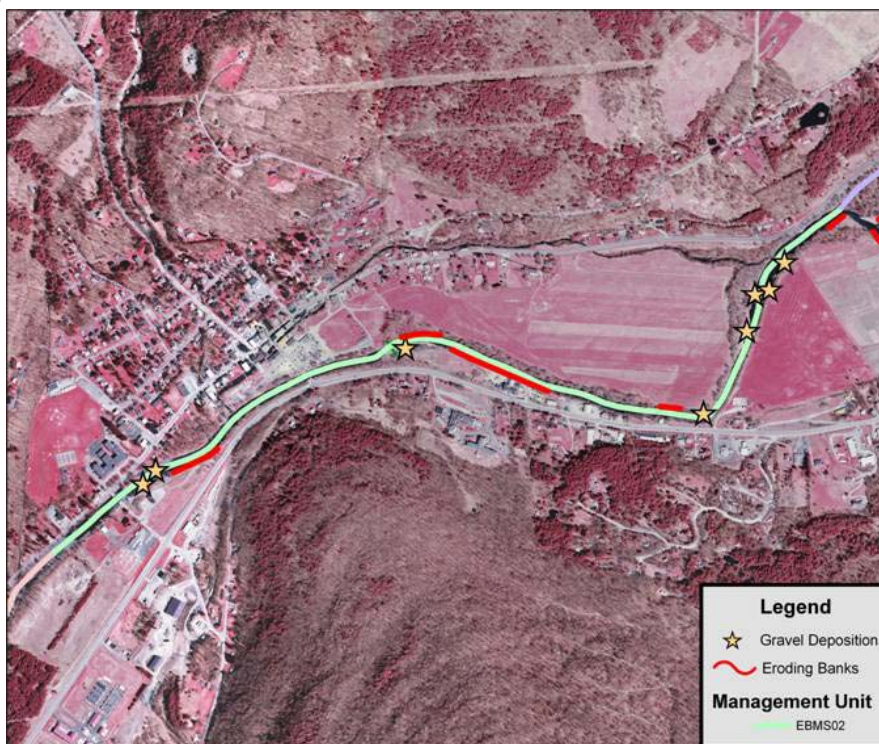
EBMS 02

This reach is about 8,746 feet long and ends at the Dry Brook confluence. This reach has been straightened in the past and it flows through a very broad valley. Bull Run is the only tributary in this reach that contributes water and sediment. The Village of Margaretville is built on the ancient alluvial fan for the Bull Run Hollow. The broad valley is naturally constricted at the outlet of Bull Run by the alluvium from the tributary on the right bank and the steep hillside on the left bank. Two bridges, located on Fair Street and Bridge Street, cross over the river in this reach and essentially define the extent of the valley/floodplain constriction. USGS Stream Gage 01413500 (East Branch Delaware River at Margaretville NY) is located on the right bank downstream of the bridge on Fair Street. The drainage area at the stream gage is 163 square miles. The period of records that is available for this gage is from February 1937 to the current year. The stream corridor, which runs through a portion of the Village of Margaretville, is about 37% built-up/residential and about 33% fields/open area. Narrow riparian buffer widths of 0-25 feet wide are common along the streambanks. About 99% of the length has a narrow vegetation buffer on one streambank or the other bank. Revetments on the streambank cover 30% of the reach length. At the beginning of the reach, the stream flows along the right valley wall before cutting diagonally across to the left valley wall. The slope of the river becomes more level at the point where it moves across the valley. This short section exhibits half the deposition (10%) of the entire stream reach (20%). Upstream of the Village of Margaretville, the East Branch Delaware River branches off into the Binnekil through the bulkhead. Historically, the Binnekil was used to feed water to a mill, but is now used as a tourist attraction for the Village of Margaretville. A FEMA grant has been obtained to improve the bulkhead. As previously described, a DCSWCD/DEP demonstration stream restoration project was constructed during the

summer of 2007 within this reach upstream of the Bridge Street bridge near the village fair grounds.

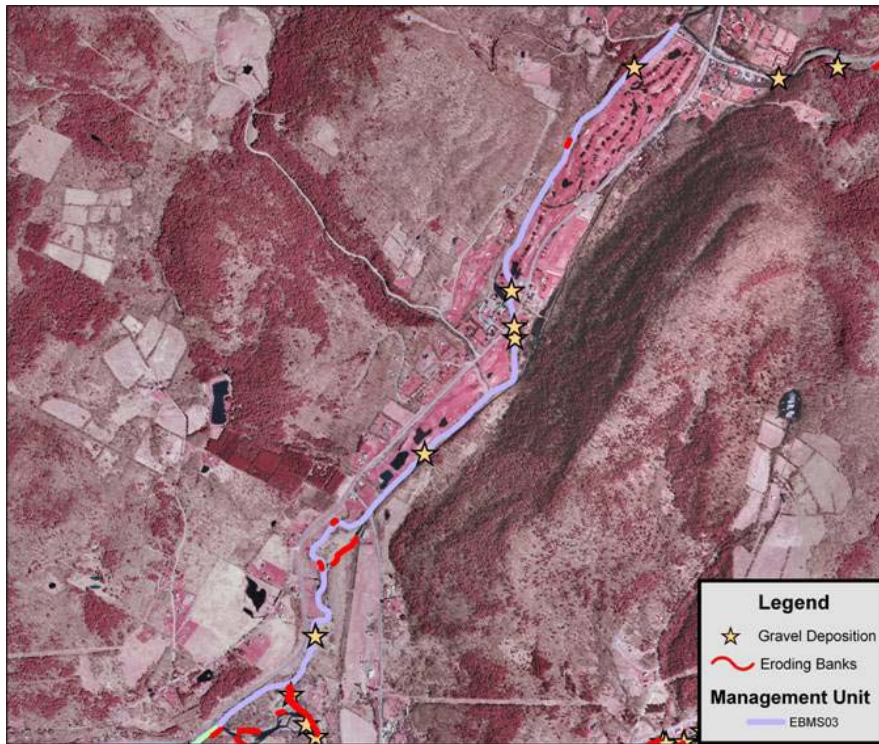
EBMS 03

This reach is approximately 15,514 feet long and ends at the confluence with the Batavia Kill and the East Branch Delaware River headwaters. The valley is very broad and most of the stream is straightened as it flows against the valley wall. A 2,000-foot-long section downstream from Delaware County Bridge #38-1 appears to have been less manipulated as it flows in the center part of the valley and is much more sinuous. The reach has excellent streamside vegetation, which helps maintain the stability of this reach. There are seven tributaries that enter into this reach, including Hubbell Hill Hollow and the Batavia Kill. The four bridges in this reach are Delaware County Bridge #38-1, the NYS Route 30 bridge, the East Hubbell Hill Road bridge, and a golf cart path bridge. The stream corridor is forested on the valley walls while the floodplain is covered with brush, abandoned fields, and a golf course. Eroding streambanks and revetment lengths each total 5% of the total reach length. Depositional features are also low at 4% of the reach length. A narrow riparian vegetation buffer of 0-25 feet wide can be seen on one streambank or the other for about 72% of this reach, mostly due to the golf course and abandoned fields located in the downstream portion. At this time, the narrow buffers are not affecting streambank stability but may not be wide enough to help water quality issues.
