West Branch of the Delaware River Stream Corridor Management Plan

May 2006

Prepared by:
Delaware County Soil and Water Conservation District

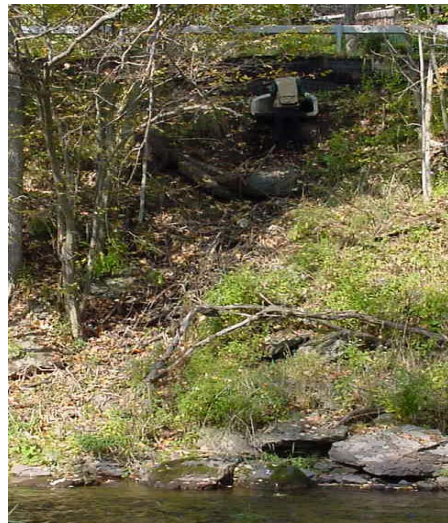
Figure 2.2 Poorly designed culvert outfall along NYS Route 10 upstream of Bloomville. Note direct discharge into river with lack of energy dissipation and sediment control measures. This site could benefit from a stormwater retrofit.

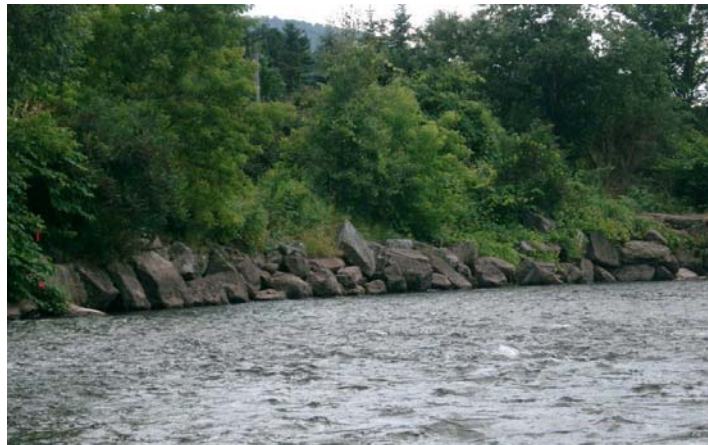
Figure 4.2 Example of streambank riprap above County Route 2 bridge in Delancey

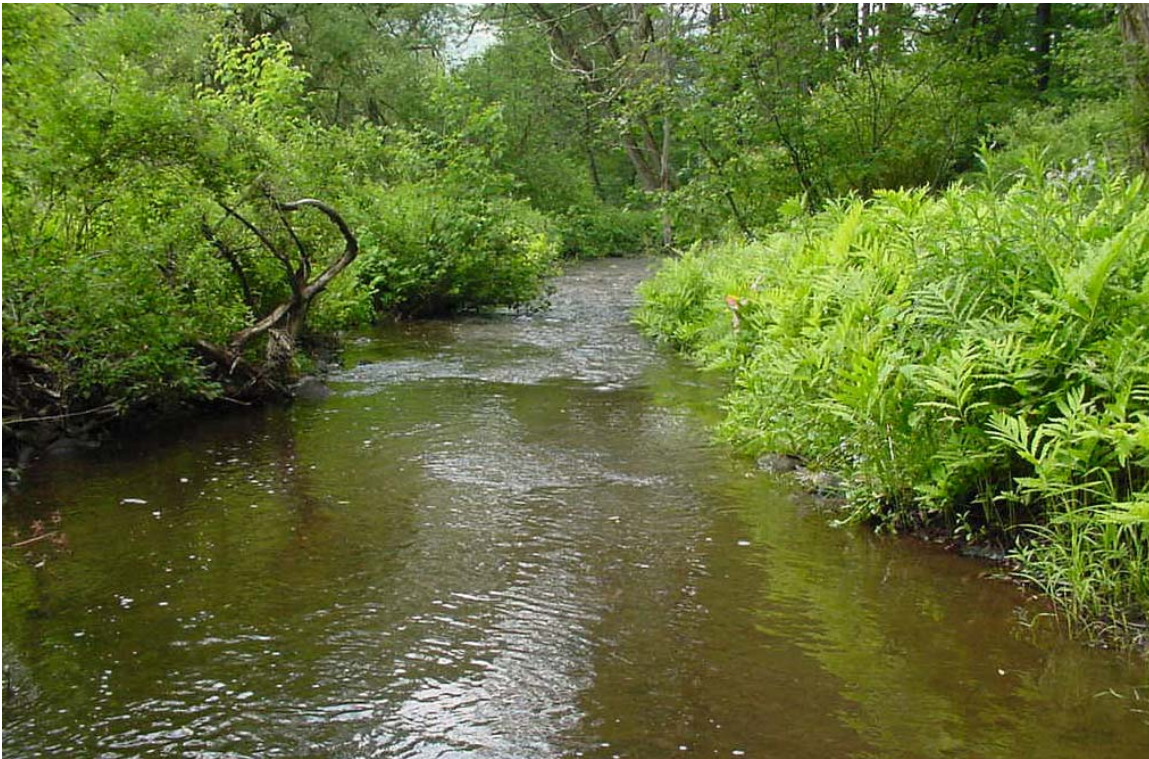
Figure 6.7 Natural riparian forest buffer near the Village of Stamford. Note abundance of vegetation and lack of erosion. Stream also has noticeable natural riffle-pool sequence.

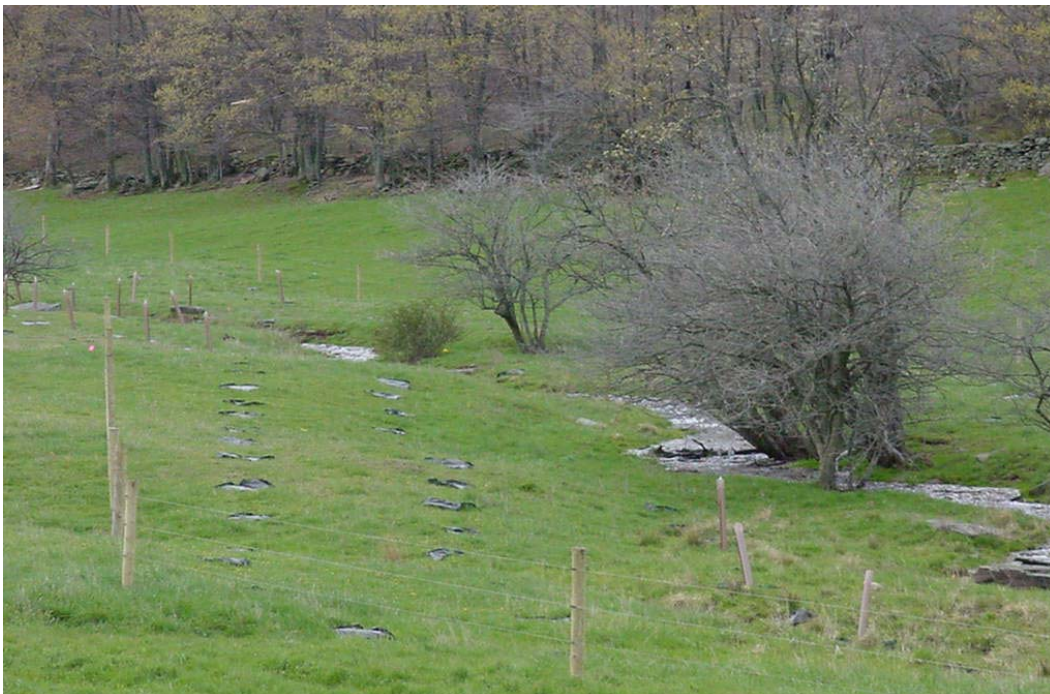
Figure 6.8 CREP buffer with fencing. Note brush mats and tree tubes (lower right) to protect seedlings and facilitate growth.

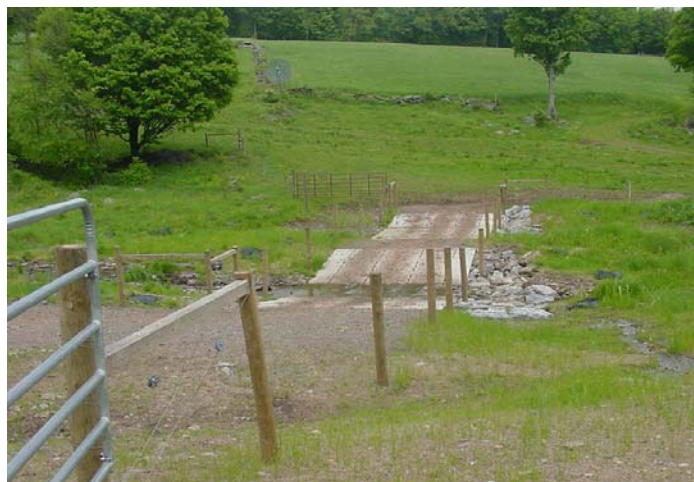
Figure 6.10 Fenced livestock crossing with animal walkway.

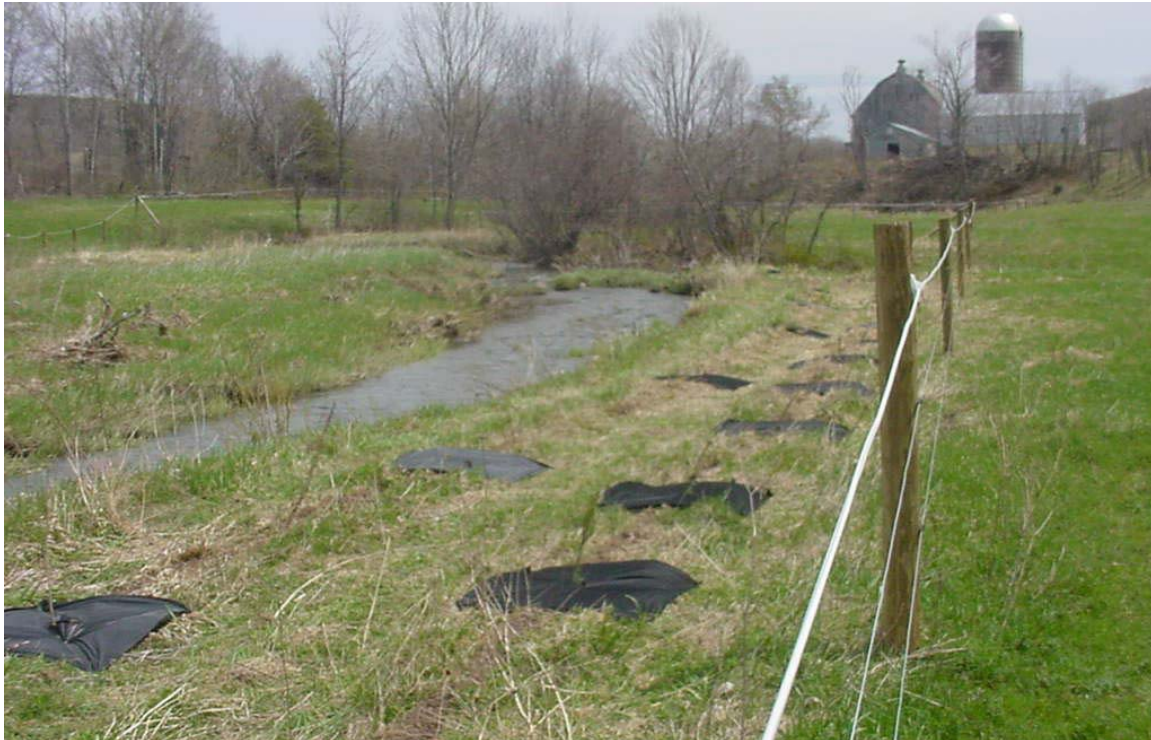
Figure 6.11 Newly implemented riparian forest buffer system, with exclusionary fencing, and newly planted trees in brush mats.

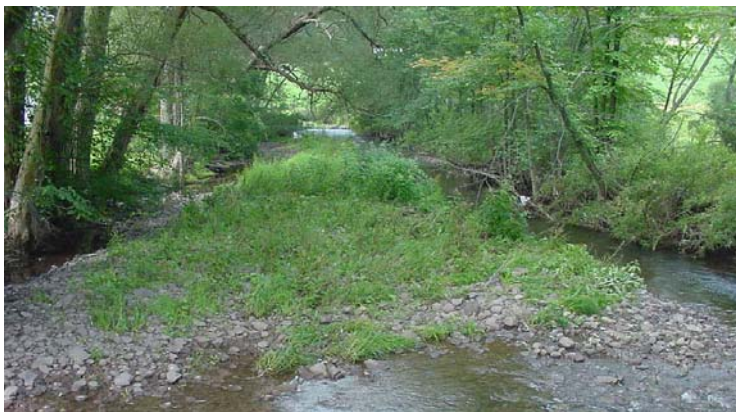
Figure 6.12 Wide and shallow flow around a gravel bar downstream of county bridge 33-1 on County Route 33, just north of Bloomville

Stream flow through many bridges during periods of low flow exhibit the characteristics of a stream that is too wide and too shallow, resulting in lack of adequate energy to effectively transport its sediment (see **Section 5.9.2** for description of width/depth relationship and sediment transport). This can result in deposition downstream of or inside the structure, which in turn

creates further flow issues (**Figure 6.12** above). Other bridges exhibit deposition upstream of the structure which is indicative of a backwater effect. Woody debris accumulations are another common concern at bridge crossings.

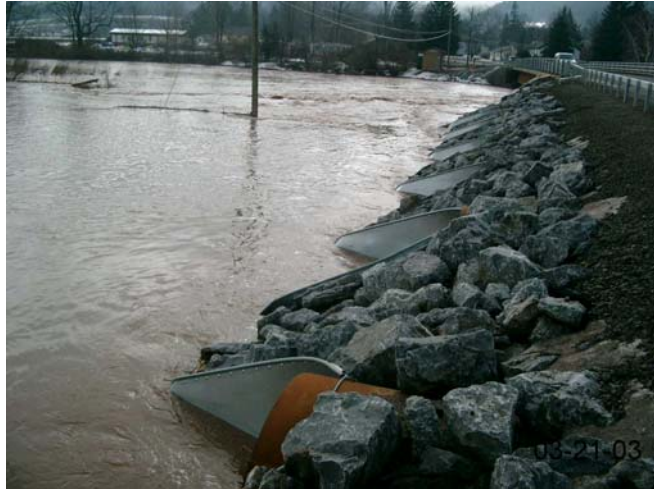
At some bridge crossings the highway approaches are elevated above the floodplain elevation. This creates an obstruction to floodplain flow, forces overbank flows under the bridge, and can create flood debris accumulation under the bridge. One solution that is being evaluated is the placement of culverts under the approaches to allow for some continuity of flood flow across the floodplain. This method has been applied where County Route 2 crosses the West Branch in Delancey (County Bridge 2-1, **Figure 6.13**). Although this application has met with some success, the practice is still being evaluated to determine its effectiveness.

Figure 6.13 Floodplain relief culverts installed at County Bridge 2-1 in Delancey. Photo taken looking upstream, March 21, 2003

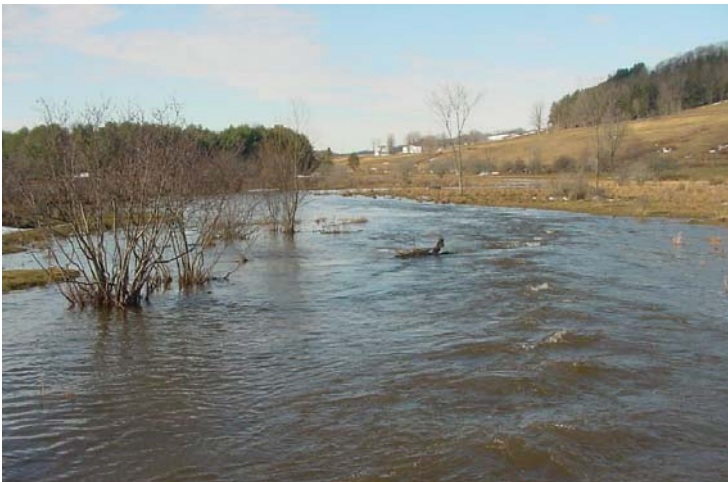
“The floodplain is defined as the flat area bordering a stream, constructed by the river in the present climate and inundated during periods of high flow.” (Leopold, 1997). The floodplain has key roles in stream function, perhaps the most important being energy dissipation during overbank flows. The normal elevation for the floodplain is the bankfull elevation. Water flows that are higher than bankfull will flow across the floodplain with a much lower velocity than in the main channel in a properly functioning riverine system (**Figure 6.14**).

Figure 6.14 Photo of overbank flow taken just downstream of the Village of Stamford, March 21, 2003.

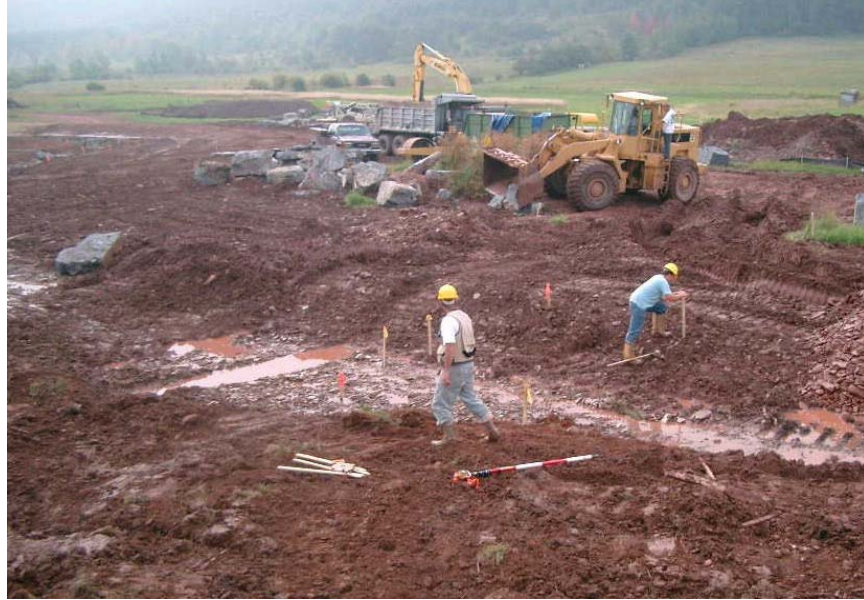
Figure 6.16 Photo taken during construction showing newly excavated channel and layout for a vane structure.

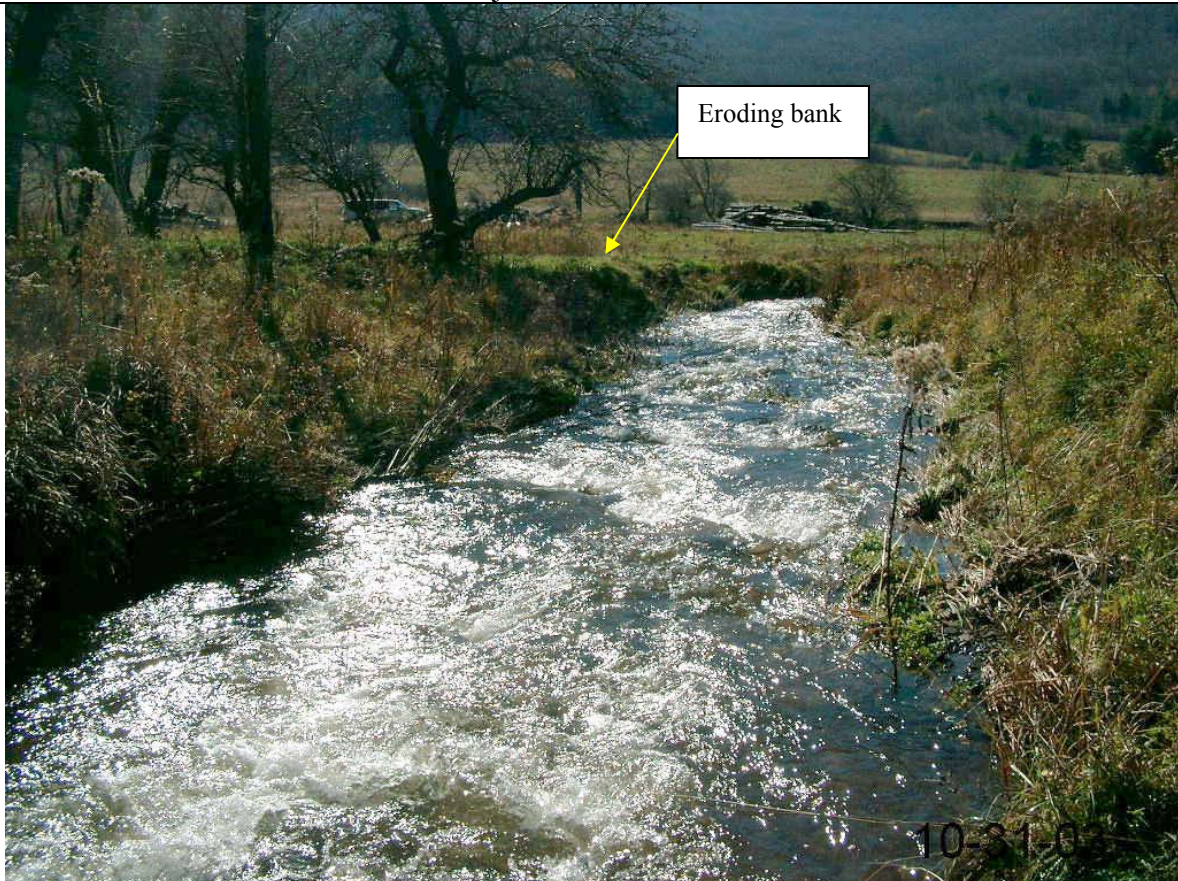
- Incision: The stream was incised; banks were vertical, and the stream could not properly access its floodplain (photos 6.17, 6.23 & 6.24).
- Over width: The stream was too wide for its proper stream type (photo 6.29).
- There were very few pools, and they tended to be quite shallow.
- Four headcuts were observed in the project reach, also indicating stream incision (photo 6.29).
- Severe bank erosion: This was due to incision and the absence of a sound riparian buffer on the overbanks.

Photo 6.17: Just below culvert, 10-31-03. Stream entrenched with no floodplain.

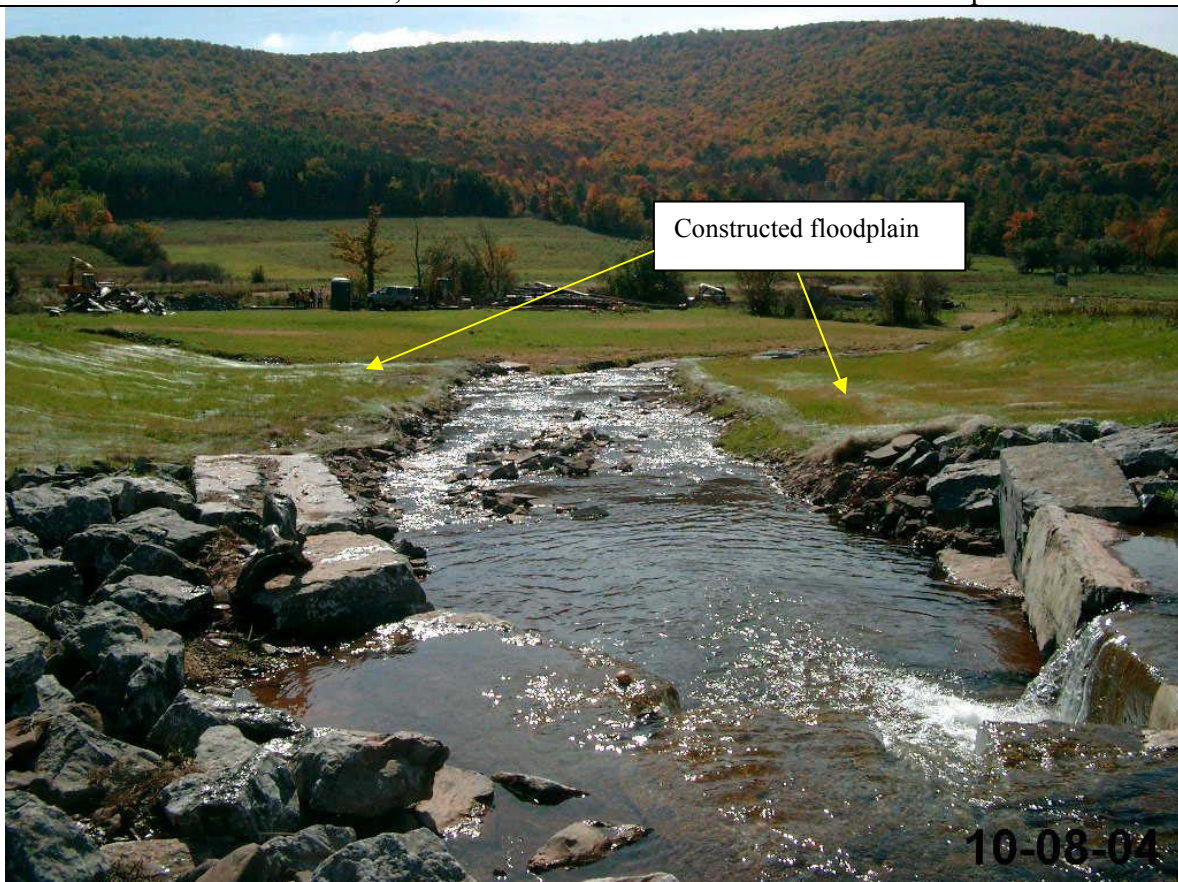
Photo 6.18: Just below the culvert with a newly constructed floodplain, 10-08-04.

- A “rock lined riffle” at the culvert outlet, which was lined with medium stone fill to prevent erosion from the high *velocity* water leaving the culvert outlet during large storms (photo 6.18).
- Excelsior matting on the floodplain banks near the culvert outlet.
- Excelsior matting on the top of the channel bank as a temporary erosion control measure until vegetation became established (upper left corner of photo 6.22).
- Live willow stakes at the top of the vane arms. When grown the willows will reinforce the bank at the top of vane arms and help prevent the bank being eroded during major floods.

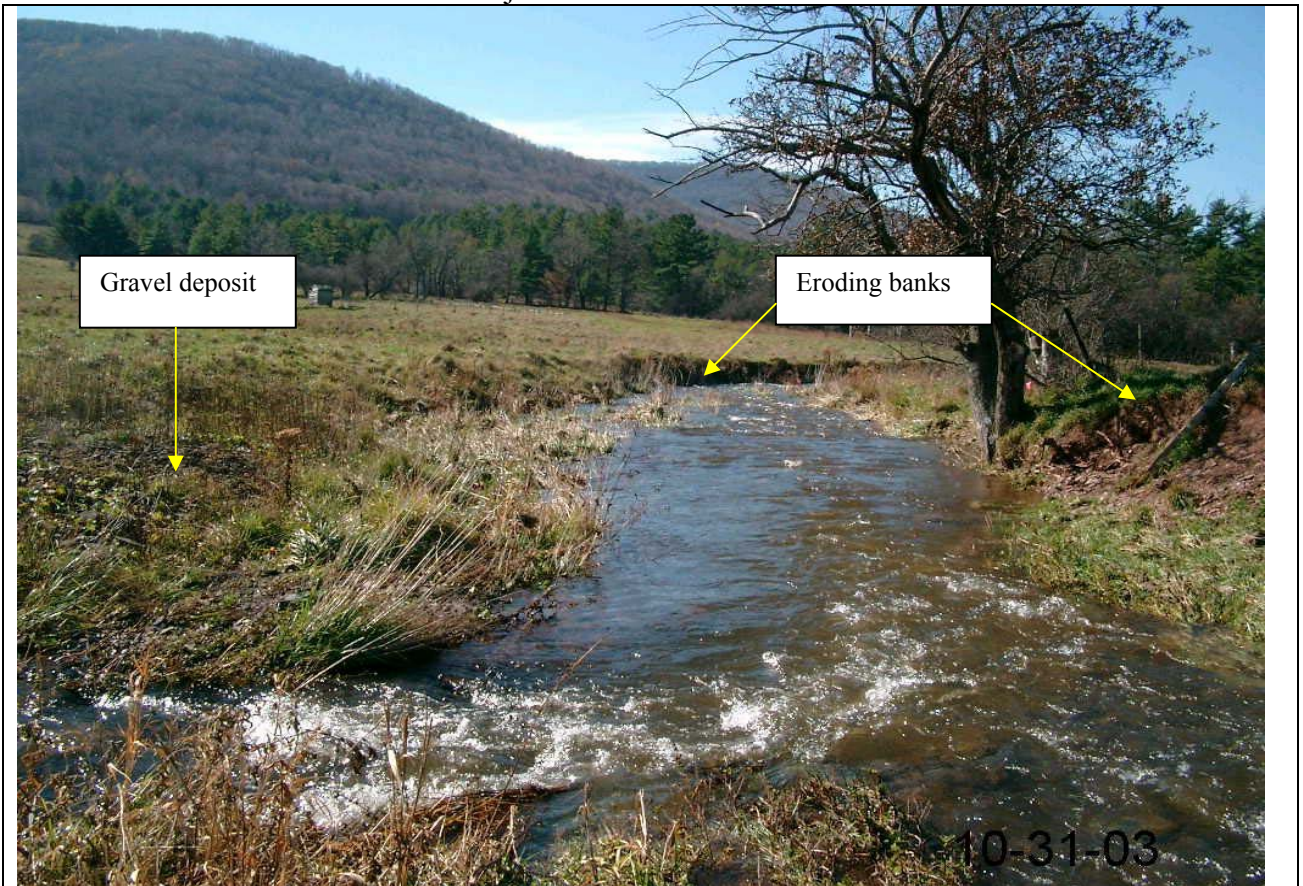
Photo 6.19: At tributary confluence (trib. on left). Lack of adequate floodplain. 10-31-03

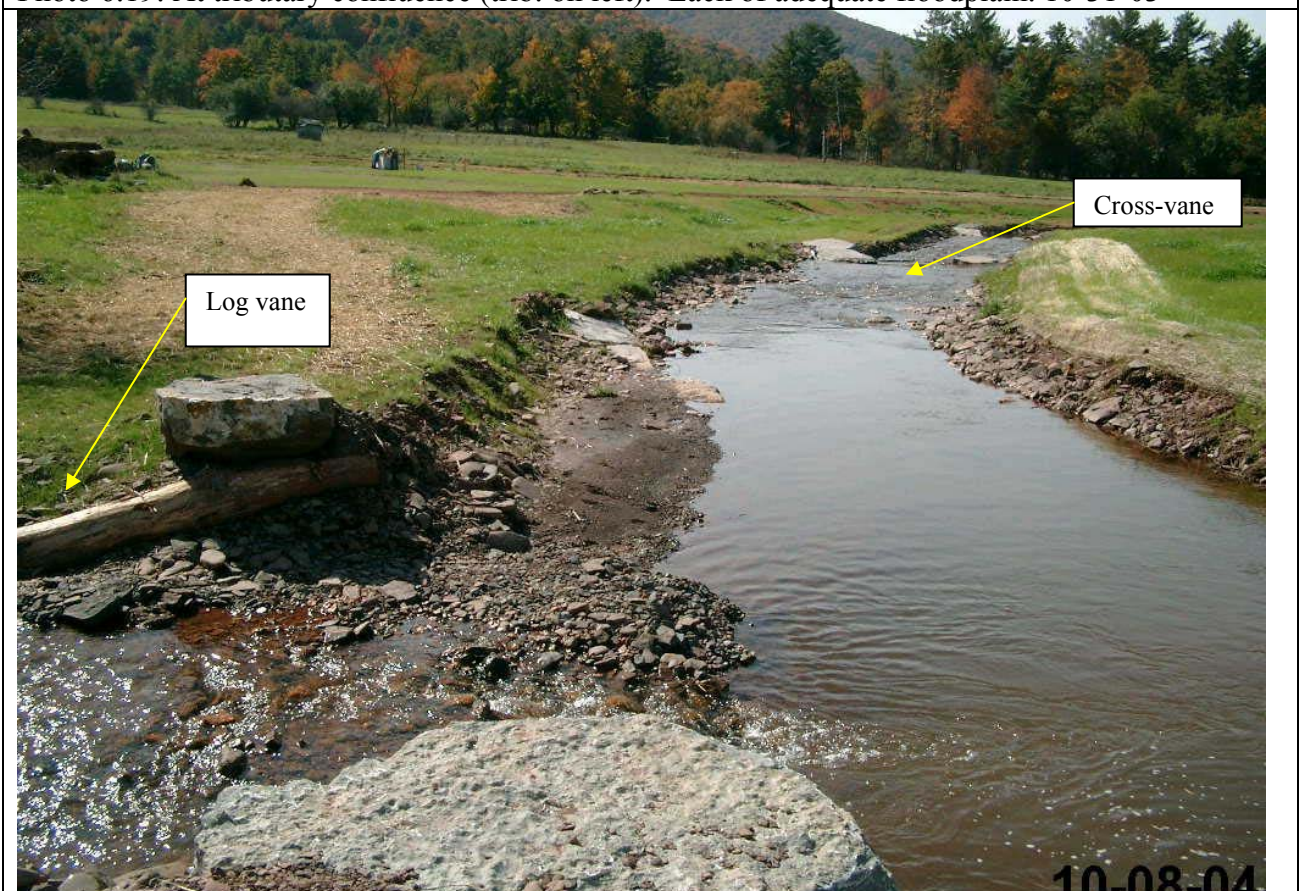
Photo 6.20: Tributary on the left with log vane enters town brook at cross-vane.

There is a single log cross vane structure on the project (photos 6.20, 6.34). It is located at the outlet of a small brook (tributary), just a few feet from the bank of Town Brook. This log cross vane was intended to concentrate flow from the small brook and prevent a delta from being formed where it enters Town Brook.

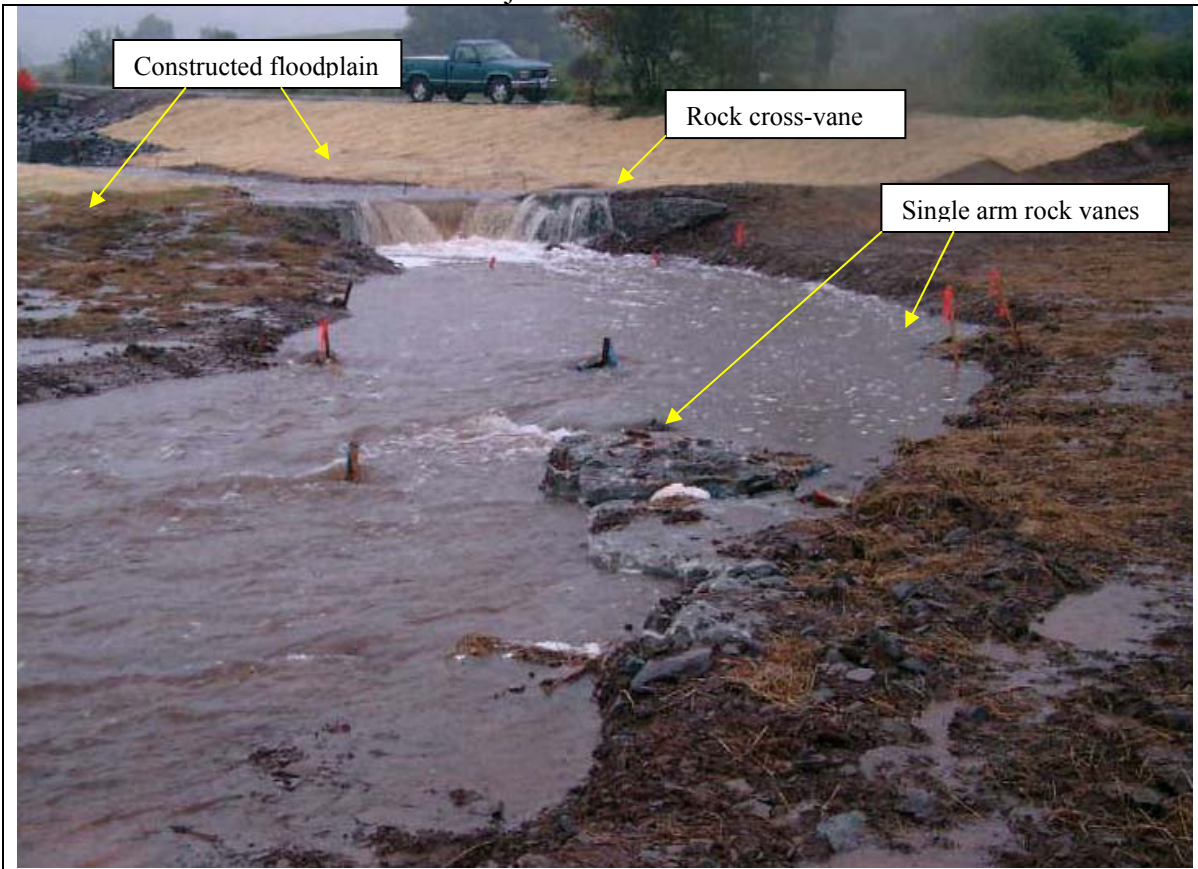
Photo 6.21: Looking U.S. at near bankfull flow across three structures, 8-13-04.

The most obvious feature of the new stream is the rock vane structures (photos 6.21, 6.22, 6.25, 6.26, 6.28, 6.30, 6.33). These serve 4 purposes:

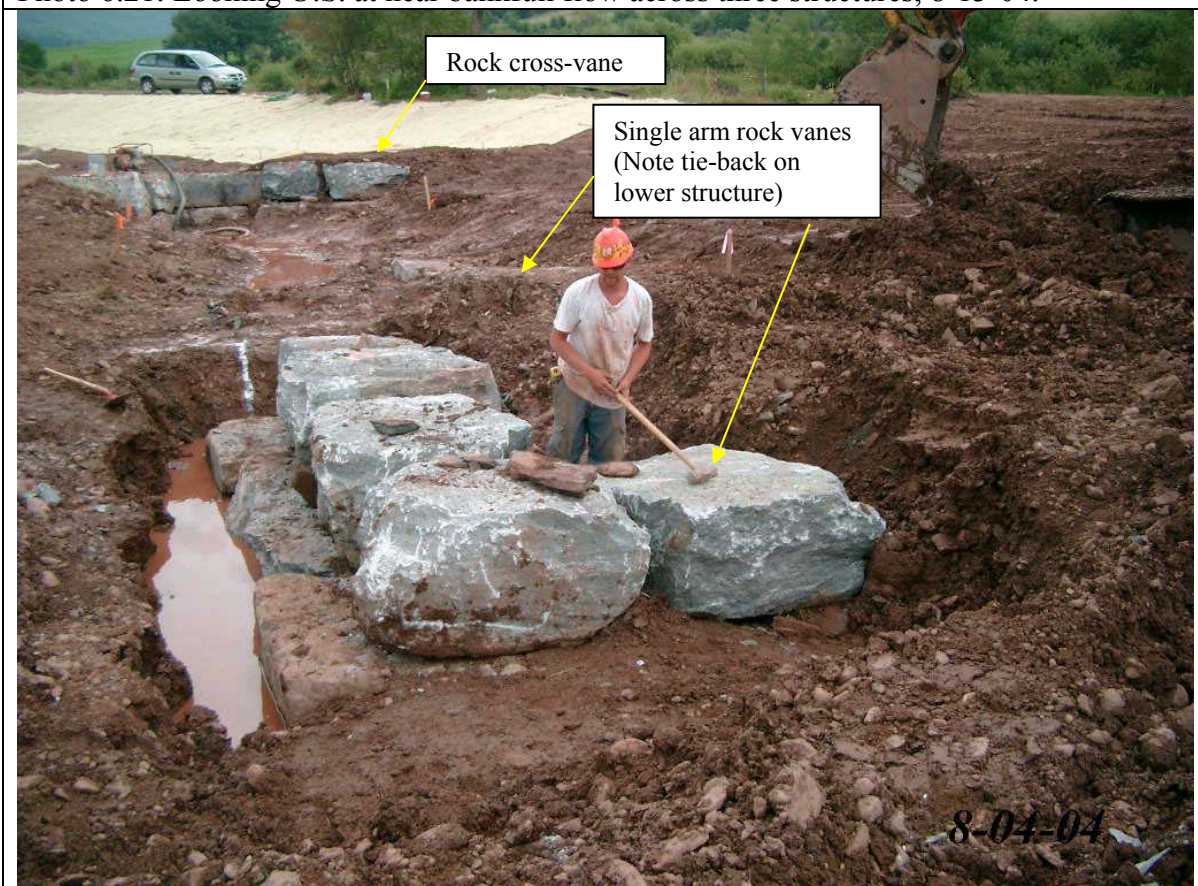
Photo 6.22: Looking U.S. the same three structures in photo 7 during construction, 8-04-04.

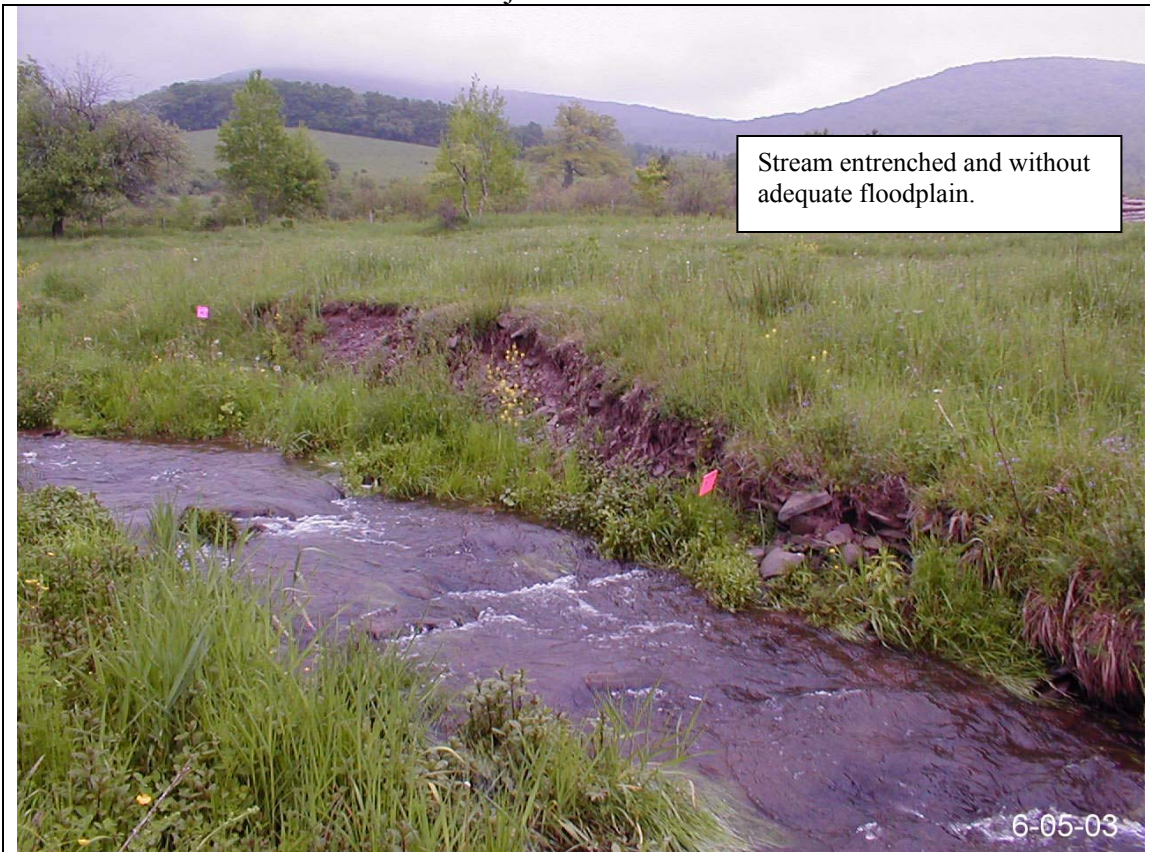
Photo 6.23: Approximate area of lower rock vane structure in photos 5 & 6, 6-05-03

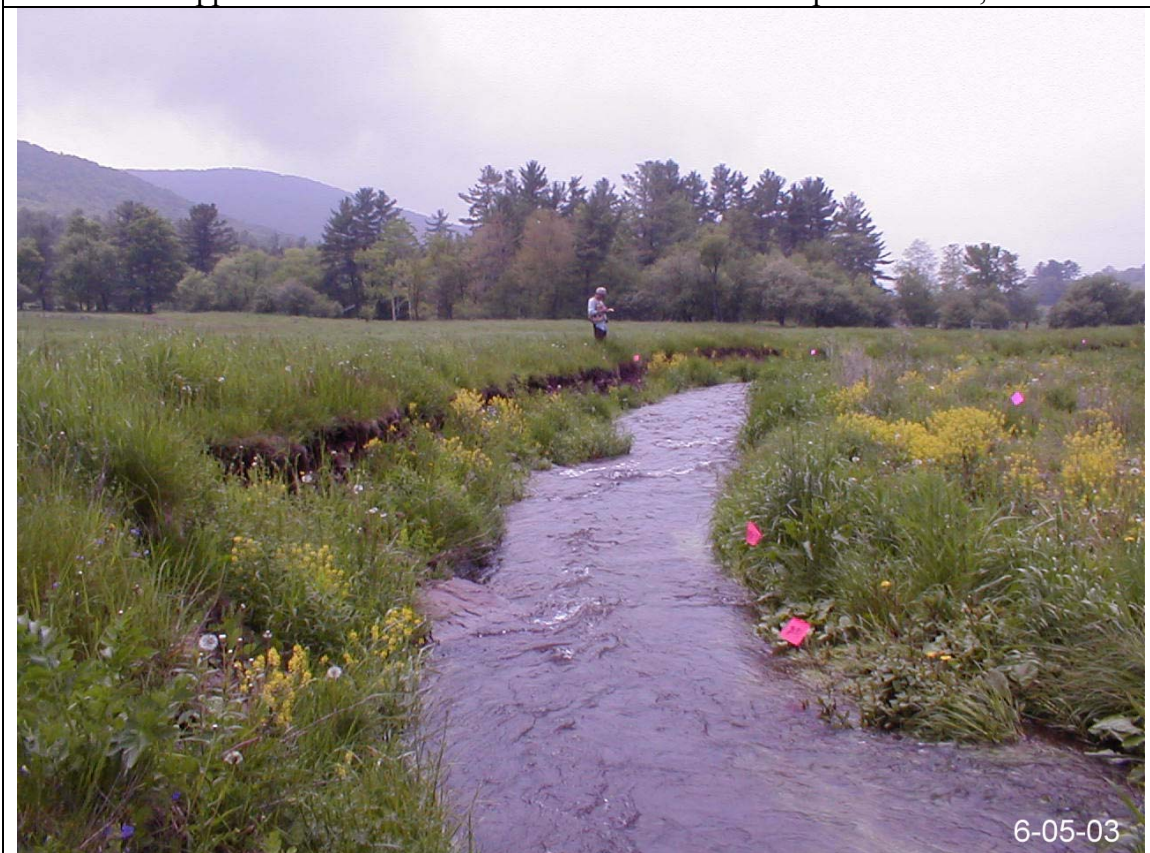
Photo 6.24: Approximate location of double cross-vane structure shown in next 2 photos.

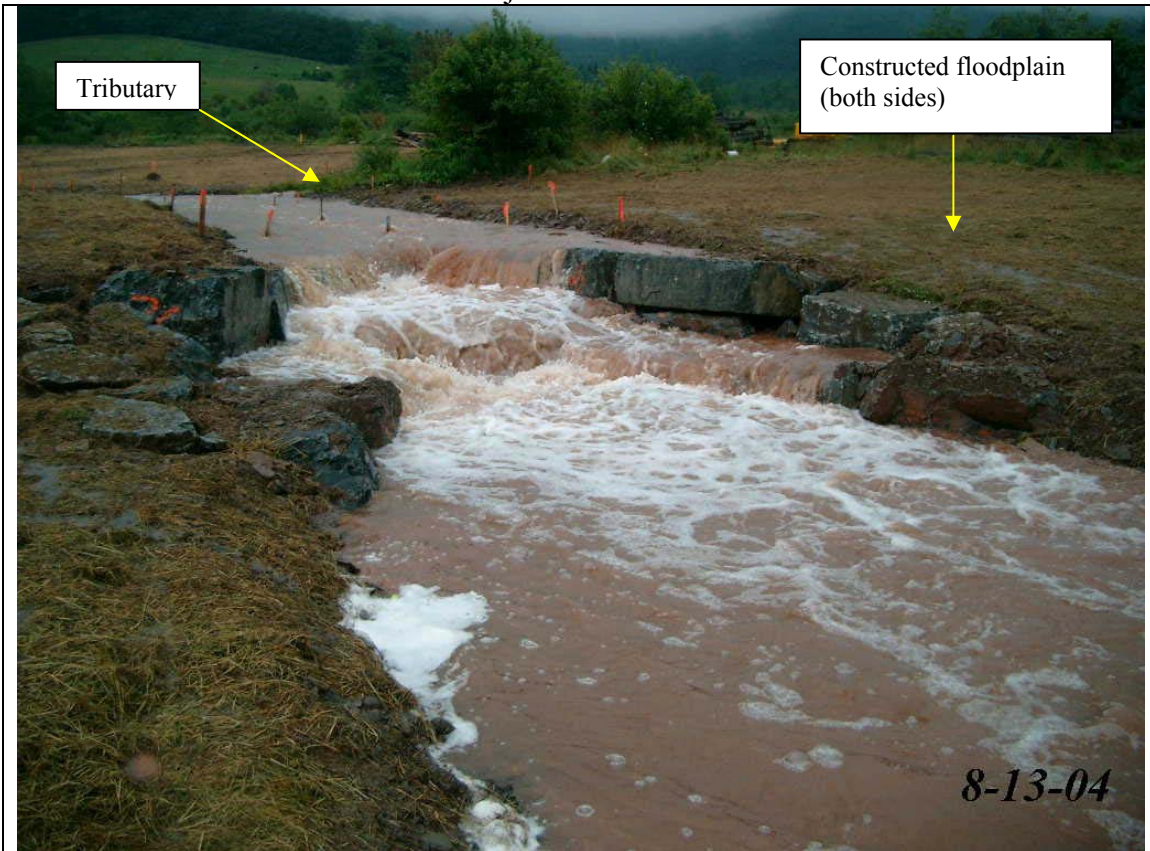
Photo 6.25: Near bankfull flow through the double cross-vane structure, 8-13-04.

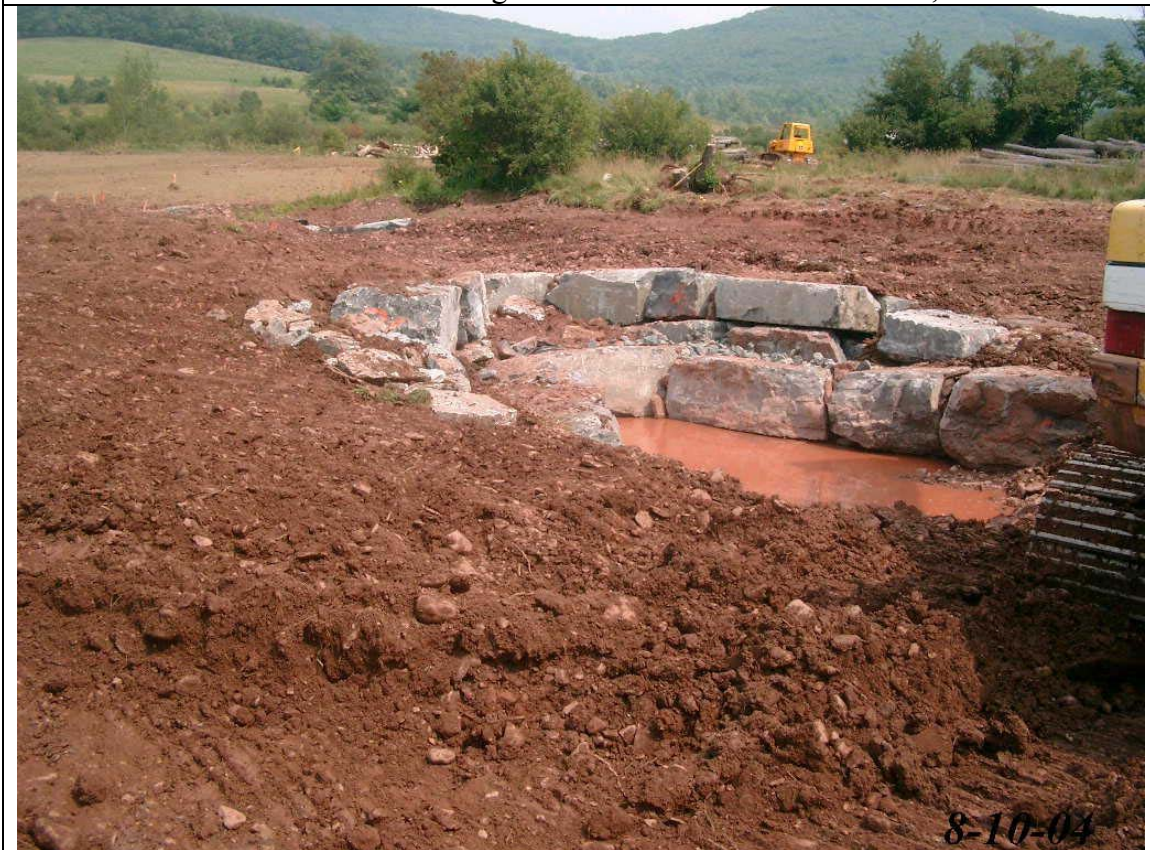
Photo 6.26: The double cross-vane structure during construction, 8-10-04.

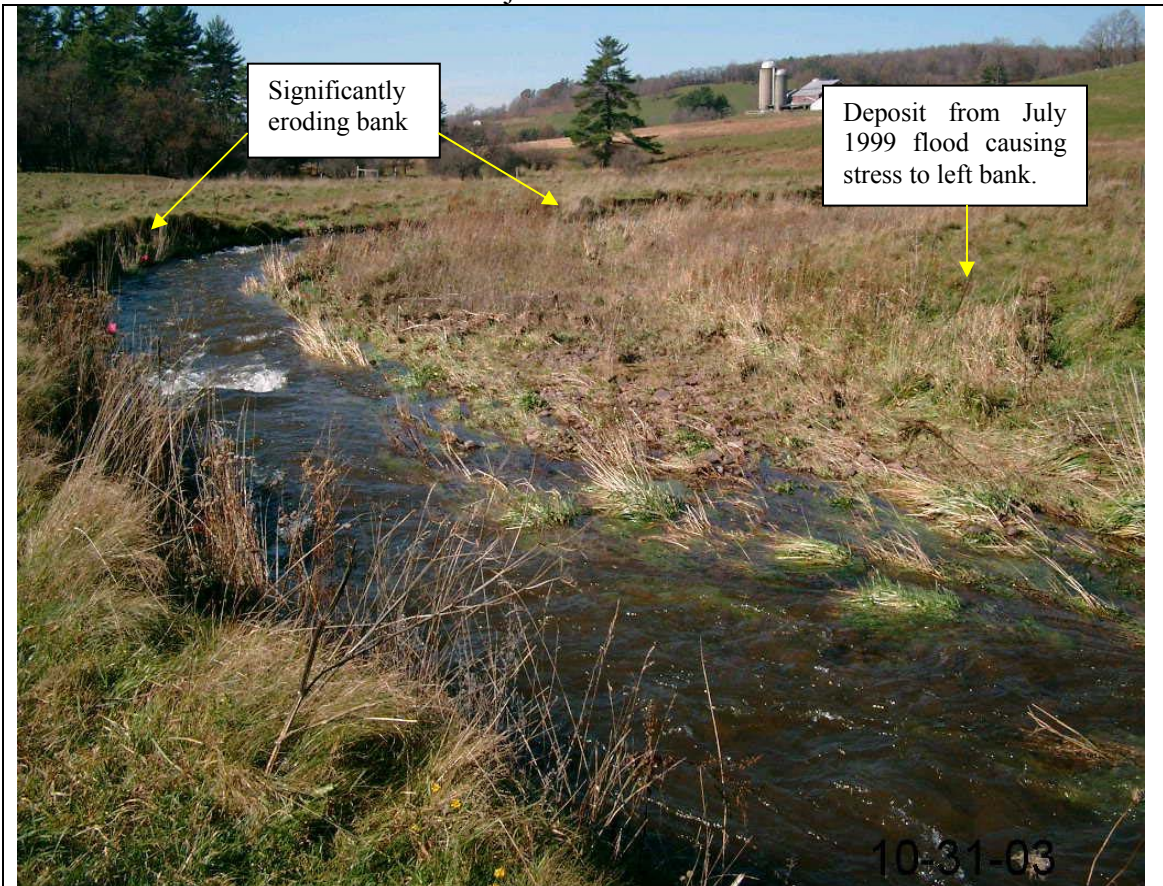
- A large gravel deposit had formed in 1999, when the stream burst its banks during a record flood. (This flood was the result of a localized storm in which over 6 inches of rain fell in approximately a 4-hour period on July 4, 1999. The resulting flow from this storm was significantly higher than the January 1996 event) (photos 6.27, 6.29).
- The existing stream on the Post farm was trending heavily toward a Type F (photo 6.31).

Photo 6.27: Approximately at the middle of the project reach, 10-31-03.

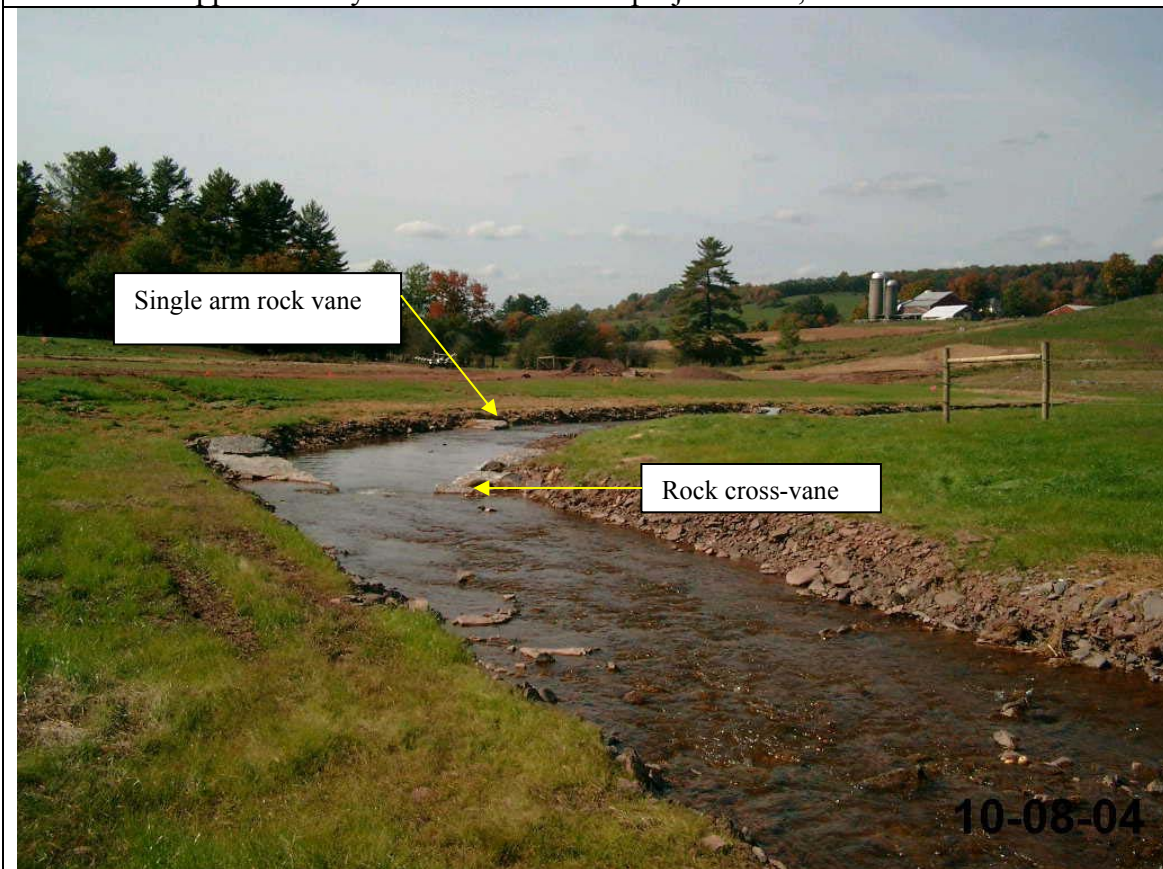
Photo 6.28: Looking D.S. at cross-vane approximate area as the above picture, 10-08-04.

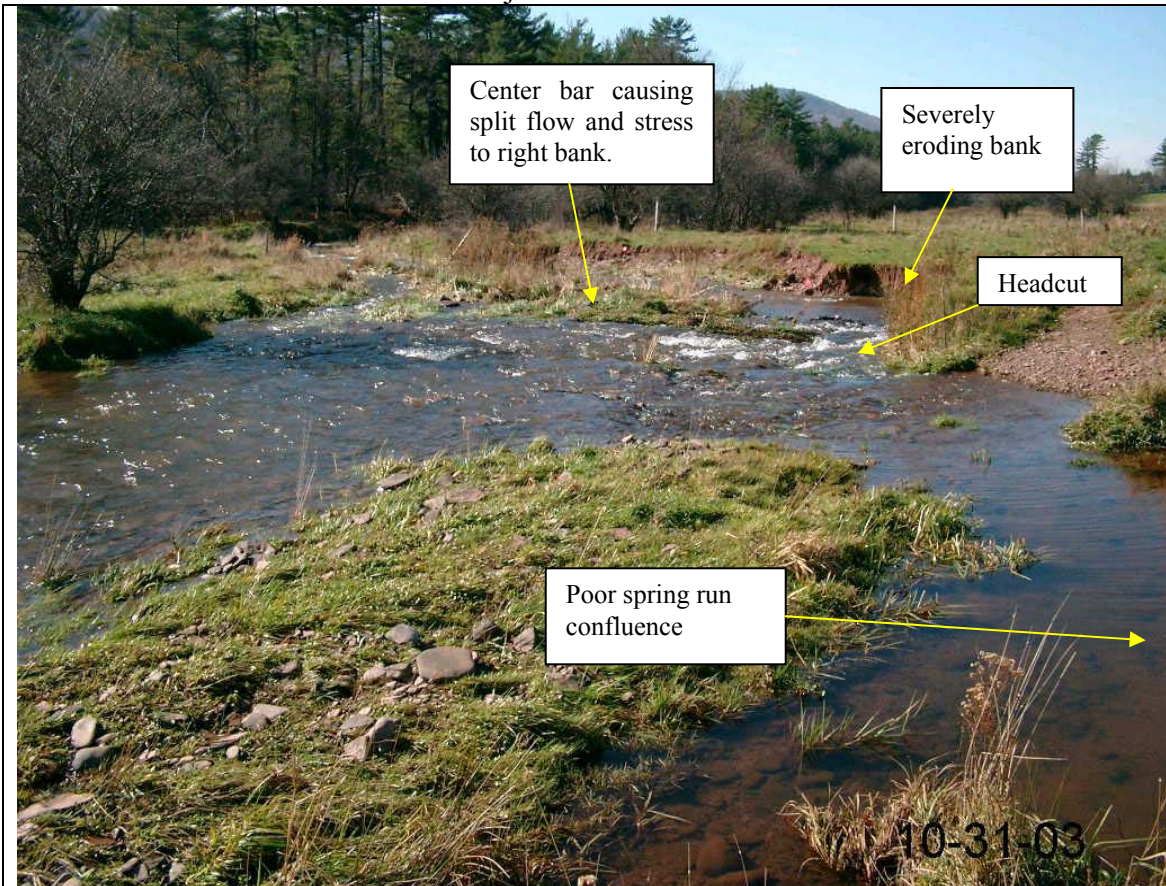
Photo 6.29: At existing cattle crossing, 10-31-03. Stream over-widened with split flow.

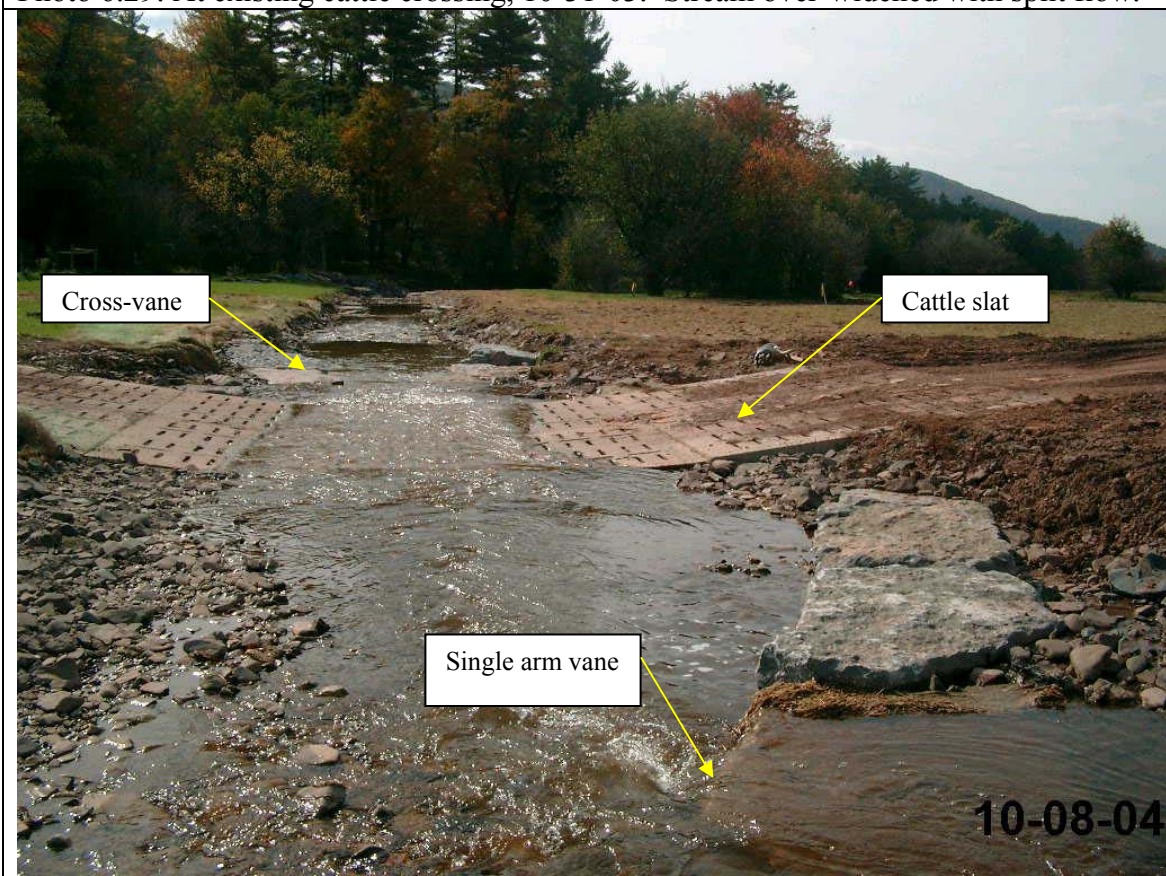
Photo 6.30: Looking D.S. at cattle slat, 10-08-04

A cattle crossing consisting of pre-cast concrete slats was constructed across the new stream in coordination with the Watershed Agricultural Program CREP project (photo 6.30). The cattle crossing was designed in coordination with the stream reconstruction to insure that the crossing did not interfere with the hydraulic properties of the new stream.

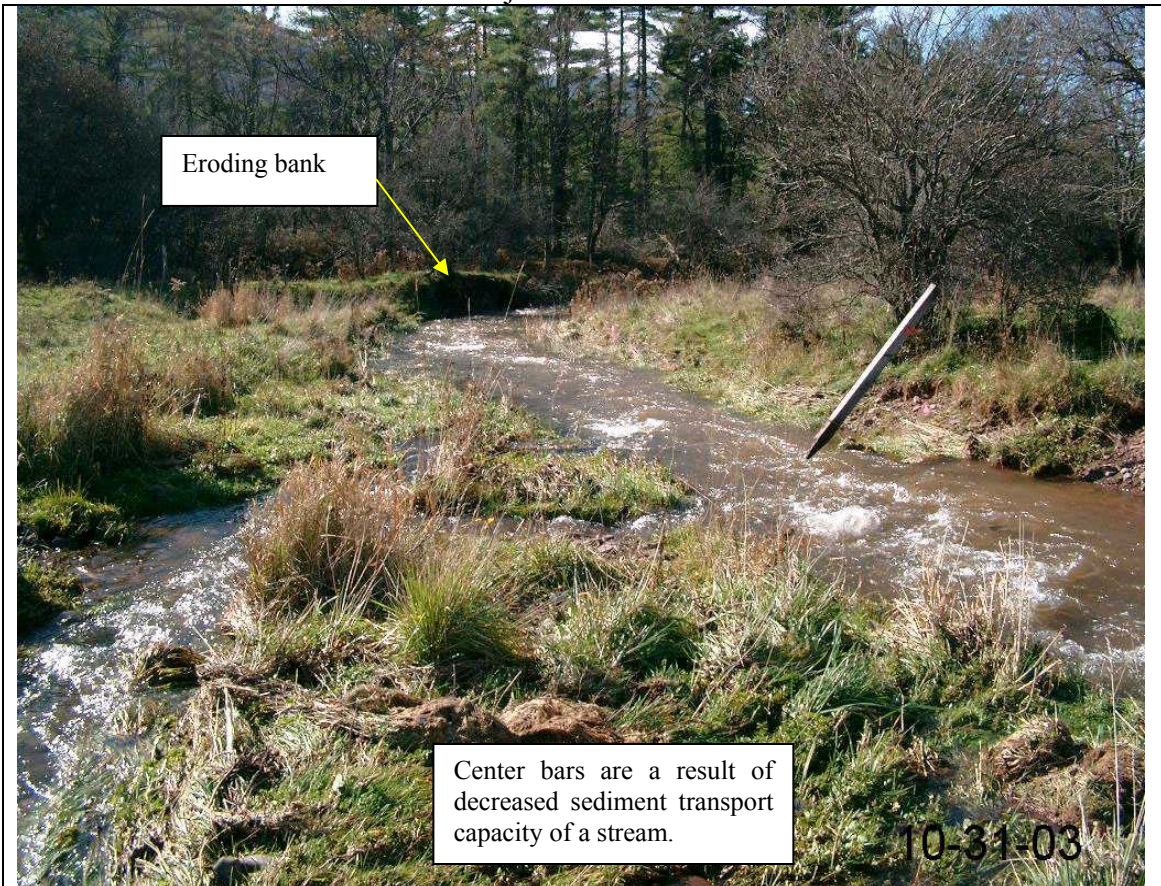
Photo 6.31: Lower end of project reach, 10-31-03.
