West Branch of the Delaware River Stream Corridor Management Plan

May 2006

Prepared by:
Delaware County Soil and Water Conservation District

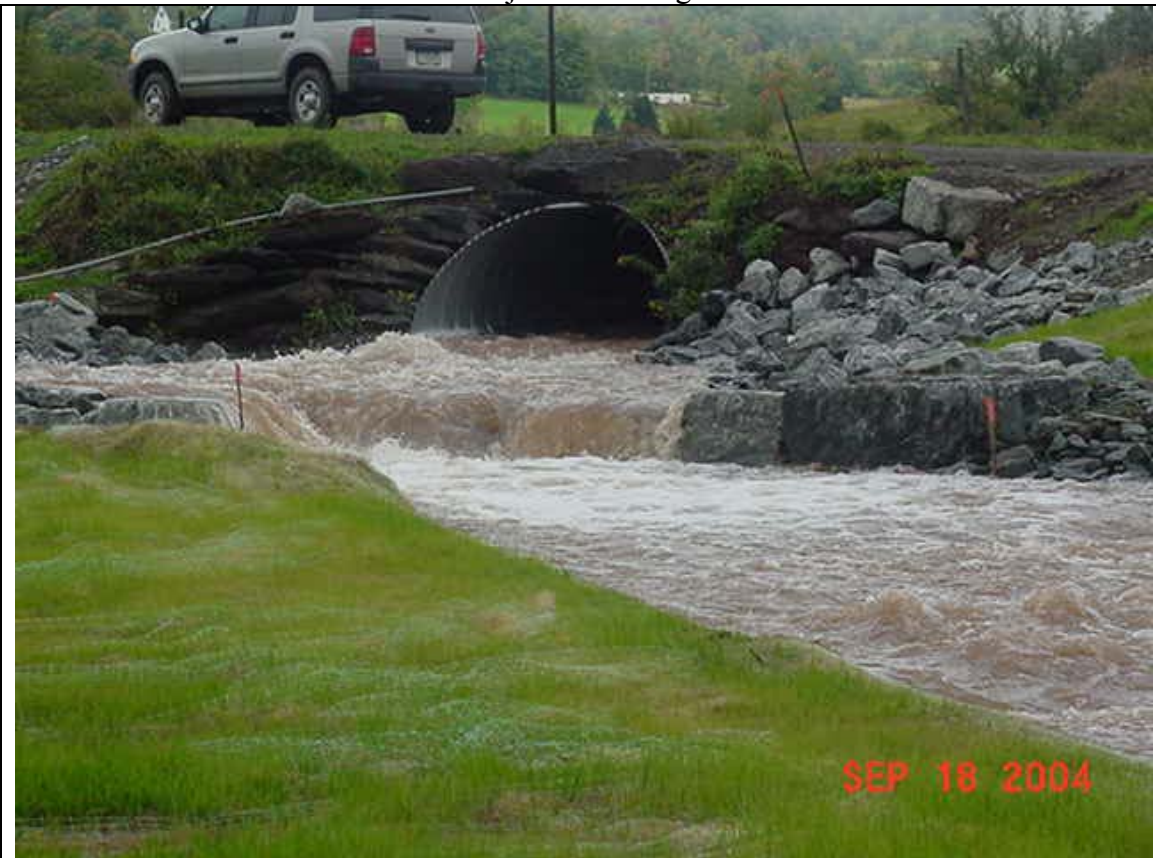
- Flooding: We experienced four major storms while building this project. The first was estimated to be about a “five-year” storm event. Work had just begun, there was no vegetation started, and the floodplain was raw earth. Fortunately, there was virtually no damage and the floodplain withstood the flood with essentially no damage. This gave us confidence that our design judgments were correct. Two smaller but still significant events followed. Work had to be suspended briefly, and when it resumed the ground was saturated, making earth-work difficult. When the channel and floodplain were about 80% completed, we had a 25- year event (estimated). There was no damage to the floodplain to speak of, as only some seed was washed off. The structures handled it well (photos 6.33-6.36), reaffirming that our design was adequate.

Photo 6.33: Looking U.S. at the beginning of the project, 9-18-04.

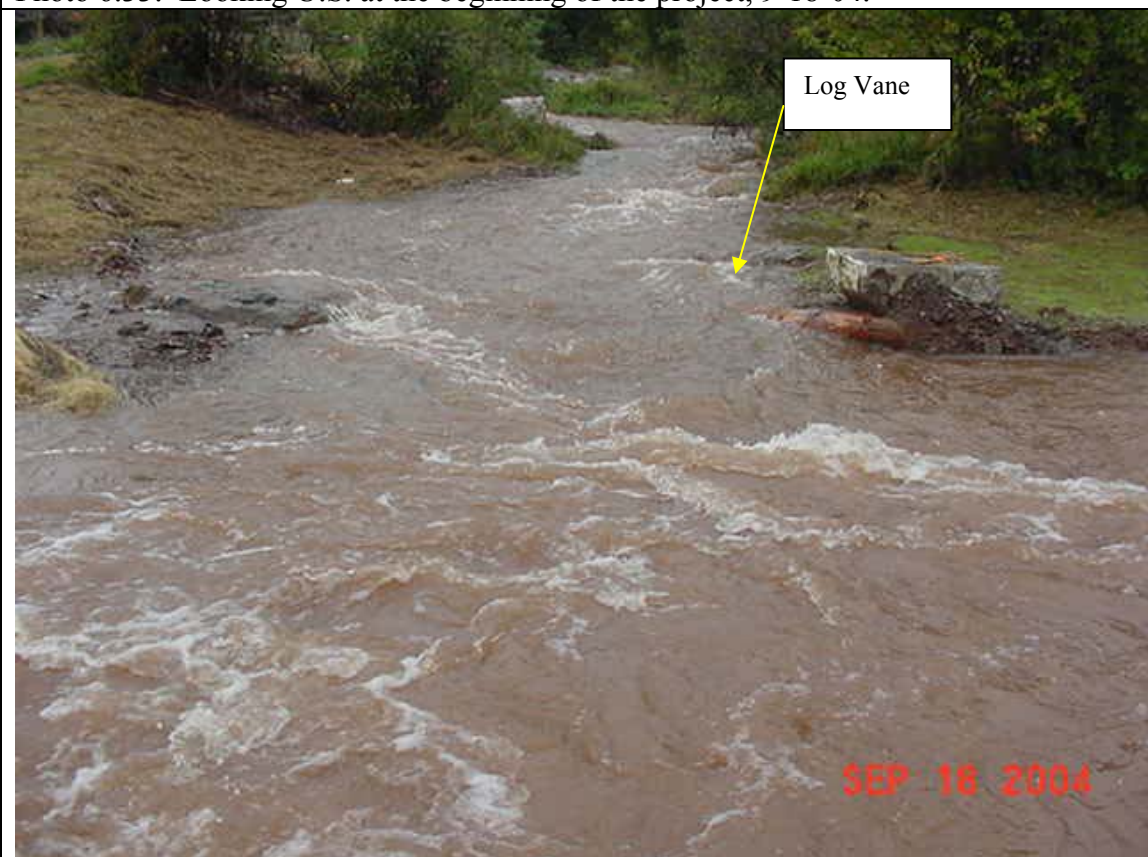
Photo 6.34: Looking U.S. of the tributary with log vane, 9-18-04.

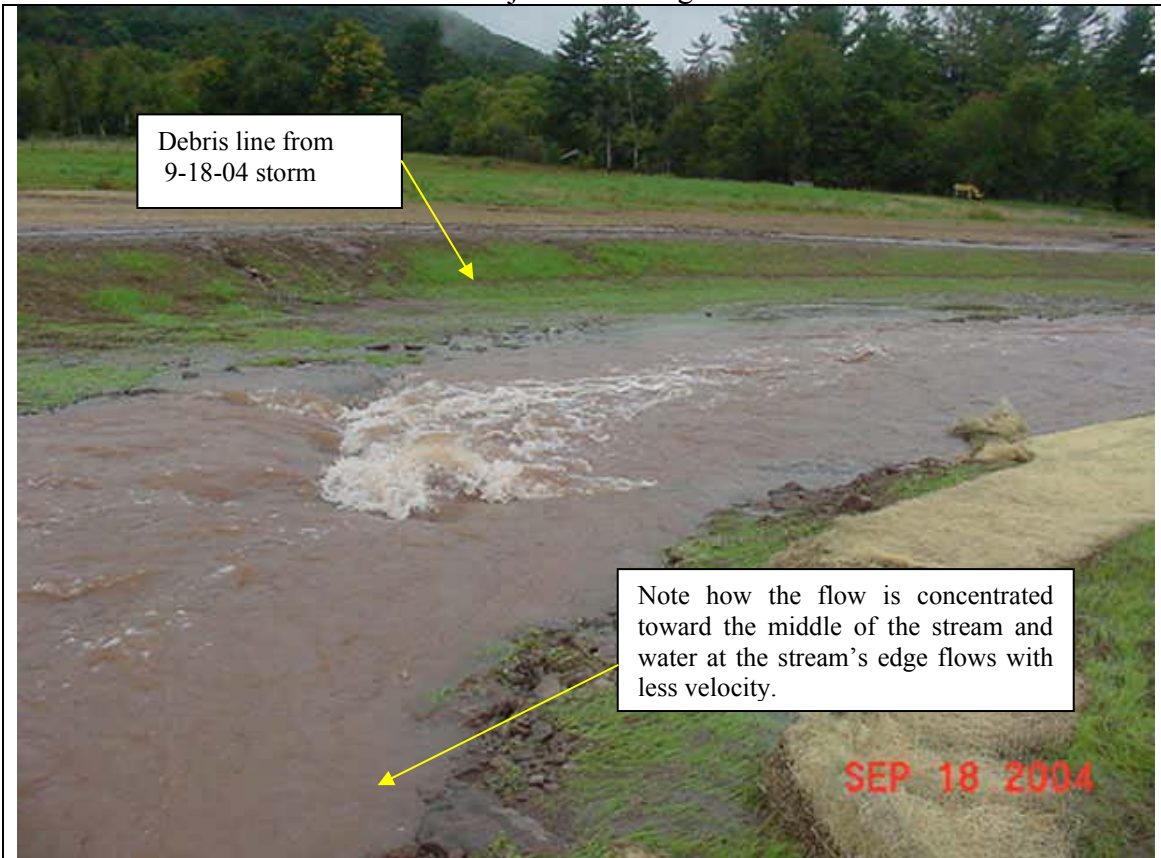
Photo 6.35: Looking D.S. at cross vane at debris line from 9-18-04 storm.

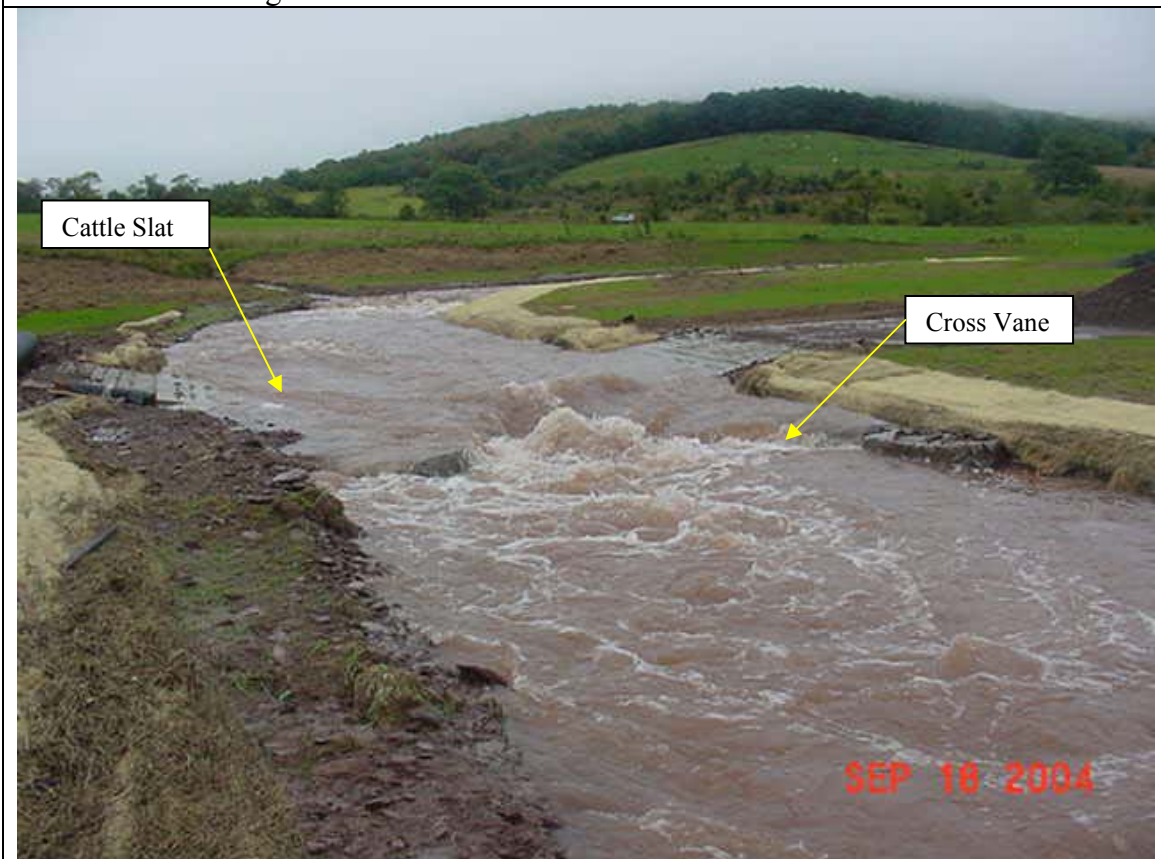
Photo 6.36: Looking U.S. at cross vane and cattle slat, 9-18-04.

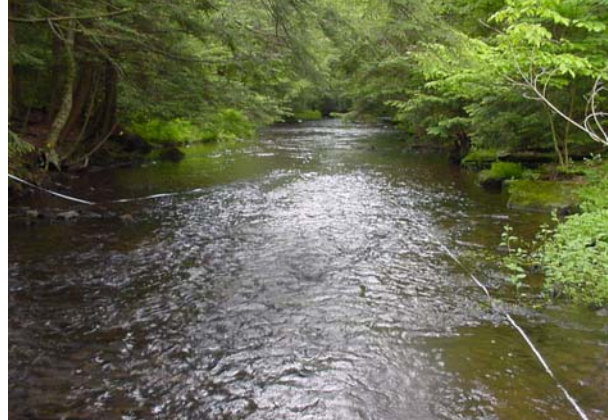
Management Unit 1 is in good condition with a well forested floodplain and wetland areas protecting the stream's stability. The reach is relatively undeveloped, or has returned to a largely undisturbed condition. There are a few low stream banks with evidence of minor erosion and a short section of undercut bank. There are a few short sections that appear slightly over wide, with one small central bar. Cross-Section

Figure 7.2.1 Typical scene in Management Unit 1 looking downstream located approximately 1,320 feet from Lake Utsayantha.

2 is located in the middle of the reach and has a width/depth ratio of 27 compared with an upper limit for a C stream type of 24 (see **Figure 7.2.1**). This management unit is rated stable and contains monitored cross-sections 1, 2, and 3.

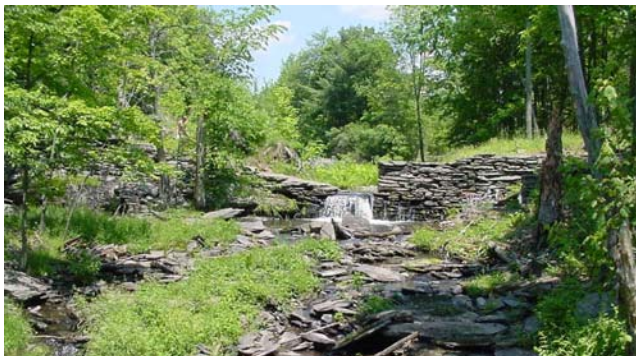
There is one small private bridge and an old dam at the bottom of the reach. The Lake Utsayantha dam, a bedrock outcrop just above the mill dam and the old mill dam provide grade controls through this reach (see **Figure 7.2.2**).

Figure 7.2.2 Remains of the old mill dam located approximately 375 feet upstream from River Street stone arch bridge.

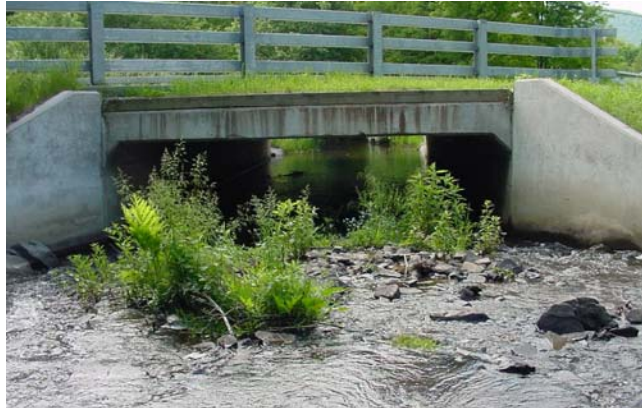
Figure 7.2.3 Deposition at the upstream end of the box culvert located on River Street.

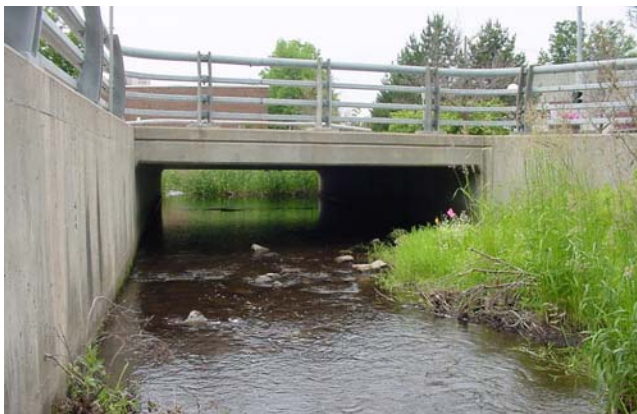
Figure 7.2.4 Looking downstream at NYS Route 23 Bridge.

Other private driveway bridges/culverts allow driveways to cross the channel through this reach before the channel becomes revetted for the last 300 ft before crossing under NYS Route 23 (**Figure 7.2.4**). The landowners living along this section of the river have been plagued with flooding, but the river's low slope and the intensity of land use through this 1700 foot reach provide few options for alleviating this condition. Reestablishment of a limited floodplain (converting the channel from an F to an entrenched E channel) may provide some relief, but would require that landowners along the stream be willing to move their activities away from the channel.

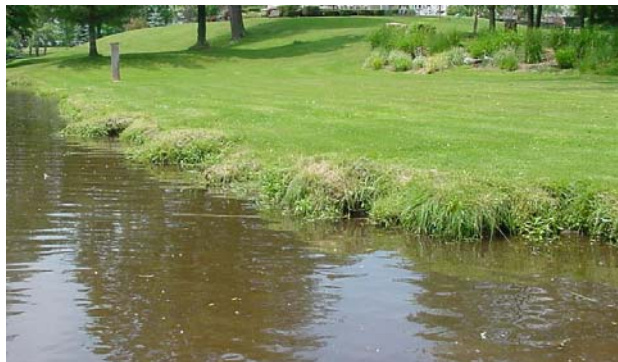
Figure 7.2.6 Lawn maintained to edge of water located approximately 350 feet upstream from Railroad Avenue culvert.

After passing under the rail trail bridge, the stream returns to a C stream type although the flat slope of the stream is maintained by a small dam at the end of a long pool just upstream from the culvert on Railroad Avenue. In this reach, the riparian buffer on the right bank is weakened by the maintenance of a lawn up to the edge of the water (see **Figure 7.2.6**). Integration of shrubs and a few trees would increase bank stability and help ensure that the river does not circumvent the check dam above the Railroad Avenue culvert.

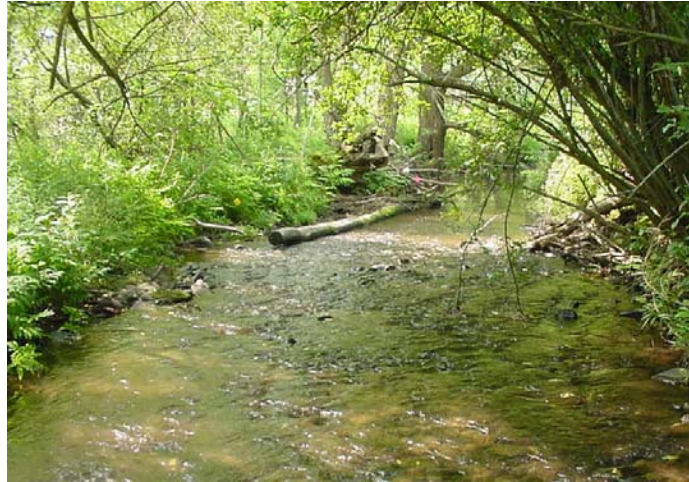
Figure 7.2.7 Typical scene in Management Unit 4 looking downstream located approximately 160 feet upstream from Axtell Road.

have been related to a previous aerator/settling tank upgrade to the treatment plant. The entire reach along the treatment plant shows evidence of instability with the frequent use of rip rap indicating the repeated need to strengthen the banks. Even the two residential properties at the end of Axtell Rd have had to rip rap their stream banks. Additional vegetation at key points along the stream bank would help improve the riparian buffer and reduce the need for rip rap maintenance. The stream type below the wetland changes from C4 to B4 and then back to a C4 at the bottom of the reach near the treatment plant outlet. The change is due to the rip rap placement which confines the stream and minimizes its access to a floodplain.

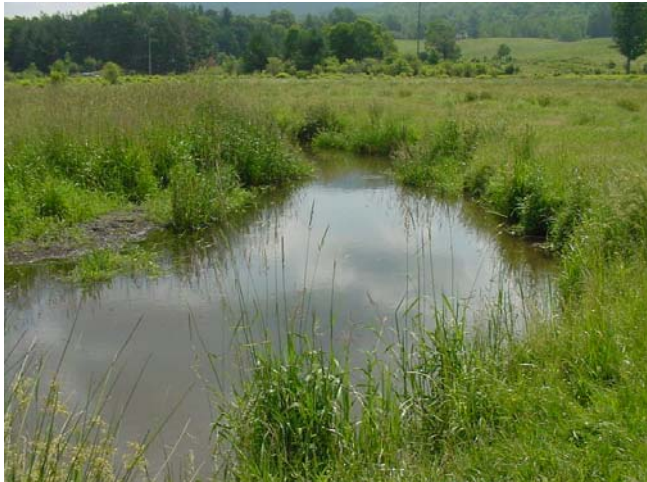
Figure 7.3.2 C6c- stream type that is located at the top of Management Unit 5 downstream of bridge.

The top portion of this unit is classified as a C6c- stream type. It is very sinuous, with a low width to depth ratio. The C6c- section may have evolved from an E6 type stream. It is currently destabilizing as a result of recent cattle access to the stream and destabilization of the banks by hoof shear. **Figure 7.3.2** provides an example of the C6c- stream type with its broad shallow floodplain. Removal of the cattle may enable the stream to regain its stream bank vegetation, maintain its sinuosity, and remain a stable C6c-.

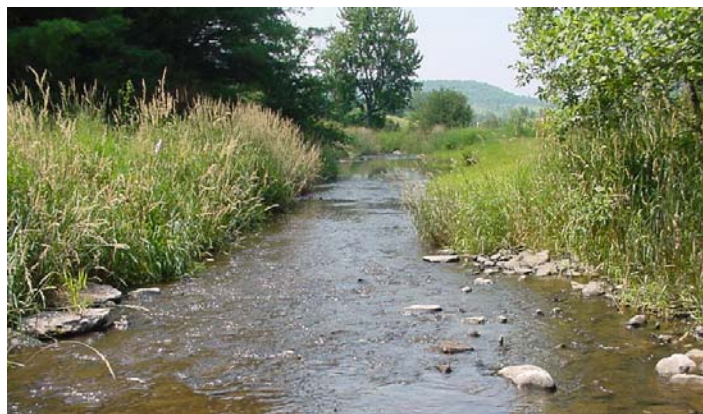
Figure 7.3.3 Typical scene of the river located at the top of Management Unit 6.

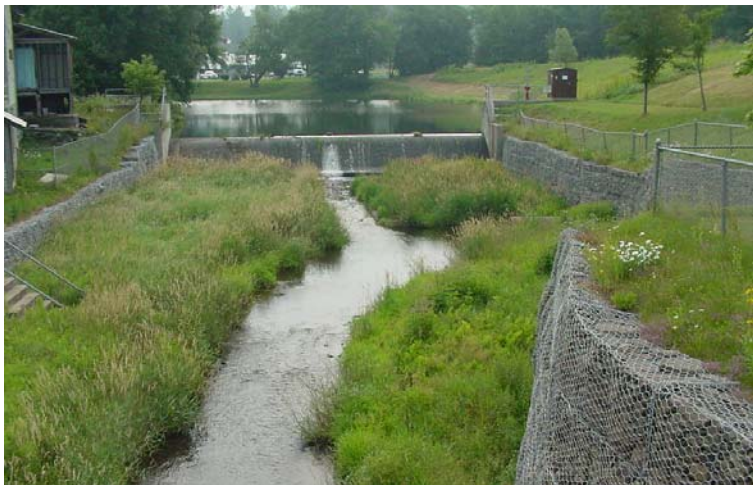
This reach contains two dammed ponds connected by a manmade stream. Gabion baskets are found in the river bed and along the banks which continues downstream through Maple Avenue Bridge. **Figure 7.3.4** shows the upper dam from Maple Avenue Bridge. The outfall of the lower pond is of similar construction. These structures trap sediment behind the dams.

Figure 7.3.4 Looking upstream at one of the dams in Hobart from Maple Avenue Bridge.

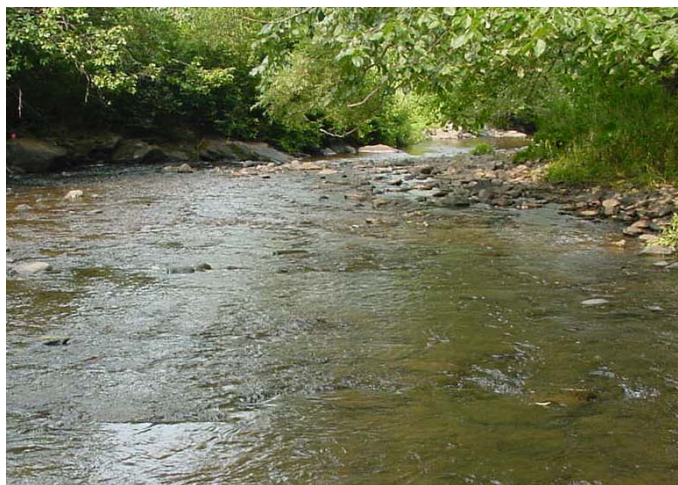
Figure 7.3.6 Typical scene looking downstream in Management Unit 9 located approximately 1,450 feet downstream from Town Brook.

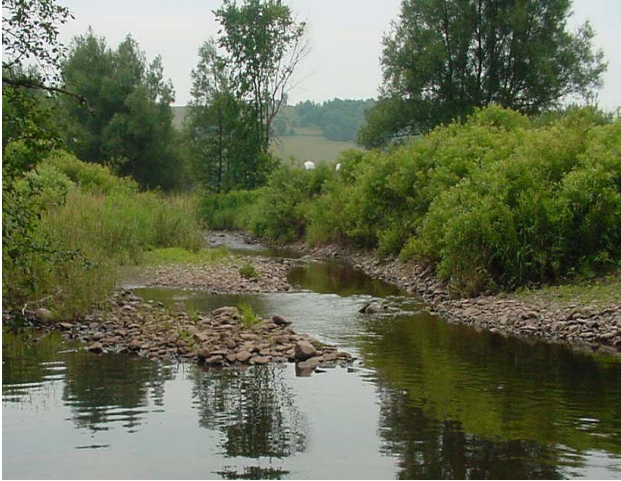
Figure 7.3.7 Looking upstream at the confluence of Town Brook.

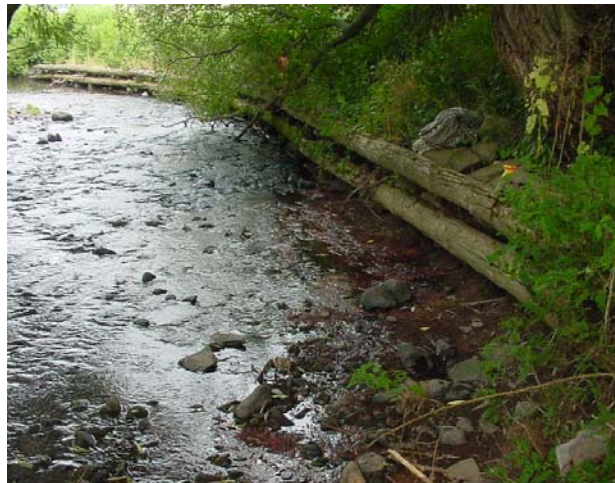
of Environmental Conservation structures are found in this reach, including log cribbing, log deflectors and fish habitat structures. **Figure 7.3.8** shows log cribbing along the right bank. Bank erosion is common at the downstream ends of these revetments. There was over 2100 feet of bank erosion along this 10,500 foot reach. Over 50% of this eroded bank length had an average bank height of 4.5 feet or greater.

Figure 7.3.8 Log cribwall on the right bank located approximately 1,200 feet downstream from Town Brook confluence.

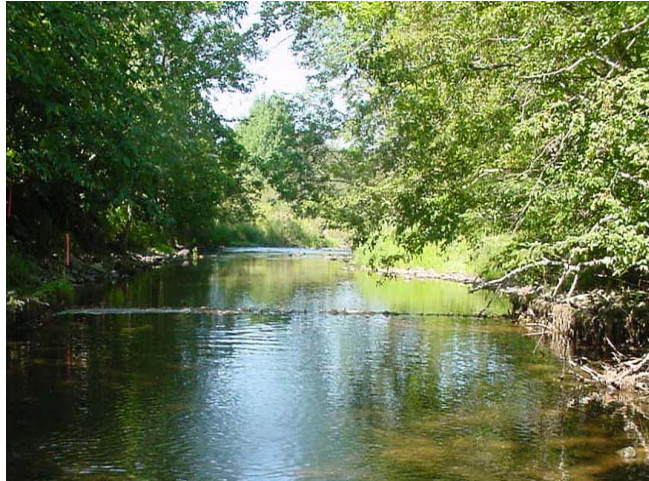
Figure 7.3.9 Typical scene in Management Unit 10 located downstream at a Department of Environmental Conservation pool digger located approximately 1,350 feet upstream of the Post private bridge near DEC fishing access parking lot.

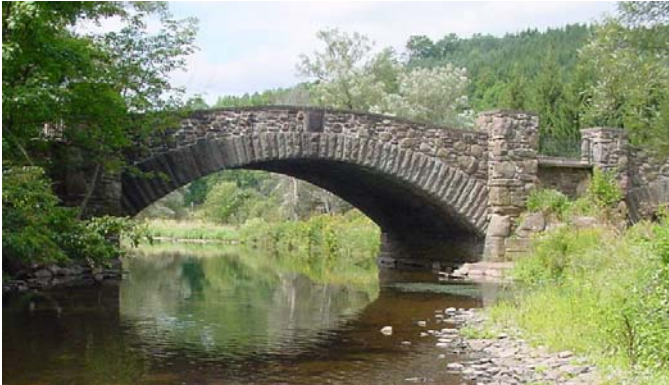
Figure 7.3.12 Looking downstream at County Bridge 18-6.

Just upstream from the Dry Brook tributary there is a grade control consisting of massive flat stones set into the streambed. This structure is the remnants of an old dam. The County Route 18 Bridge (18-6) crosses the river in the hamlet. The bridge has two arches with the right arch acting as a high flow by-pass channel. This feature enables the river to function through this reach without significant aggradation or scour. There are only a few bars found downstream of the bridge.

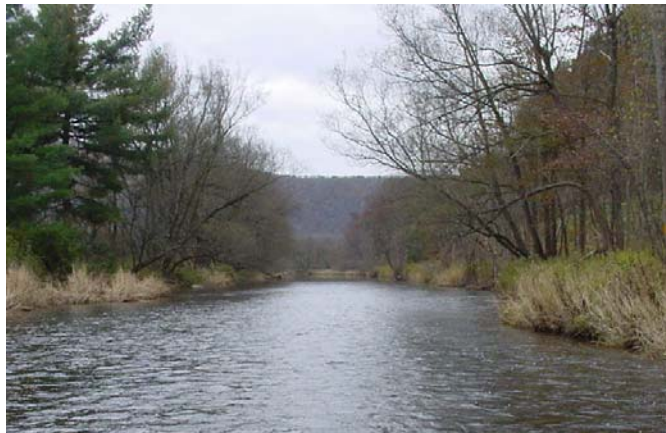
Figure 7.3.16 Typical scene in Management Unit 13 located approximately 4,500 feet downstream from County Bridge 82.

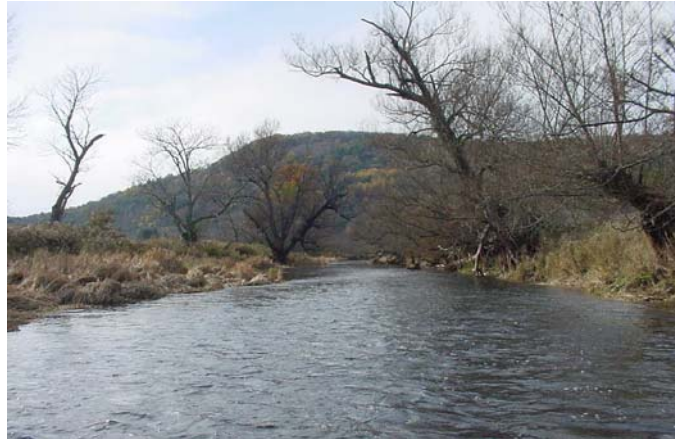
Figure 7.4.1 is a picture of a stretch of the West Branch Delaware River within Management Unit 14. This management unit is rated unstable. There are two locations where the West Branch comes in contact with the valley wall. This section of the West Branch should have wider floodplains where agricultural fields are located. Some of the agricultural lands have extensive berms along their fields that prohibit floodplain access.

Figure 7.4.1 Typical scene in Management Unit 14 located approximately 6,500 feet downstream from County Bridge 33.

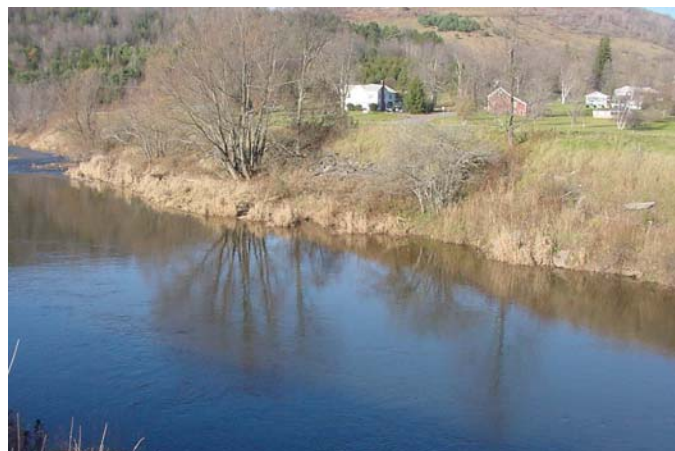
Figure 7.4.4 shows a typical scene that is within Management Unit 15. Most of the river in this unit is bounded by agricultural land with little riparian buffer. Management Unit 15 is moderately stable.

Figure 7.4.4 Typical scene in Management Unit 15 near the Elk Creek tributary.

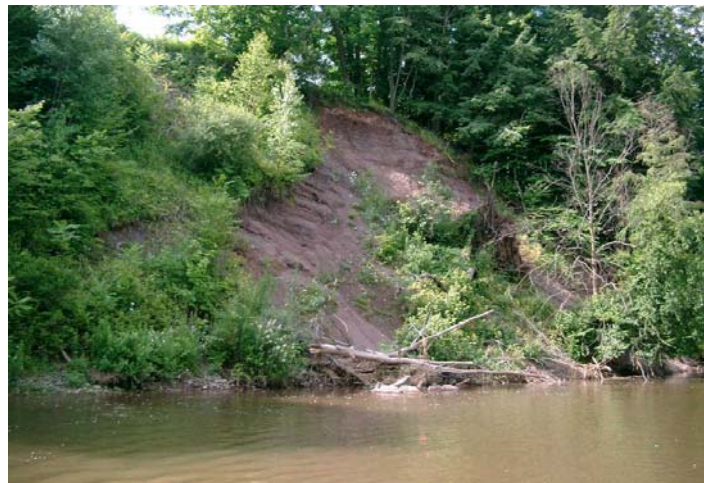
Management Unit 16 is unstable with a significant number of center bars, islands and by-pass channels. There are numerous clay/silt exposures on the banks and an increase in the amount of Japanese knotweed through this reach.

Figure 7.4.6 High eroding bank on the left side of the river near the top of this management unit.

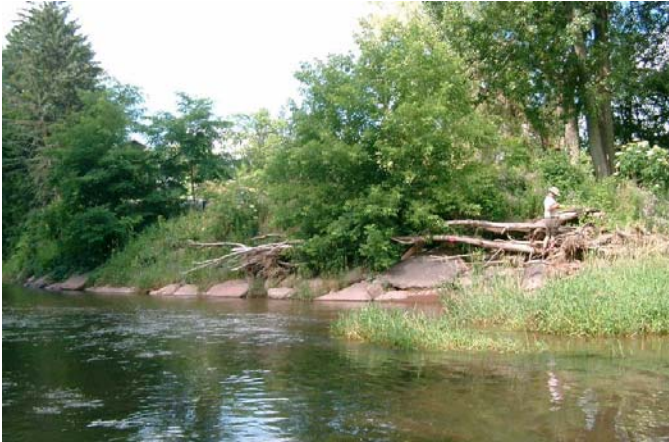
Figure 7.4.8 Rip rap along the island upstream from Kingston Street Bridge.

There are noticeably more revetments along the banks (3110 feet of revetment over 4500 feet of stream) and a decrease of eroding banks (1081 feet). **Figure 7.4.8** shows rip rap along the island upstream from Kingston Street Bridge.

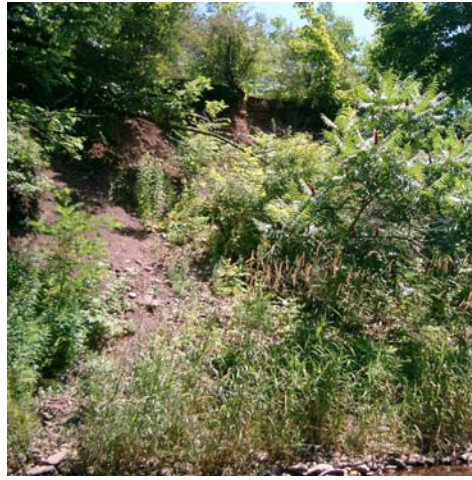
Steele Brook tributary contributes a high sediment load which is forming side, transverse and center bars downstream of its confluence. This excess sediment from Steele Brook is forming a center bar downstream of the outflow forcing the river toward the opposite bank. An old gage station was located just downstream of Steele Brook confluence and now the high bank is presently eroding as shown in **Figure 7.4.9**.

Figure 7.4.9 High eroding bank opposite of Steele Brook confluence.

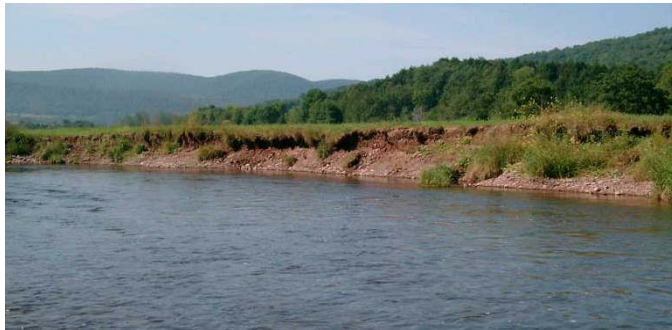
Figure 7.5.1 Typical eroding bank along agricultural field with no riparian buffer approximately 4,000 feet downstream of Platner Brook.

The significant number of eroding banks in the vicinity of aggradation areas suggests that the river is attempting to alter its alignment to enable it to move around the deposits. As many of these banks have little to no vegetation as shown in **Figure 7.5.1**, the river is able to rapidly remove huge sections of bank with each storm event. The riparian buffer width should be increased for almost all of the agricultural fields along the river in this management unit. The stream program should also continue to review

stable or “reference” stream alignments for large C streams in an effort to provide recommendations for channel realignment as needed by stream bank stabilization and river restoration efforts.

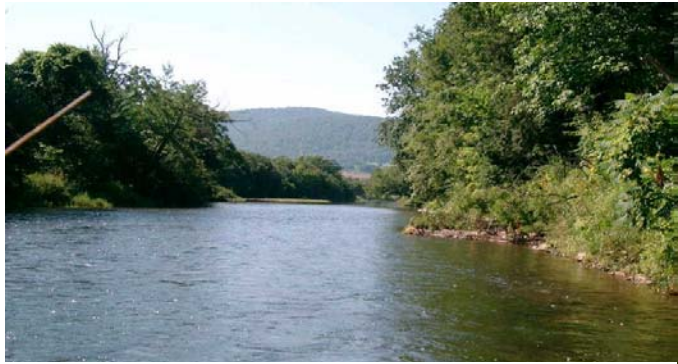
Figure 7.5.2 Typical scene of the West Branch in Management Unit 21 located approximately 4,000 feet upstream from Bagley Brook confluence.

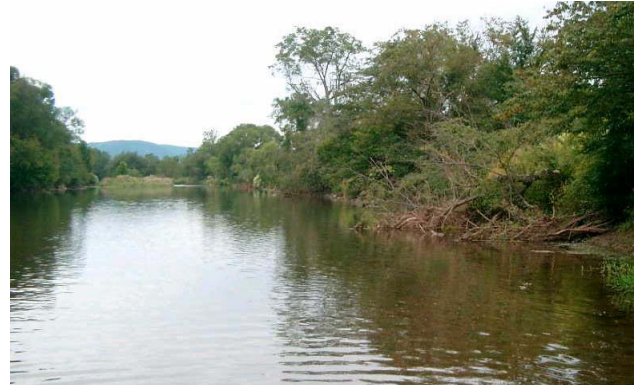
Figure 7.5.4 Typical scene in Management Unit 22 and is located 1,600 feet downstream from Launt Hollow.

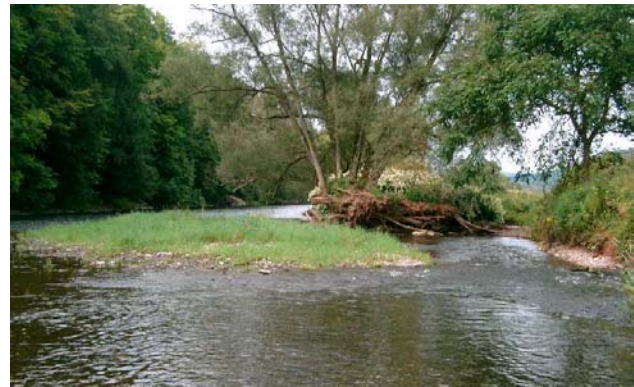
Figure 7.5.5 Confluence of Launt Hollow.

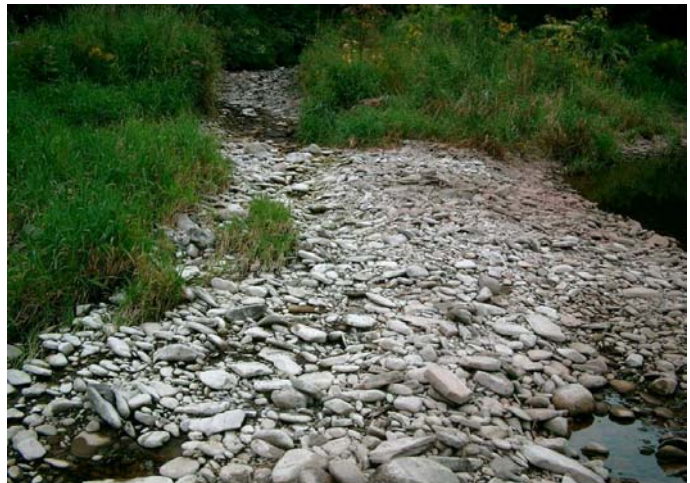
This management unit is unstable. In the upper portion of this unit there is a by-pass channel on each side of the river. Approximately 700 feet downstream is a large gravel deposit that forced water around it creating a second new channel approximately 800 feet long. Chambers Hollow supplies large amounts of sediment to the river system which is shown in **Figure 7.5.6**.

Figure 7.5.6 Confluence of Chambers Hollow tributary with high sediment load.

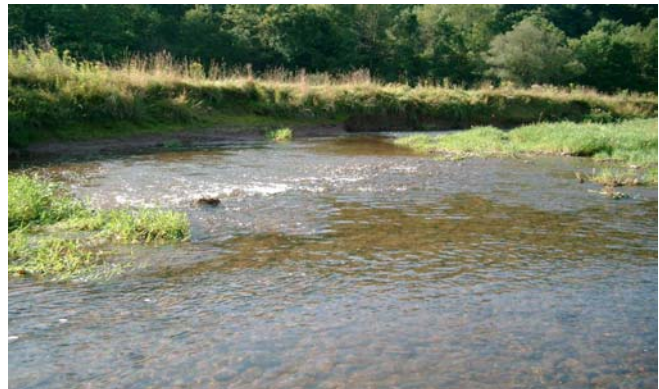
This area is primarily agricultural lands and there is a significant amount of erosion on poorly vegetated banks. **Figure 7.5.7** shows an eroding bank with poorly vegetated banks.

Figure 7.5.7 Poorly vegetated eroding bank that is associated with a transverse bar located 350 feet downstream of the confluence with Chambers Hollow.

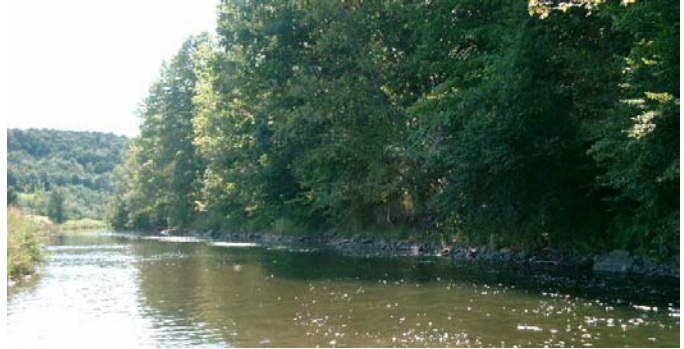
Figure 7.5.8 Typical scene in Management Unit 24 located 900 feet downstream of Mallory Brook confluence.

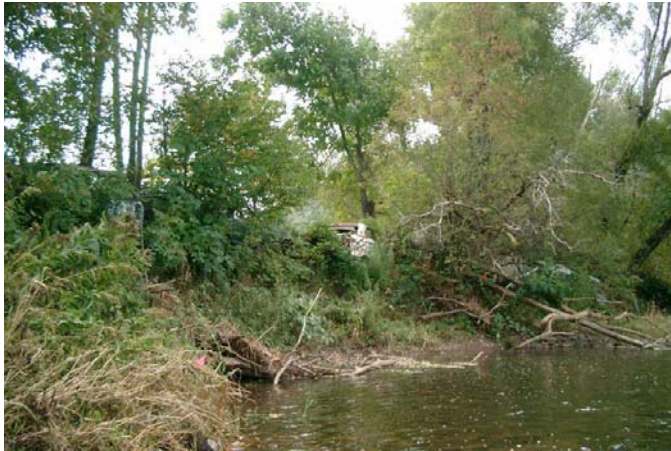
Figure 7.5.9 Vehicle revetment that is located approximately 7,400 feet downstream of County Bridge 26-6.

In the lower part of the unit there is a berm constructed of cars and school bus bodies along the left bank approximately 1,100 feet long which can be seen in **Figure 7.5.9**. This revetment is an ill-advised attempt to protect agricultural land during flooding events.

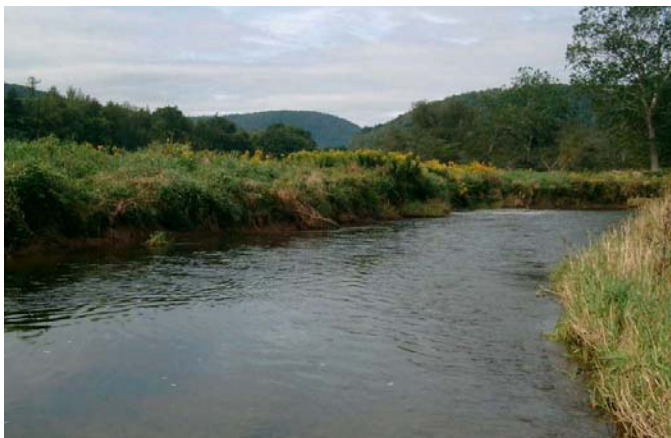
Figure 7.5.10 Poorly vegetated bank that is easily eroded on the island.

The entire reach seems to have minimal erosion. The most significant erosion is located on an island where there are several aggradation deposits directing water into the banks. These river banks are poorly vegetated and are easily eroded under high flow conditions. See **Figure 7.5.10**.

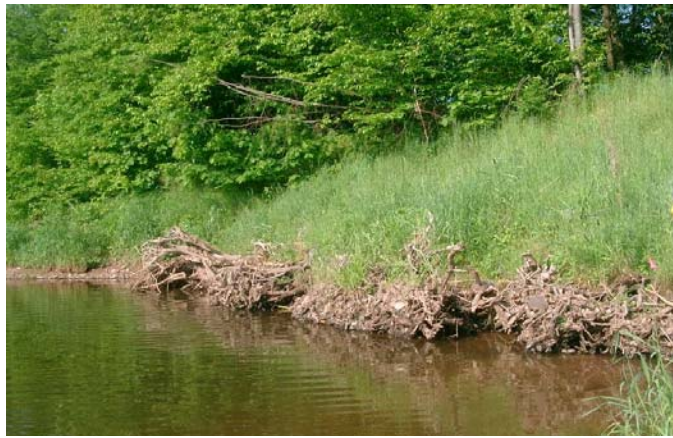
Figure 7.6.2 Root wad revetment that is located near the Delaware County Solid Waste Management Center.

This management unit is not as highly revetted as most of the other units. Most of the revetments consist of dumped stone placed along the banks. The lack of berms helps ensure that the river can access its floodplain. **Figure 7.6.2** is a picture of root wad revetment constructed by Delaware County Department of Public Works to help protect the bank from erosion located near the Solid Waste facility.

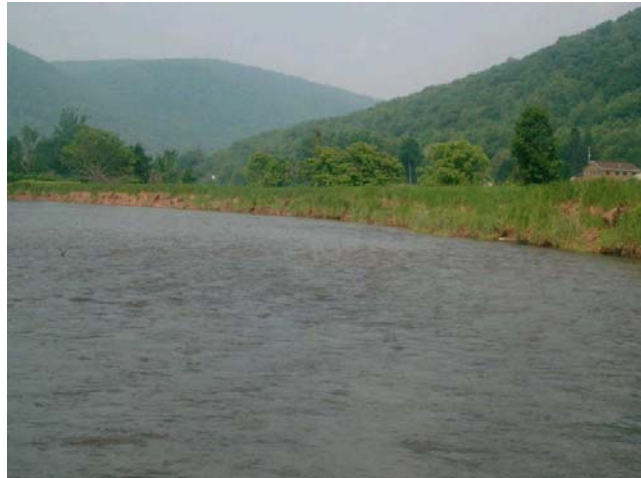
There is a total of 4,054 feet of eroding bank along this 8,545 foot long management unit. The height of the eroding banks varies from about 2 feet to about 8 feet, with about 30 percent of the eroding bank length having an average bank height of greater than 4 feet. It is likely that the stream banks in this management unit contribute a significant amount of sediment to the river.

Figure 7.6.3 Poorly vegetated right bank that is eroding located approximately 1,500 feet downstream from Bonnefond Road.

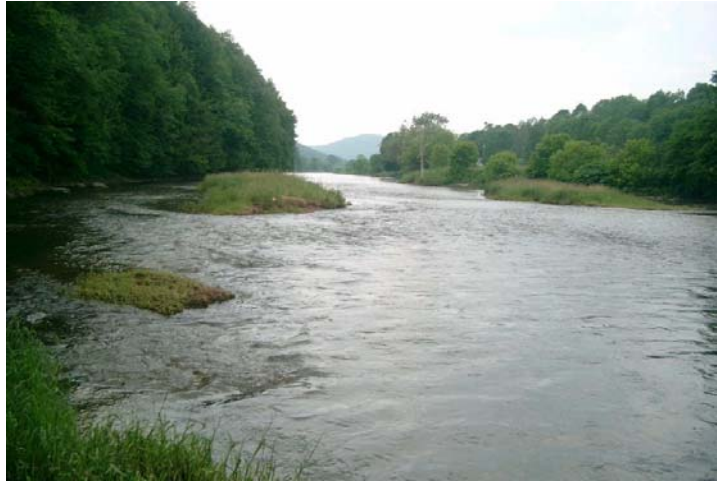
This unit consists of lands that are mainly agricultural fields and is on the outskirts of the Village of Walton. Marvin Hollow tributary enters the West Branch upstream from the village line. This unit is rated moderately stable with unstable reaches. **Figure 7.6.4** is a picture taken in this unit.

Figure 7.6.4 Typical scene in Management Unit 27 looking downstream at the top of this management unit.

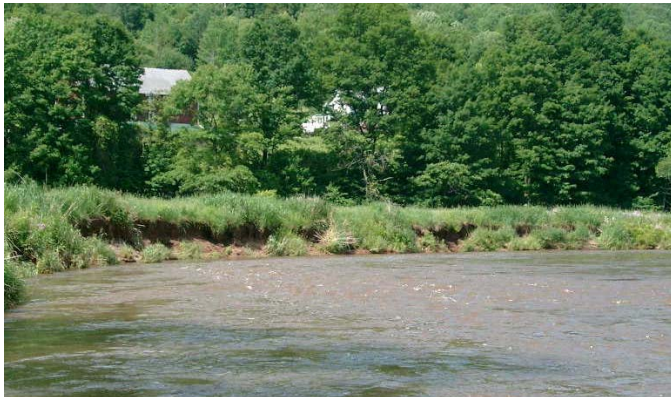
Figure 7.6.5 Poorly vegetated left eroding bank located approximately 1,500 feet upstream from Marvin Hollow confluence.

There are approximately 4,800 feet of eroding banks in this management unit. Eroded banks in this unit range from 1 to 8 feet in height, with nearly half of the eroding bank length (2,322 ft.) having an average bank height between 4' to 8' in height. The height of several of these eroding banks exceeds 10 feet.

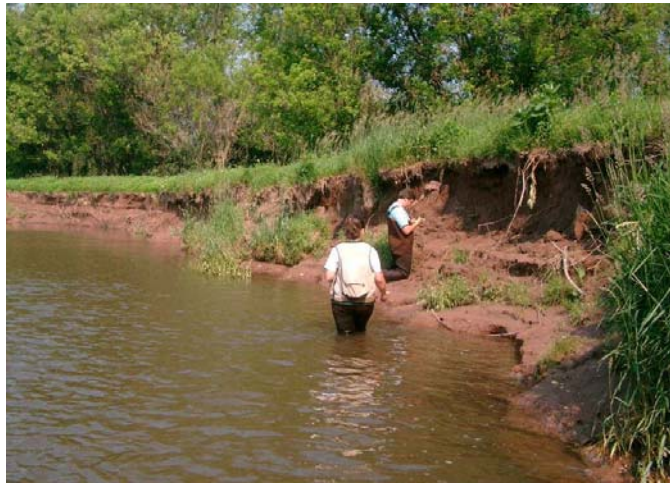
This unit has a higher than average number of depositional features. Most of these features are side bars and center bars. There is a 2,000 foot long section within this unit that consists of multiple channels. This same reach has severe erosion along its banks. At the very end of this unit there is a 4,000 foot long reach with a large number of depositional and erosional features concentrated together.

Figure 7.6.7 Poorly vegetated right bank located approximately 1,700 feet upstream from Pines Brook confluence.

In addition to these two specific locations this unit also has a large number of erosion features over its entire length. Taken together with the large number of deposition features, this unit is rated moderately stable with unstable reaches.
