THIRD BROOK WATERSHED MANAGEMENT PLAN

December 2013

MMI #4444-01

MILONE & MACBROOM, INC.
99 Realty Drive
Cheshire, CT 06410
(203) 271-1773
www.miloneandmacbroom.com

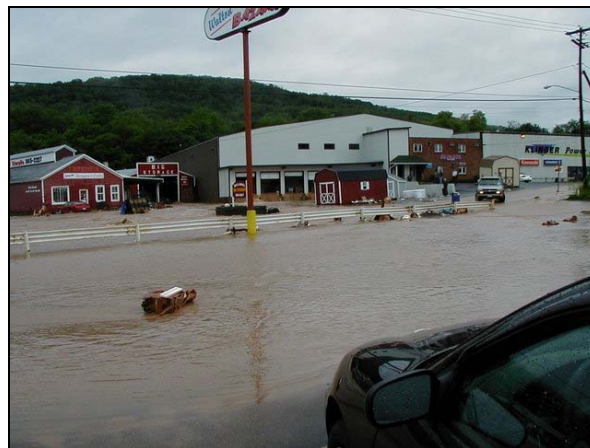
15 West Street through 33 West Street, courtesy of www.floodny06.zoomshare.com

Water from Third Brook poured onto West Street and flowed downhill between the Robinson Auction House and commercial properties on the east side of the road, damaging it.

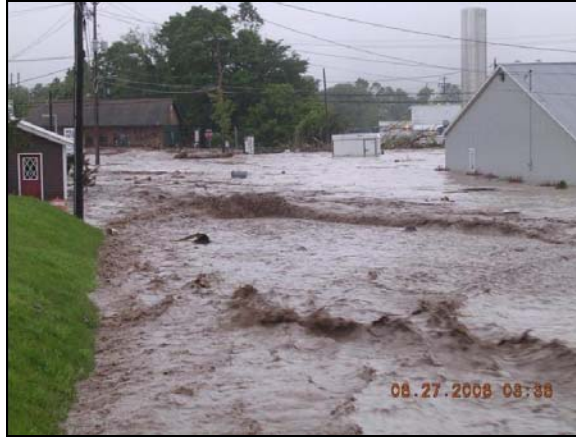
**Auction House, TA's Place, and Kraft, courtesy
Delaware County**

Debris in the Third Brook floodwaters clogged the bridge at Ogden Street and Delaware Street, making flooding worse. The Hess gasoline service station was flooded on the upstream side of Delaware Street as pictured to the right.

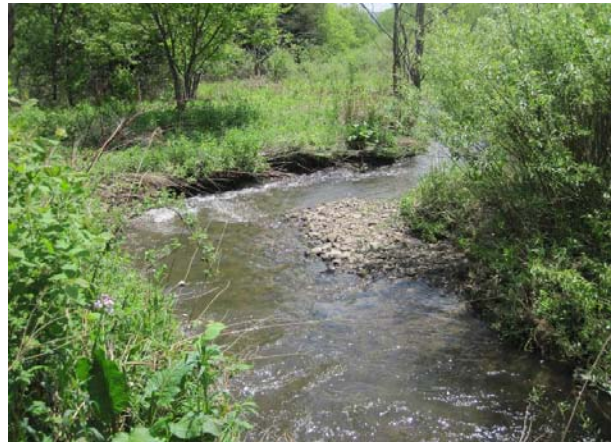
Third Brook entering wetland as braided channel near station 121+00

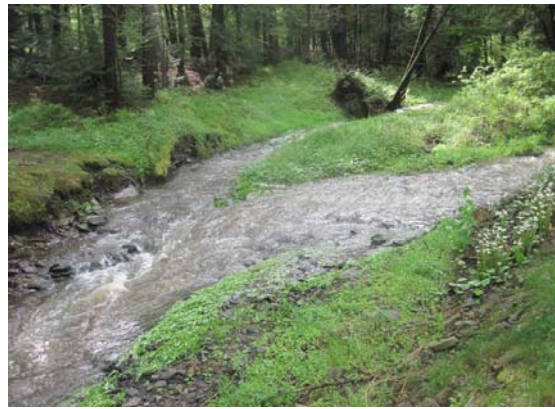
Third Brook main stem upstream of private road crossing, near station 222+00

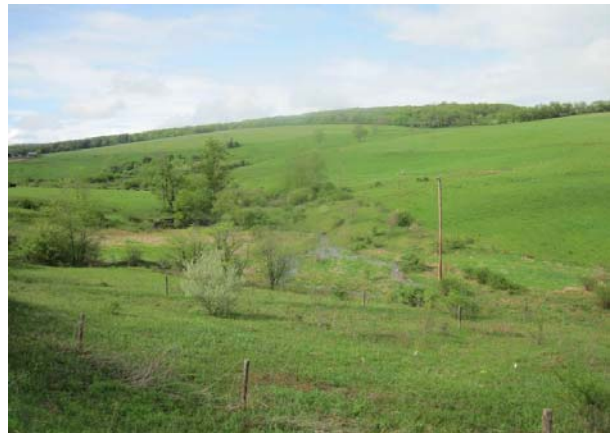
Third Brook near station 238+00 viewed from State Route 206

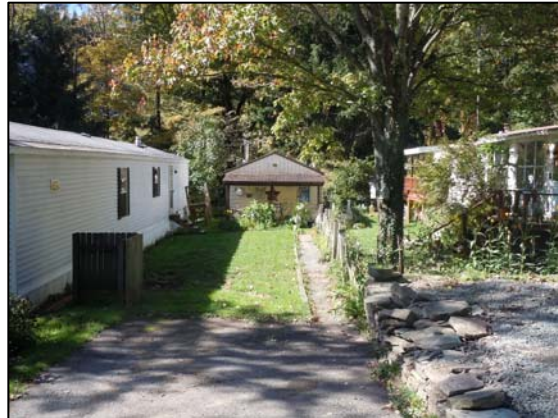
Example of outbuilding along Third Brook

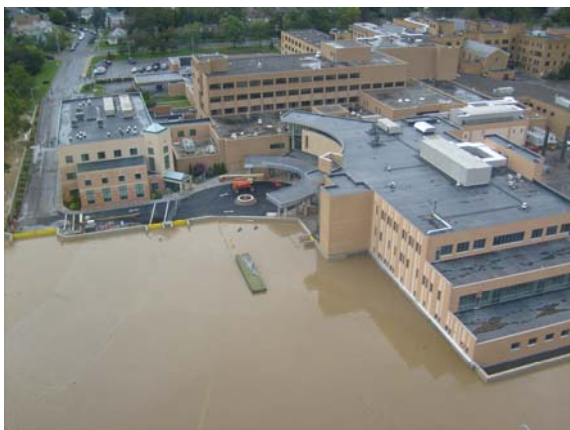
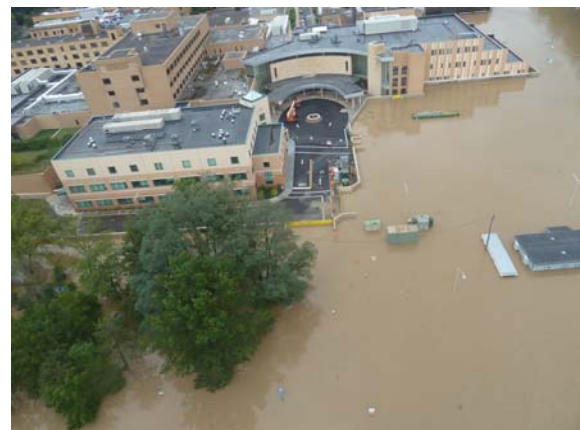
Binghamton's Lourdes Hospital provides a recent nearby example of a critical facility protected with a floodwall. The wall was deemed the most cost effective and reasonable solution for flooding from the Susquehanna River. The wall was built over five years, completed in 2011, and protected the hospital from the severe flooding that occurred a few months later due to storms Irene and Lee. The reinforced concrete floodwall extends 1,365 feet around the hospital between the parking lots and main rear entrance and reaches heights of 14 feet. It has 10 control gates, which can be operated electronically or manually and accommodates both vehicle and foot traffic.

Images of the Lourdes Hospital floodwall during flood of September 2011; courtesy of hospital
